TABLE 1  
International Control Dam – Service Deck – Span 4

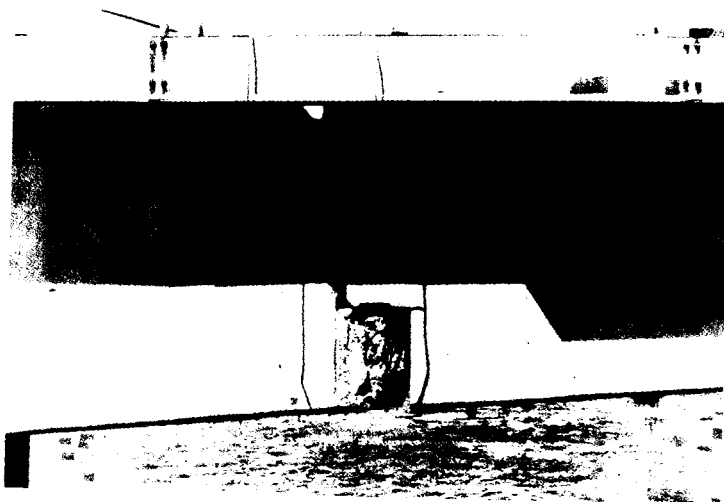
Typical View Prior to Lifting Span

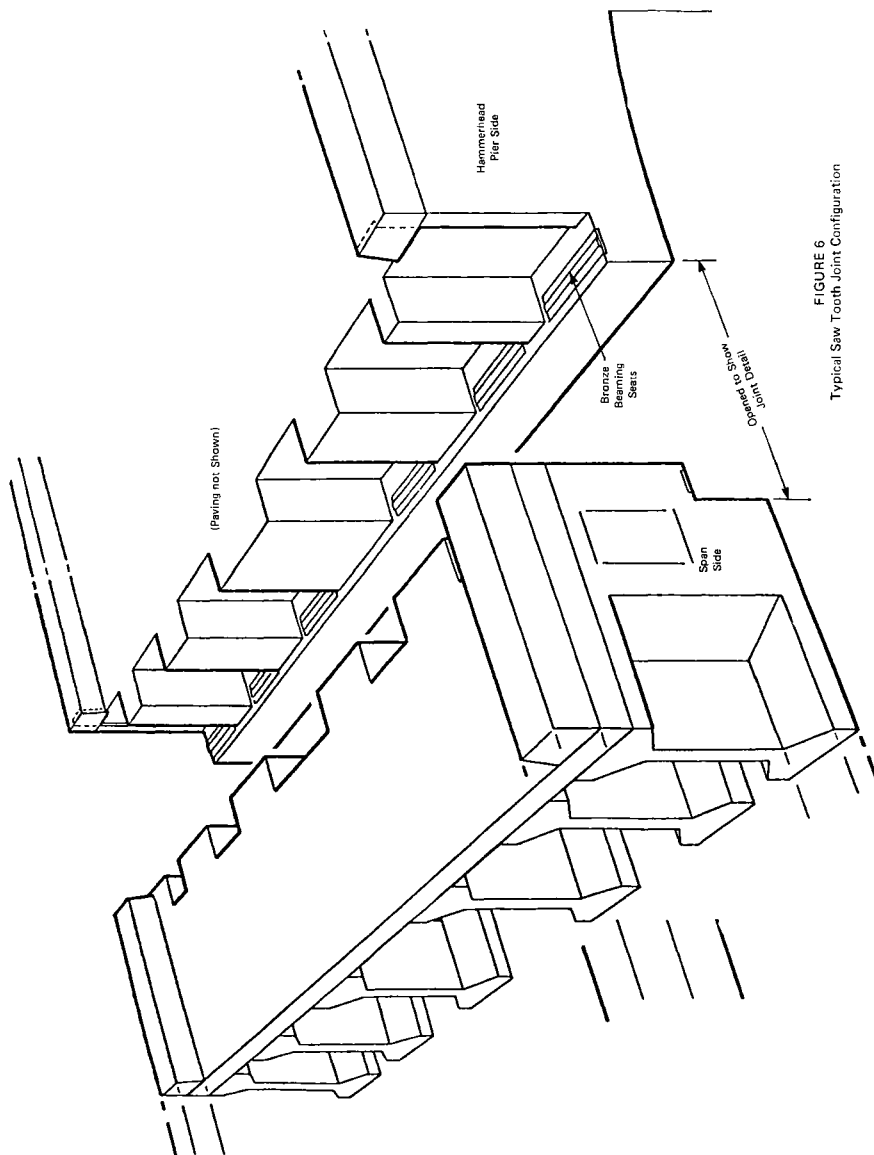
FIGURE 6  
Typical Saw Tooth Joint Configuration

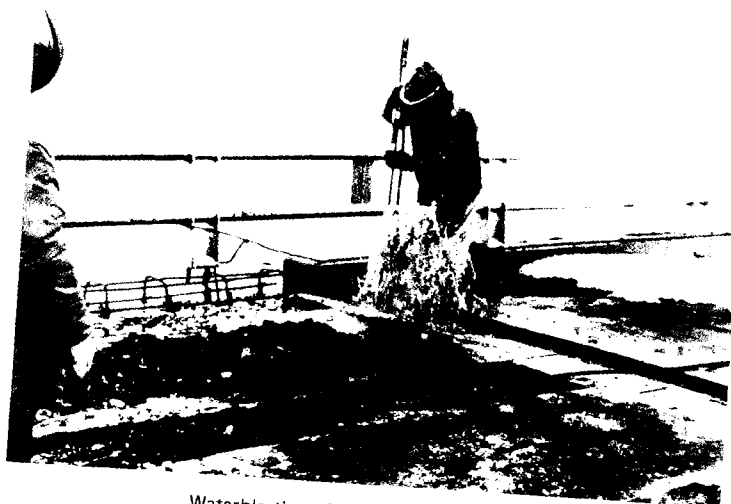
FIGURE 8

Waterblasting of Rubberized Tar Filler

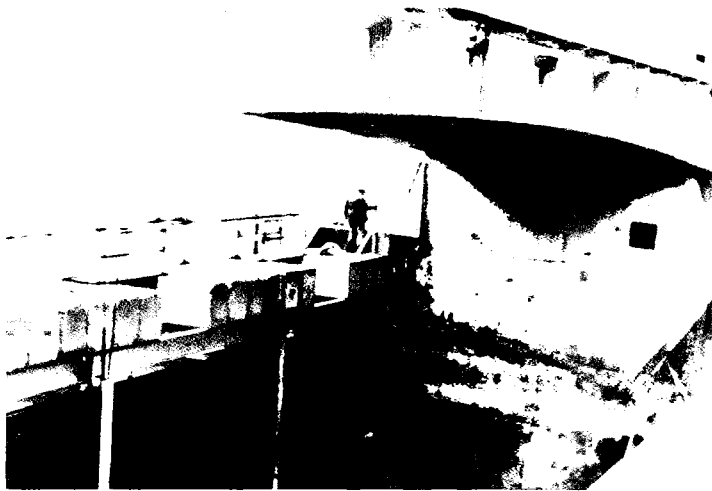
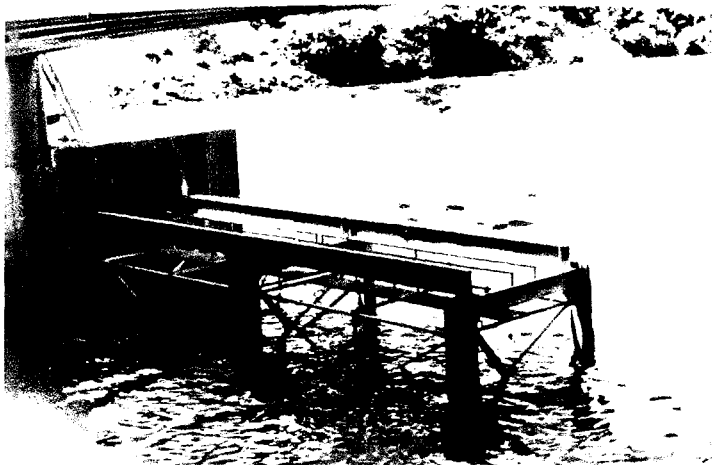
FIGURE 9

Installation of Frame Cofferdam
