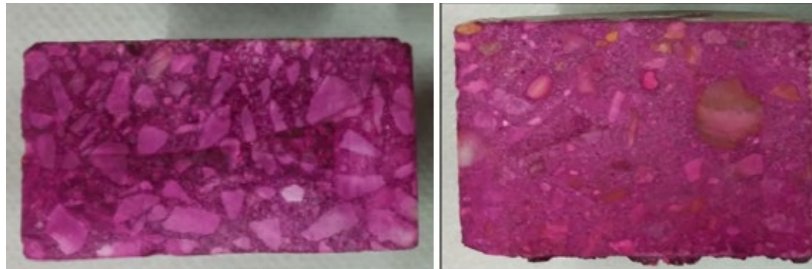
6). While no carbonation of concrete can be considered beneficial to steel rebars because the pH remains at high values, the opposite is true for GFRP reinforcement that is more sensitive to high alkalinity. Thus, the GFRP bars extracted from these cores were subject to an aggressive alkaline environment over the 17 and 11 years of service for Walker and Southview bridge respectively.

Fig. 6—Carbonation depth measurement of concrete samples extracted from Walker (left) and Southview (right) Bridge

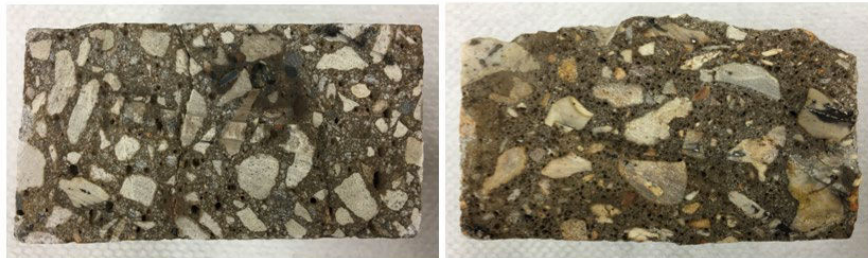
An adaptation of the rapid migration test (RMT) using silver nitrate solution was employed to determine the chloride diffusion in the concrete samples. Two concrete samples were cut in order to provide fresh split surfaces. A 0.1 mol/L silver nitrate solution was poured on the entire cut surface⁹. In the presence of chloride, a clearly visible white/silver precipitation takes place on the surface while in the absence of chlorides, the solution reacts with the hydroxides present in the concrete, changing the surface color to brown. No clear evidence of chloride diffusion was observed in all the tested specimens of both bridges using this method. It was noticed that the surface became darker, to a color similar to brown, while there was no visible gray area (Fig 7).

Fig. 7—Chloride diffusion measurement of concrete samples extracted from Walker (left) and Southview (right) Bridge

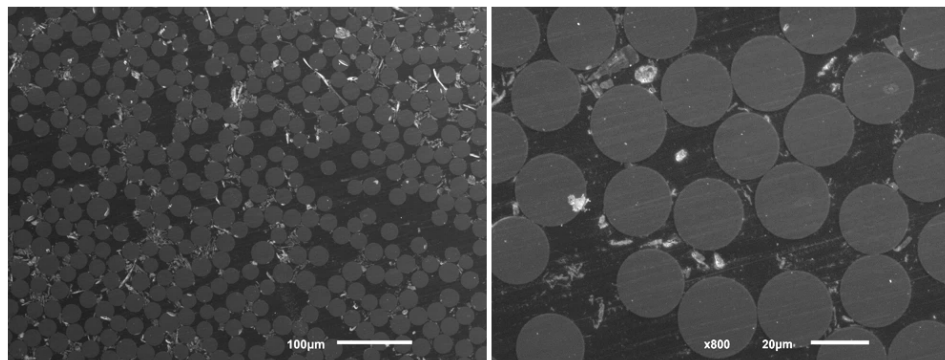
The GFRP microstructure was investigated since it is a critical parameter in performance and durability of GFRP bars¹⁰. The full cross-section of prepared GFRP coupons was scanned using SEM at different levels of magnification and images were taken at random locations. Attention was paid to the areas in the vicinity of the bar edges since possible degradation due to chemical attack starts at GFRP-concrete interface. Representative images are shown in Fig 8 and Fig 9. SEM analysis suggests that there was no apparent sign of deterioration in the GFRP coupons. No damage was observed in the matrix and at the matrix-fiber interface. Glass fibers appeared to be intact without no loss of cross-sectional area.

Fig. 8—SEM images of GFRP bar after 17 years of service in Walker Bridge in magnification levels of 200x (left) and 800x (right)

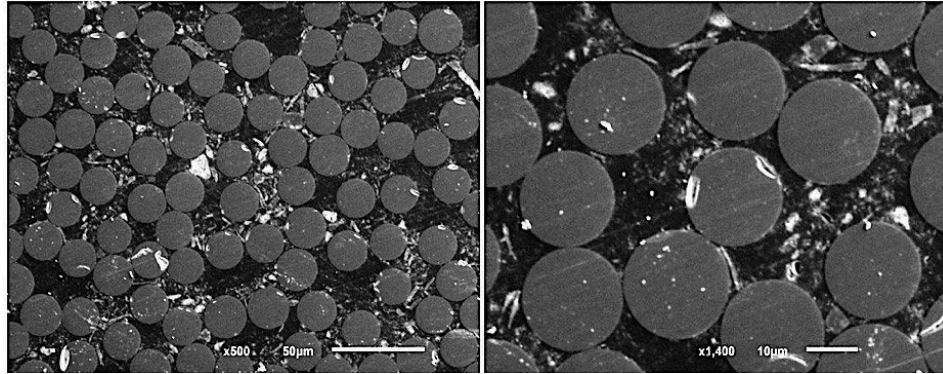
Fig. 9—SEM images of GFRP bar after 11 years of service in Southview Bridge in magnification levels of 500x (left) and 1400x (right)

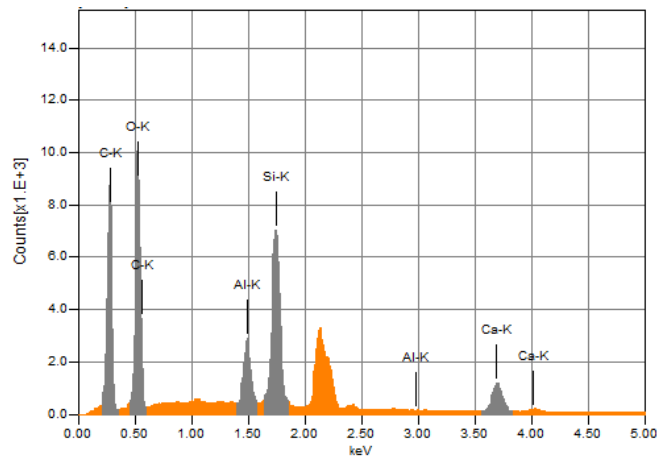
EDS was performed at several locations of each GFRP slices with a focus on the edge of the bar to identify existing chemical elements. Results are shown in Fig 10 and Fig 11 where the vertical axis corresponds to the counts (number of X-rays received and processed by the detector) and the horizontal axis presents the energy level of those counts. Si, Al, Ca (from glass fibers) and C (from the matrix) were the predominant chemical elements in the extracted samples. No apparent sign of any chemical attack was observed in the bars.

Fig. 10—Result of the EDS analysis performed on GFRP samples extracted from Walker Bridge

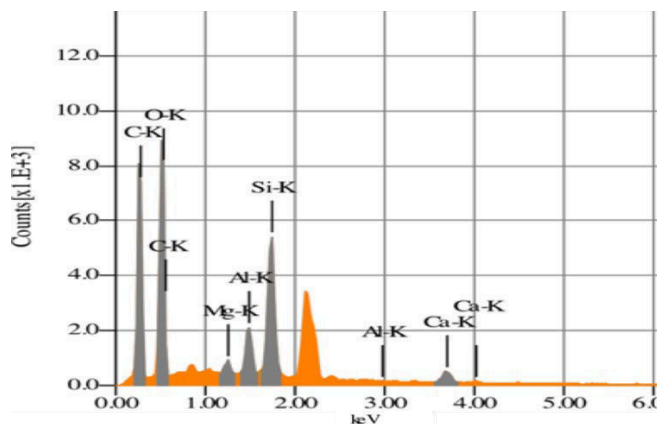
Fig. 11—Result of the EDS analysis performed on GFRP samples extracted from Southview Bridge

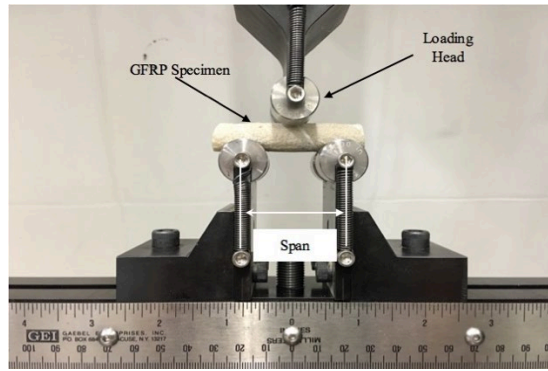
All three specimens presented the horizontal shear mode of failure and the shear strengths were determined following ASTM-D4475 as:

where S is the horizontal shear strength, P refers to the breaking load and d corresponds to the nominal diameter of the specimen. A summary of the results is shown in Table 2 where S_c and S_s , refer to the shear strength of control samples tested in 2015 and extracted samples, respectively. The same notation is employed for the failure load. The extracted GFRP bars showed about 5% increase in horizontal shear strength compared to the samples produce in 2015.

Since the horizontal shear is affected by the resin properties, the increase may be a result of resin crosslinking over time especially if it was not cured 100% at time of construction. It is recognized that the number of tested samples was not sufficient for a proper statistical analysis. However, the result of horizontal shear strength provided an additional evidence of GFRP long-term durability.

Fig. 12—Horizontal shear test performed on GFRP bars extracted from Southview Bridge
