Guide to the Code for Assessment, Repair, and Rehabilitation of Existing Concrete Structures

University of Houston East Garage Fire Emergency Response

2019 ICRI Award of Excellence – Parking Structures Category

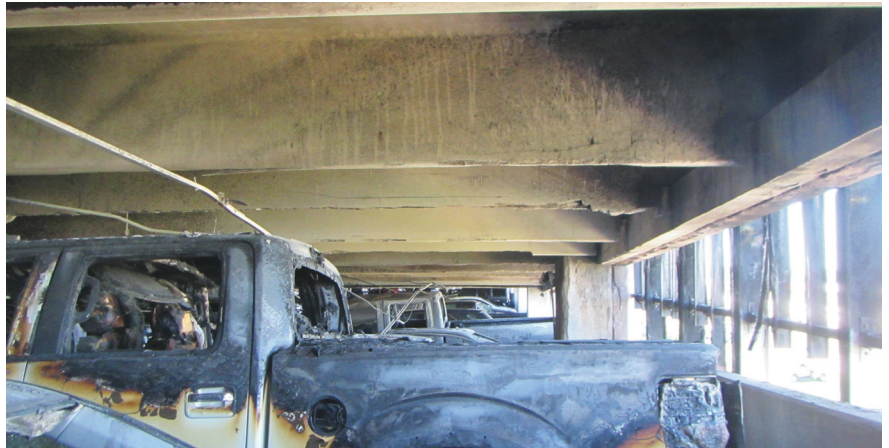
In April 2018, a multiple-vehicle fire occurred on the third level of the four-level University of Houston East Garage (Fig. 2). Significant structural damage occurred to two columns, the framing of the level above, and the exterior signage (Fig. 3). Before a survey of the damage could be completed, shoring was installed as a precaution to prevent the possible collapse of damaged members (Fig. 4).

Fig. 2—Fire damage on Level 3 of parking garage

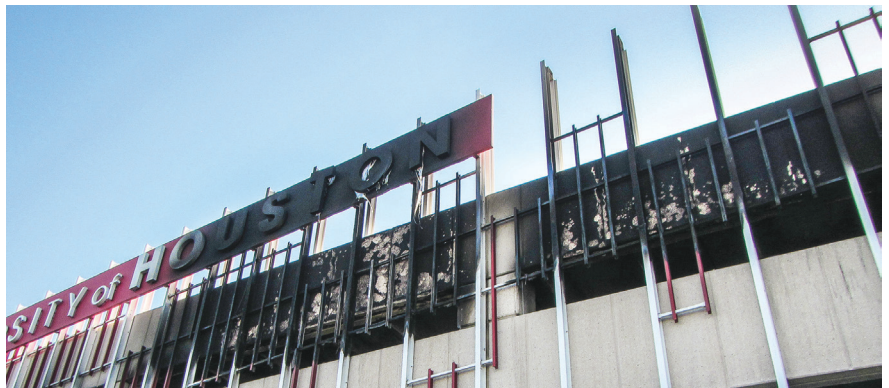
Fig. 3—Fire damage at exterior of garage

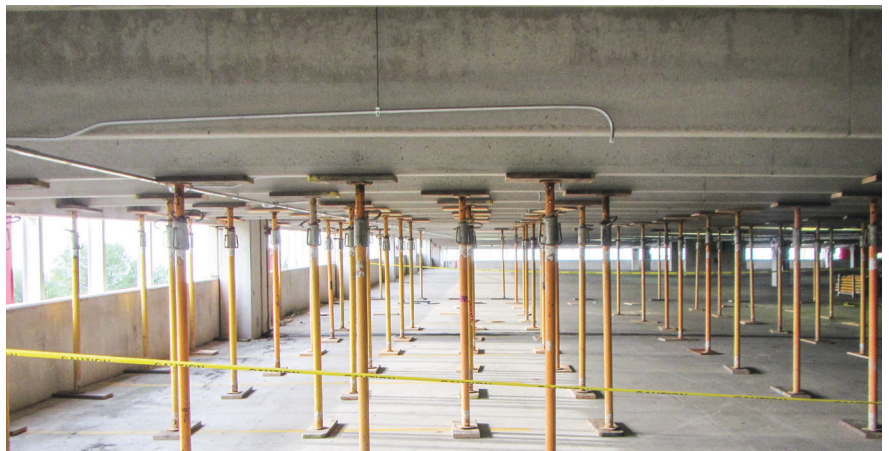
Fig. 4—Shoring installed in affected areas

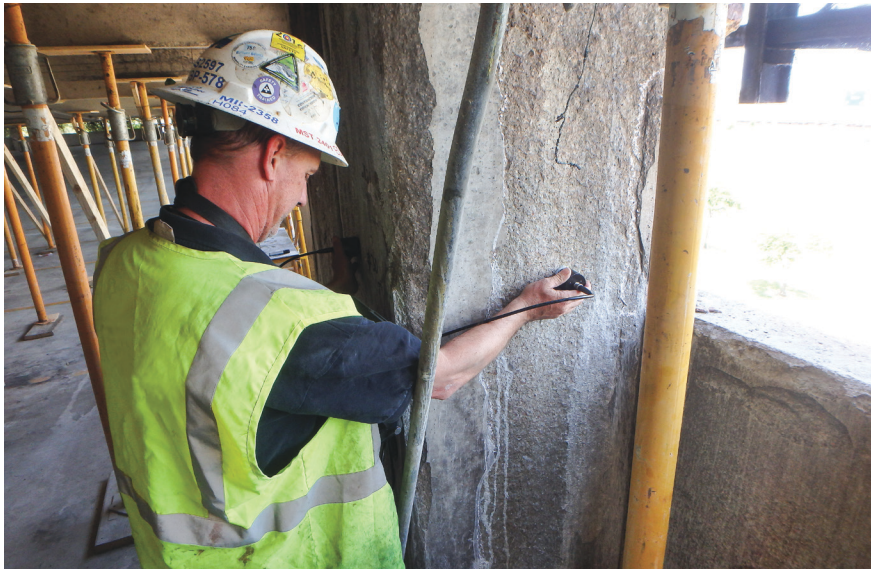
Fig. 5—Nondestructive testing performed at damaged column

Concrete testing was performed (compressive strength and petrographic examination) and nondestructive evaluation (NDE) methods were used to determine the severity of damage and repair approach. NDE methods included ground-penetrating radar (GPR) survey, ultrasonic pulse velocity (UPV) testing, and pulse-echo scanning (Fig. 5).

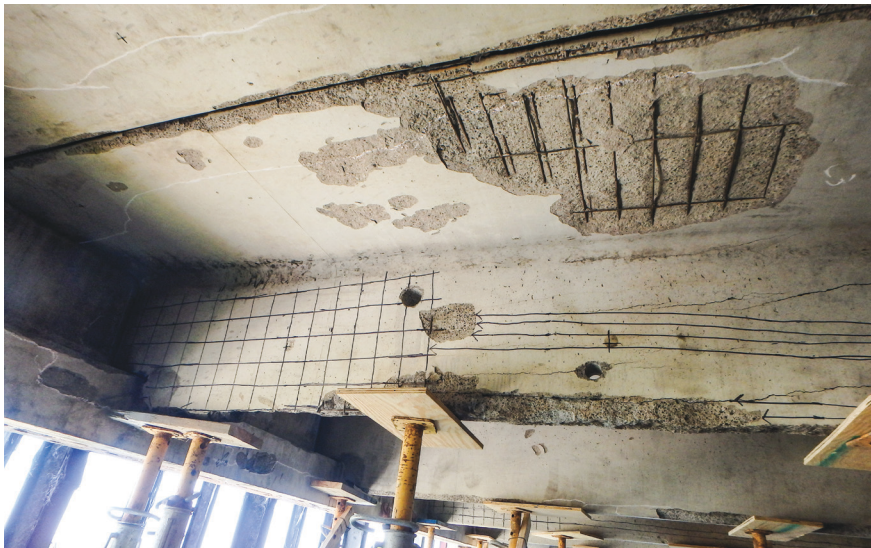
Fig. 6—Concrete cracking and spalling due to fire

The visual reviews and delamination survey indicated that fire-related distress had occurred in the form of concrete cracking and spalling, including delaminations identified in several crucial structural beams and columns (Fig. 6). The concrete distress was more severe at members near the expansion joint. Core compressive strength testing did not show degradation of compressive strength as a result of the fire event. However, the petrographic examination of the concrete cores indicated the extent of surficial concrete damage as a result of exposure to fire-elevated temperatures was up to a depth of 0.4 in. (10 mm).

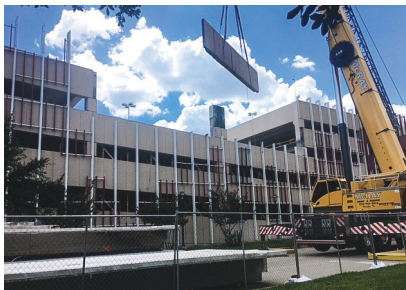
Fig. 7—Spandrel beam replacement

reinstalled in their original position. Two spandrel beams were hoisted down, removed from the site, and replaced with new members (Fig. 7). New replacement double tees were hoisted into place for final repairs (Fig. 8).

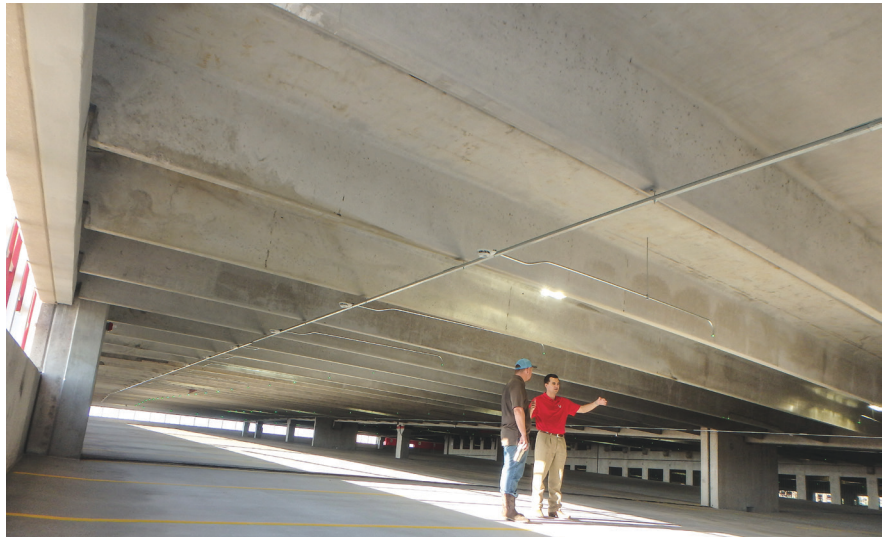
Fig. 8—New replacement double-tee beams at completion

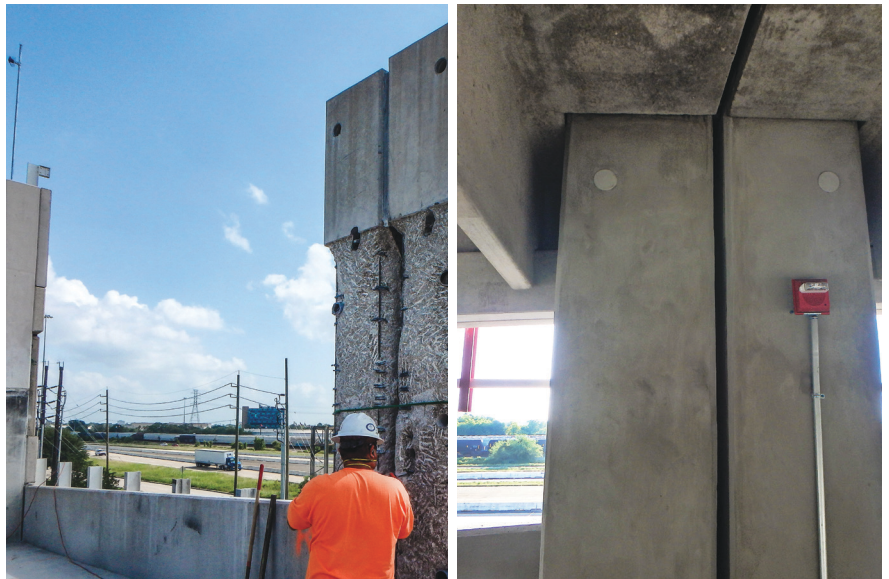
Fig. 9—Column during repair (left) and after repair (right)

Other repair works included the repair of concrete columns supporting Level 4 (Fig. 9), spandrel beams on Levels 3 and 4, double-tee members on Level 4, topping slab replacement on Level 3, and waterproofing installation on Levels 3 and 4. The damaged expansion joint system on Level 3 was replaced and a new expansion joint system was installed on Level 4. Joints were tooled in the topping slab and sealed above the double-tee flange-to-flange joints, and construction joints were routed and sealed. Cove sealant was installed at the perimeter bumper wall and columns.
