CASE STUDY #2 – INSULATION DEGRADATION

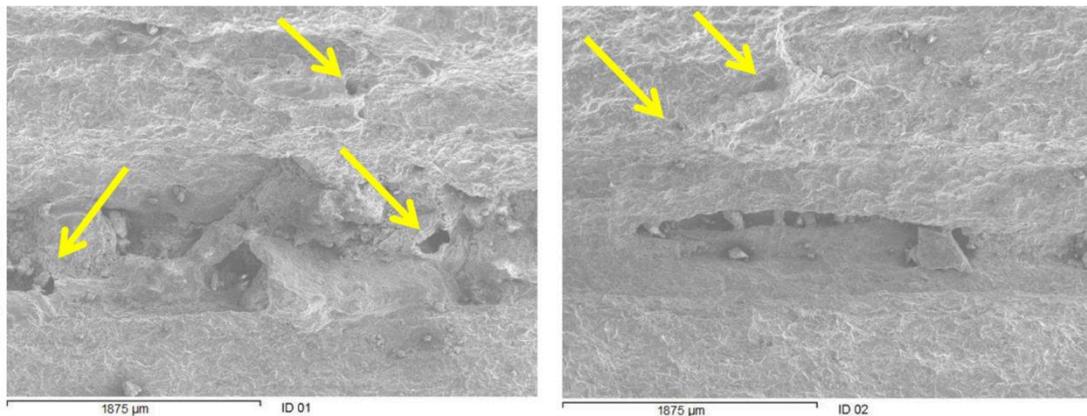
SEM examination of the leak location was also conducted. Representative SEM images are shown in Fig. 6. Small pits within the crevice were observed, consistent with MIC. EDS analysis of a tubercle deposit sample removed from the pipe segment inner surface detected the presence of iron, oxygen, chromium, molybdenum, and silicon, consistent with iron oxide. EDS analysis of the adherent material on the pipe inner surface away from the crevice detected iron, oxygen, chromium, phosphorus, and zinc, consistent with iron and chromium oxides.

Fig. 6 Representative SEM images of the leak location on the ID surface, with pits observed in the crevice (indicated by arrows).

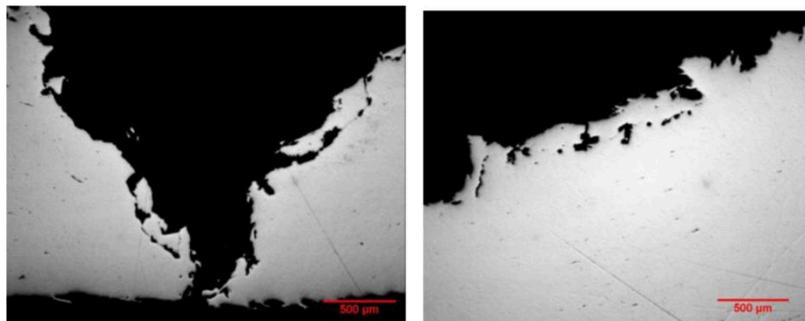
A specimen at the leak location was cross-sectioned and prepared for analysis using standard metallographic preparation techniques. Within the crevice, irregular-shaped cavities were evident, consistent with MIC (Fig. 7). In the etched condition, the base metal was comprised of a ferrite-pearlite microstructure consistent with plain low-carbon steel (Fig. 8). No evidence of weld metal was observed in the specimen.

Fig. 7 Metallographic images of the perforation in the as-polished condition.

Results of the evaluation of the secondary water riser pipe segment indicated that the leak occurred as a result of localized corrosion attack from the inside of the pipe. A build-up of tubercle deposits led to stagnant water conditions that resulted in breakdown of the protective oxide layer at a rough feature created by a defective ERW seam and initiation of localized underdeposit corrosion attack exacerbated by microbiologically influenced corrosion (MIC). The build-up of significant tubercle deposits over time likely created localized stagnant or low-flow conditions that reduced the efficacy of chemical water treatment and intensified the MIC attack.

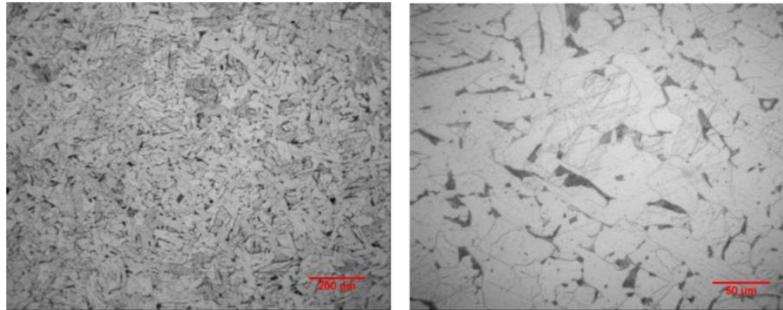
Fig. 8 Representative metallographic images of the pipe segment base metal in the etched condition.

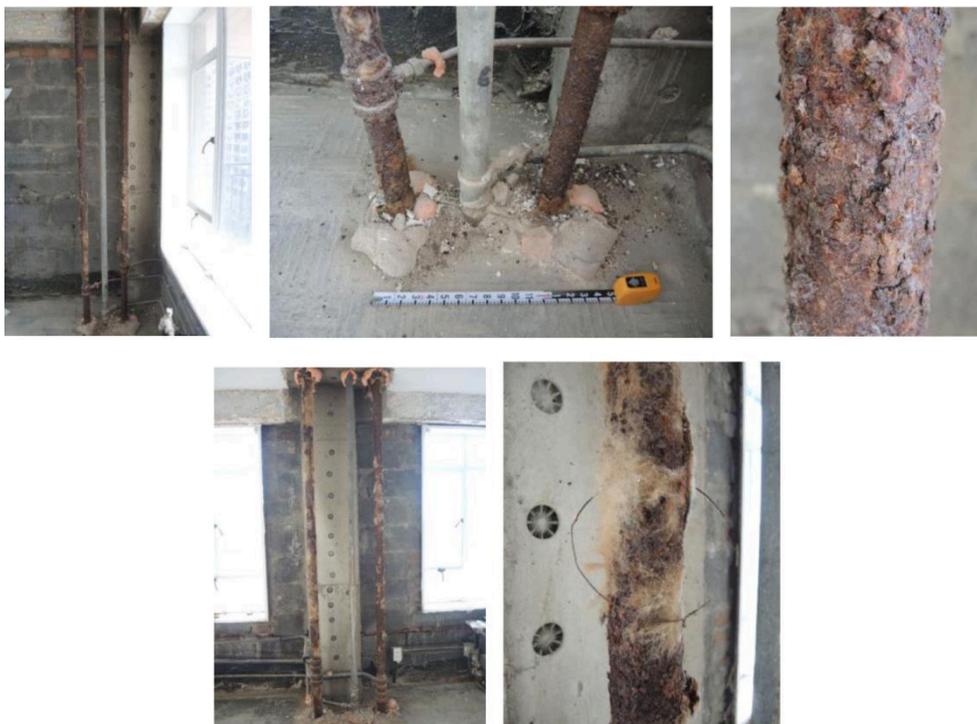
A site inspection included an examination of riser piping and branch line joints in an apartment under renovation, as shown in Fig. 9. Remnants of fiberglass insulation were present on the riser piping, but a general lack of insulation was observed. Extensive corrosion products were evident on the exterior surfaces of the riser piping and branch line tee fittings.

Fig. 9 Riser piping and branch line joints observed during a site inspection.

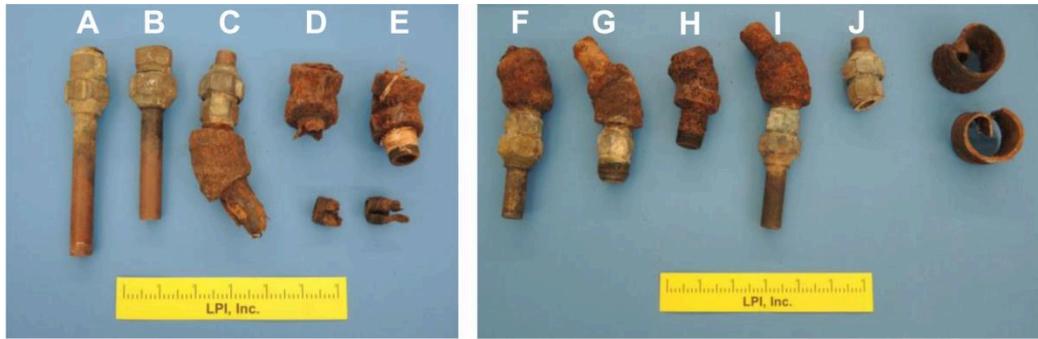
Fig. 10 Submitted branch line joints A through J in the as-received condition.

Similar conditions were observed on all five branch line joints in the as-received condition. The steel pipe segments had sustained substantial wall thickness loss, pitting corrosion was evident on the elbow fittings, and superficial corrosion was observed on the copper pipe segments and brass fittings. The appearances of the remnant portions of the steel pipe segments suggested that the material loss occurred from the external surface inward.

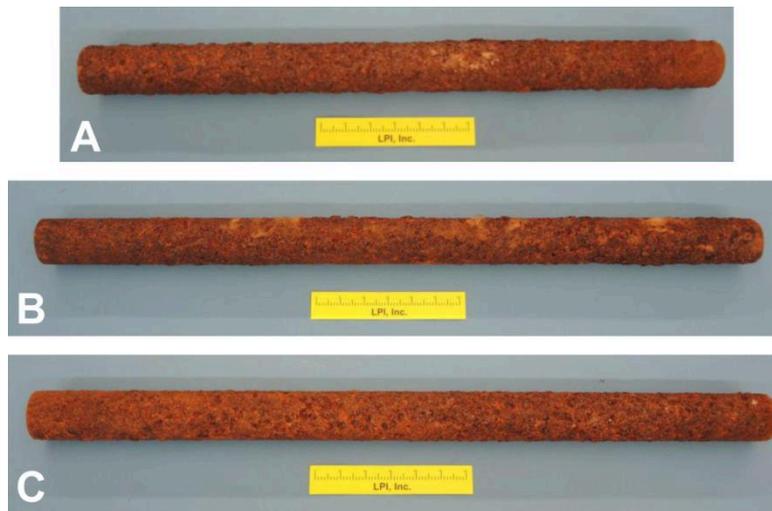
Fig. 11 Submitted riser pipe segments A through C in the as-received condition.

The three riser pipe segments were similar in appearance, with extensive pitting corrosion and corrosion products evident on the external surfaces. Remnant fiberglass insulation material was present on the segments. Some of the corrosion products were friable and flaked off the

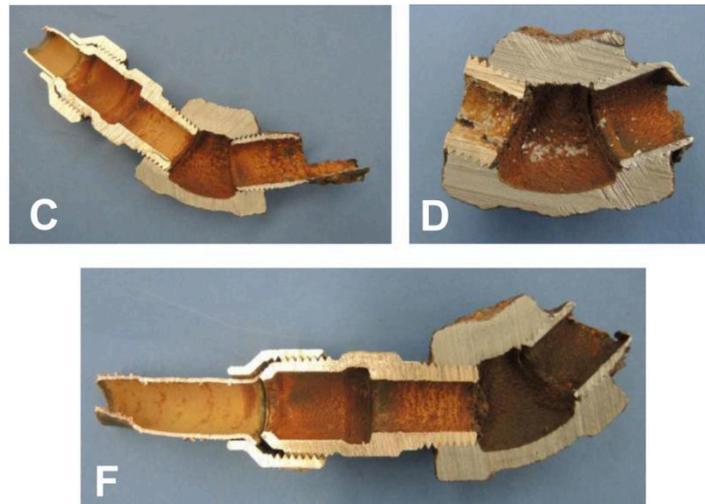
Fig. 12 Branch Line Joints C, D, and F after longitudinal sectioning to allow for examination of the inner surfaces.

Joints C, D, and F were subsequently sectioned longitudinally to allow for examination of the inner surfaces. As shown in Fig. 12, the inner surfaces of the pipe segments and fittings were covered with an adherent yellow/tan corrosion product likely consistent with a protective oxide. No evidence of degradation indicative of galvanic corrosion attack was observed at any of the threaded connections. This was confirmed by stereomicroscopic examination, as shown in representative images of the Joint C steel pipe segment and Joint D fitting threads in Fig. 13.

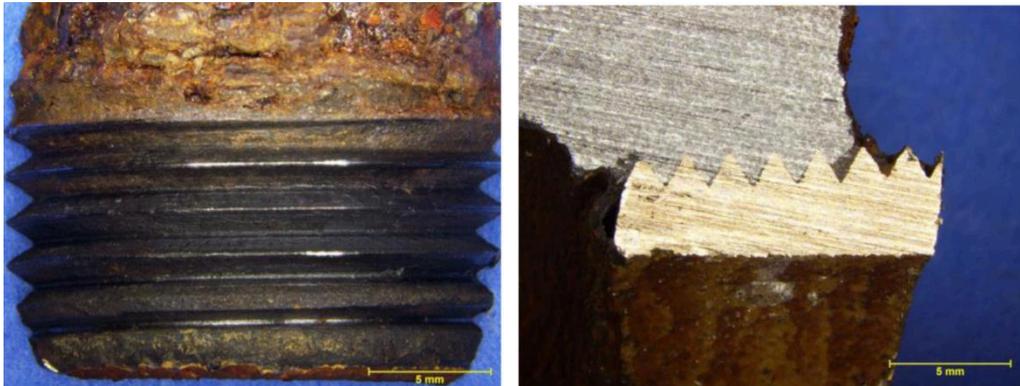
Fig. 13 Representative stereomicroscopic images of the Joint C steel pipe segment (left image) and the Joint D fitting threads (right image).

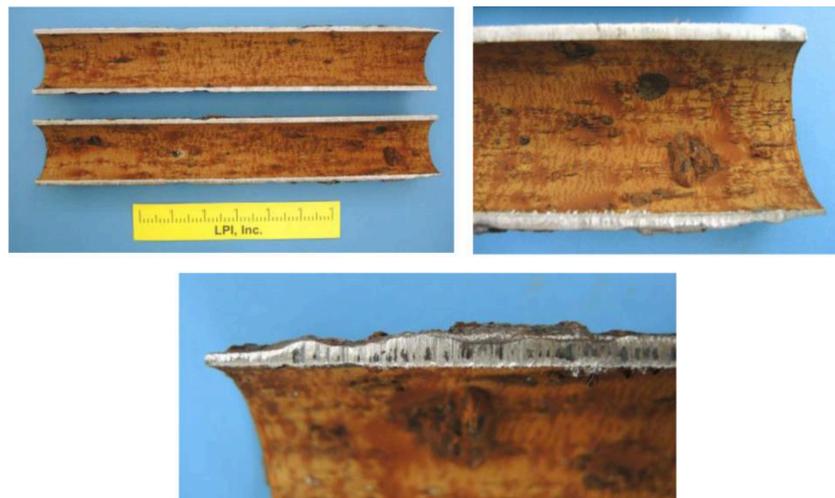
Fig. 14 Riser pipe segment B after longitudinal sectioning.

Portions from all three riser pipe segments were subsequently sectioned longitudinally to facilitate examination of the inner surfaces. An adherent yellow/tan corrosion product likely consistent with a protective oxide was present, as shown in Fig. 14. Tubercles were also evident on the inner surfaces of each segment. Reduced wall thickness of more than 50 percent was evident at locations of pitting corrosion attack on the outer surfaces. One half of each segment was then cleaned to remove the corrosion deposits. Evidence of shallow pitting corrosion attack was present on the inner surfaces of all three riser pipe segments, as shown in Fig. 15.

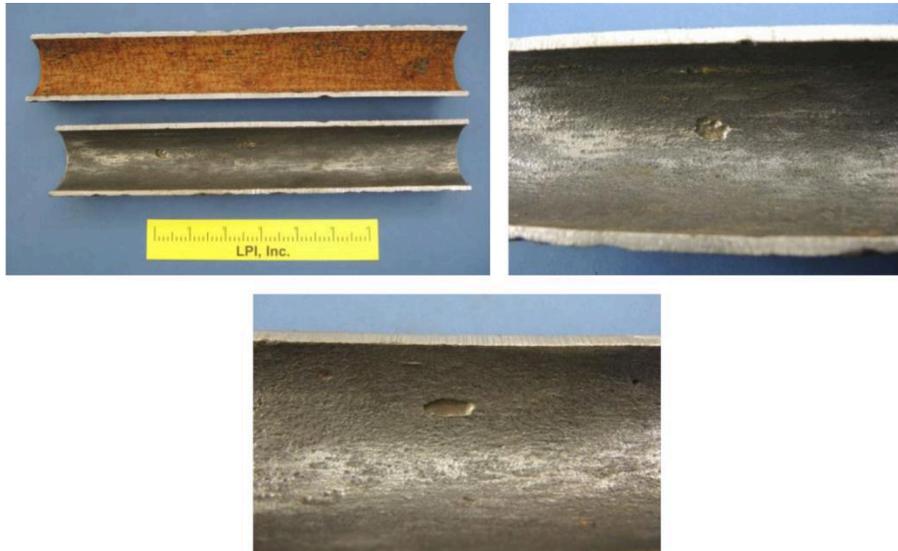
Fig. 15 Riser Pipe Segment C after cleaning.
