## 3.4 EXERCISE ON FAILED METAL CONNECTORS AT SITE 6

# CHAPTER 4

## Solar Panel Arrays

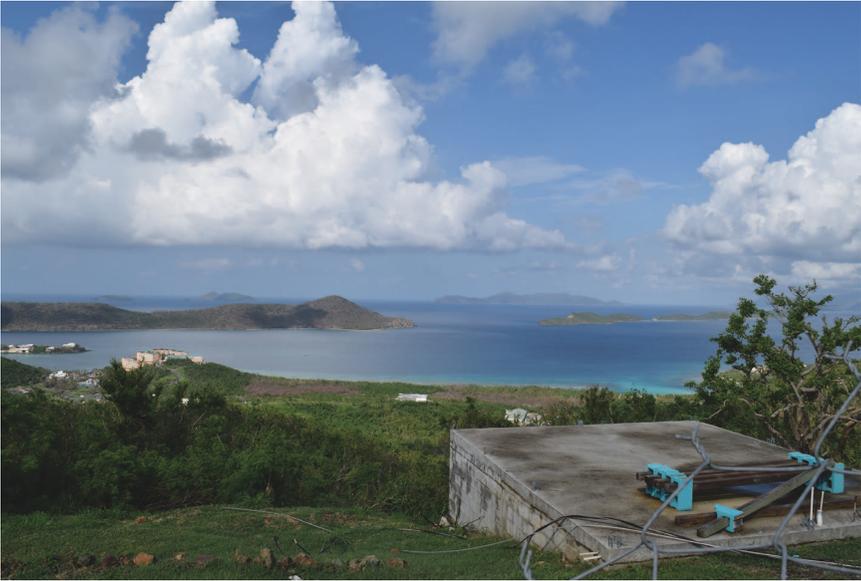
Figure 3-24. View looking northeast from Site 8.

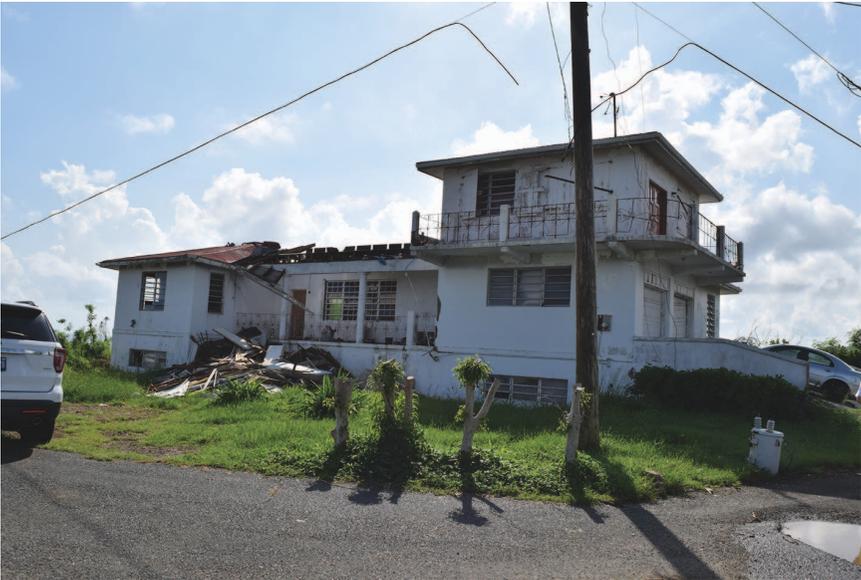
Figure 3-25. Damaged roof at Site 8.

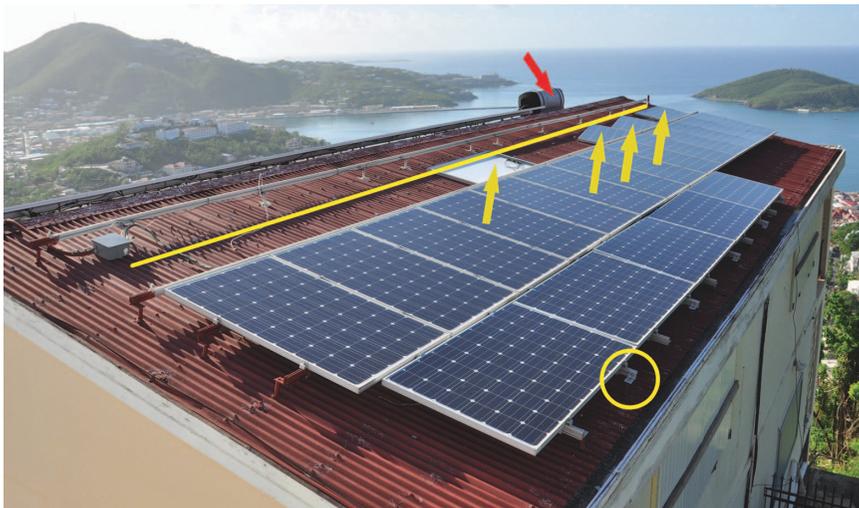
Figure 4-1 shows the roof of one of the observed buildings. Several panels had detached from the rails on one side of the roof. On the other side, all the panels remained attached. These arrays were installed over a corrugated metal roof (a very common roof covering on St. Thomas).

Figure 4-1. Rooftop solar panels detached from the rails. The yellow line indicates where 14 panels detached. Four of the detached panels (yellow arrows) remained on the roof. See Figure 4-2 for a close-up of the connection details indicated by the yellow circle. The red arrow indicates a component of a solar hot water heater shown in Figure 4-5.

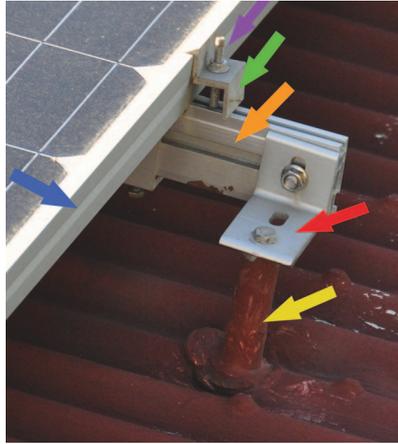
Figure 4-2 shows connection details; they are representative of connections that were commonly observed. The panels were attached with clips that were attached to extruded aluminum rails.

*Figure 4-2. Solar panel array component connections. The blue arrow indicates a panel's extruded aluminum frame. The green arrow indicates a panel end clip. The purple arrow indicates a T-bolt. The orange arrow indicates a rail. The red arrow indicates a clip angle that connects the rail to the post (yellow arrow), which is anchored to the roof structure and/or deck.*

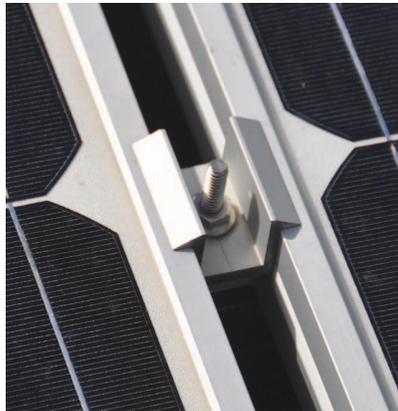
*Figure 4-3. Panel-to-panel clip and T-bolt.*

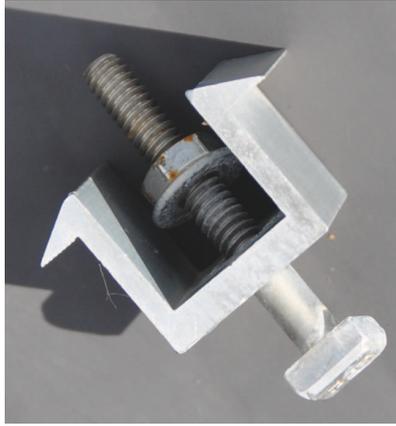
Figure 4-4. Panel-to-panel clip and T-bolt that detached from a rail.

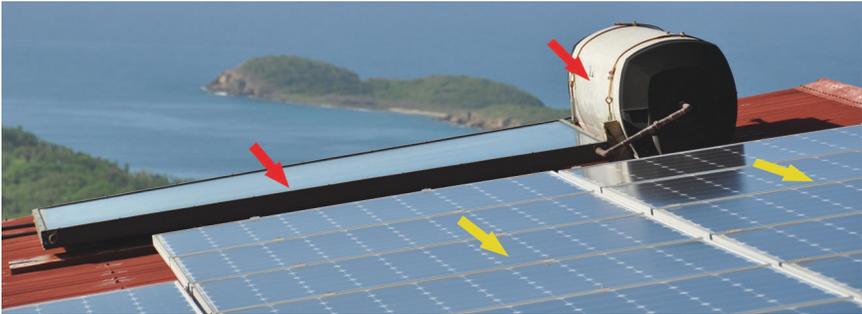
Figure 4-5. Solar hot water heater (red arrows) and PV panels (yellow arrows), also shown in Figure 4-1.

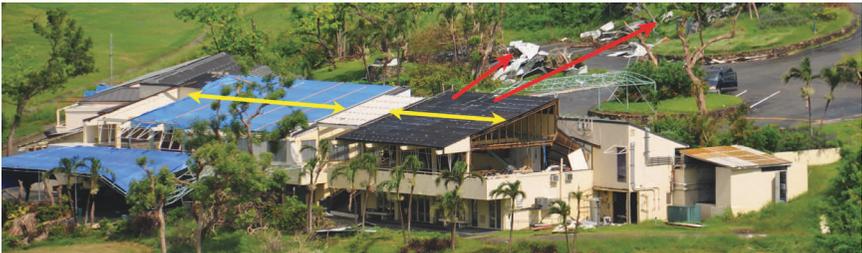
Figures 4-6 to 4-11 show a building with solar arrays attached to standing seam metal roofs (this building is discussed in Section 3.3.7). The solar panels were attached to rails that were attached to the metal panels with external seam clamps. All or most of the metal roof panels blew off one side of the building (Figure 4-6). Solar panels were attached to those roof panels. Some of the wind-borne roof panel / solar panel debris blew approximately 200 ft. The way the solar panels were attached to the roof panels likely was the direct or contributing cause of roof panel blow-off, as discussed as follows.

Figure 4-6. Solar panels and metal roof panels blown off the windward roof. The yellow arrows show the extent of the blown-off roof panels. The red arrows indicate metal roof panel and solar panel wind-borne debris.
