BRIDGE OVERPASS OUTAGE
- RIKUZENTAKATA

FLIPPED BRIDGE - ONAGAWA

Chapter 10

Seawalls and Tsunami Barriers

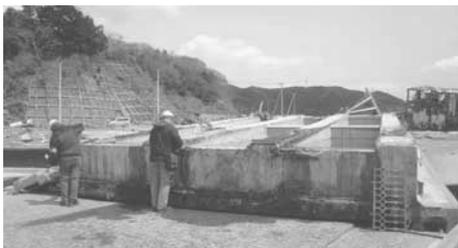
VIEW @ CURRENT LOCATION
(Chock)

Buoyancy likely added to failure
Relocation was Seaward of original location
(Indicating movement during drawdown return flow)

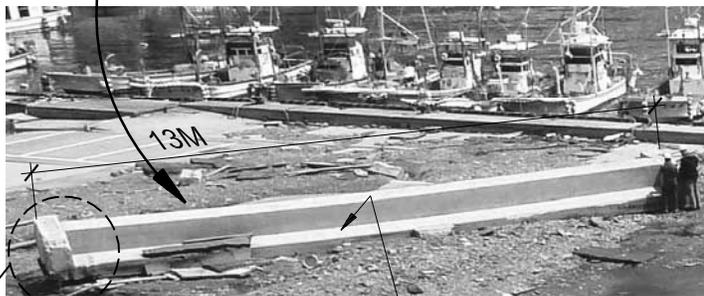
DISPLACED PRECAST CONCRETE BRIDGE (Robertson)
Bottom Side Up

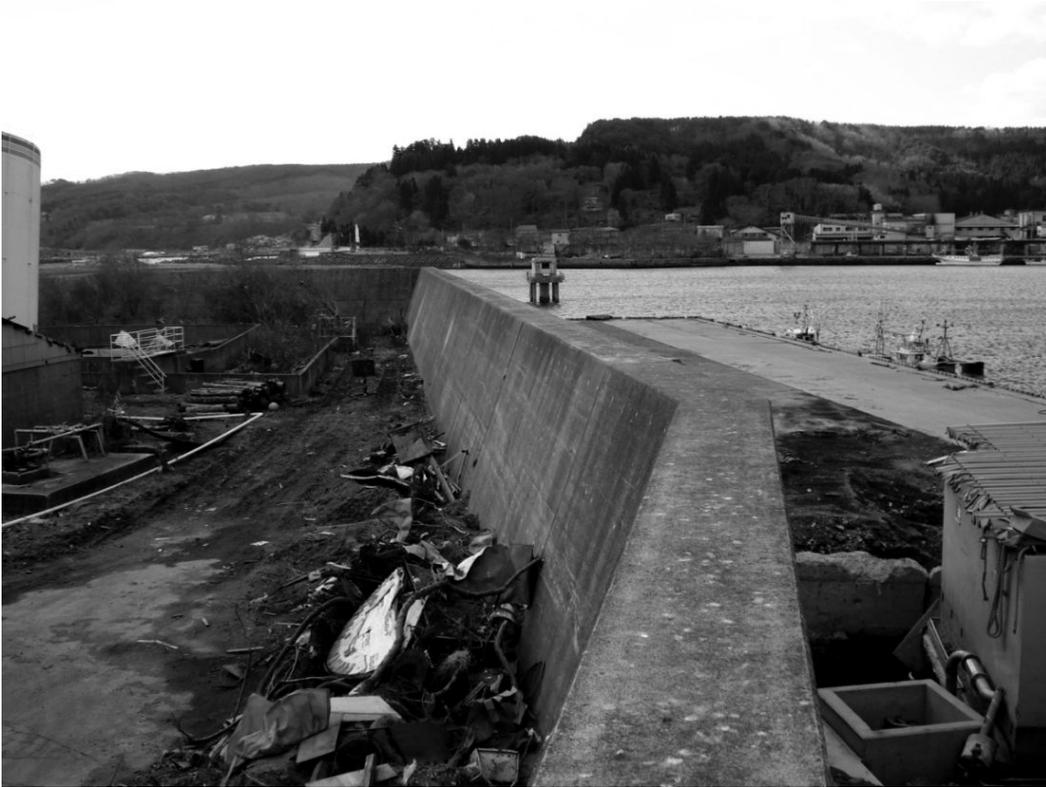
Kuji harbor was surrounded by a vertical concrete flood wall at an elevation of 8.25 m above sea level. Tsunami levels were apparently higher than the tsunami barrier as a large log and fishing net were found on top of the seawall. The basic design at Kuji featured a vertical face on the harbor side and an inclined face on the landward side, presumably to better resist overturning moments (Figure 10-1).

Figure 10-1: Kuji flood wall, viewed from landward side (Nistor)

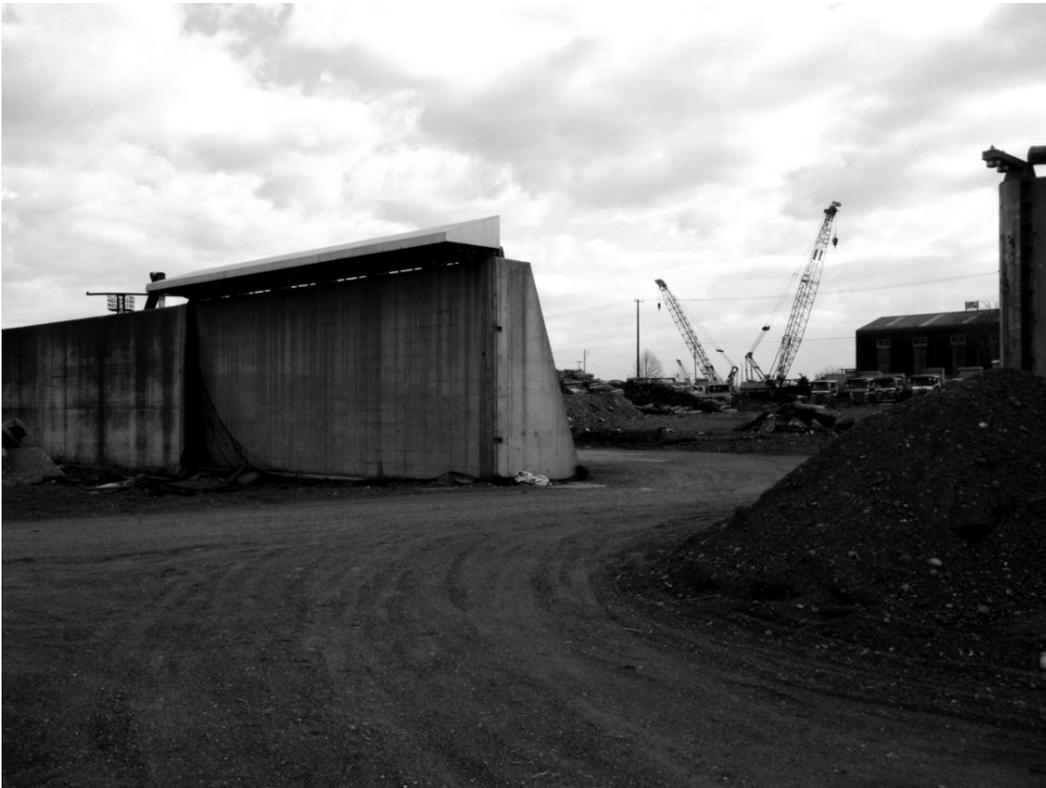
This wall was intended to keep the rising sea level out of upland areas in the event of a tsunami. The wall had several 10-m-wide openings to allow car/truck traffic through to the port, and each was fitted with a roller gate. These gates were 10 m long and 6.45 m (or 6.8 m) high (not 8.25 m as they extended from ground to the top of the wall). One gate observed to be missing had been transported approximately 60 m away and deposited in the harbor area on the quay wall (Figure 10-2 and Figure 10-3). The gate design seemed to rely on water pressures from the harbor to push the roller gate against the concrete wall. In this instance, however, it appeared that the fluid load that caused failure came from the opposite (landward) side and pushed the gate away from the concrete. After overtopping of the wall, the hydrostatic pressure on the landward side of the gate had not been considered in the design. This gate failure mode is consistent with those observed at other cities including Miyako, where the damaged gates lay on the seaward side of the seawall. Once the gates had failed, the impoundment behind the wall could drain, but the gate was no longer effective to prevent subsequent incoming tsunami waves from passing through the gate opening.

Figure 10-2: Kuji flood wall viewed from seaward side. Note missing flood gate (Kriebel)

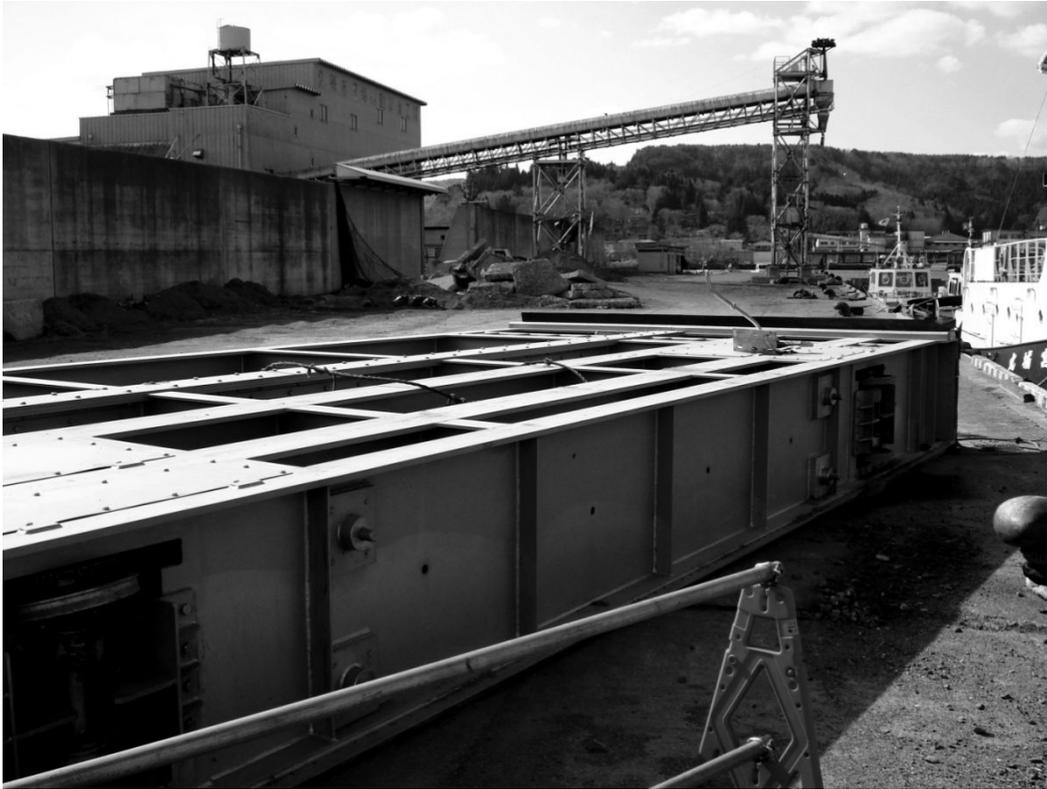
Figure 10-3: Displaced flood gate from Kuji flood wall (Nistor)

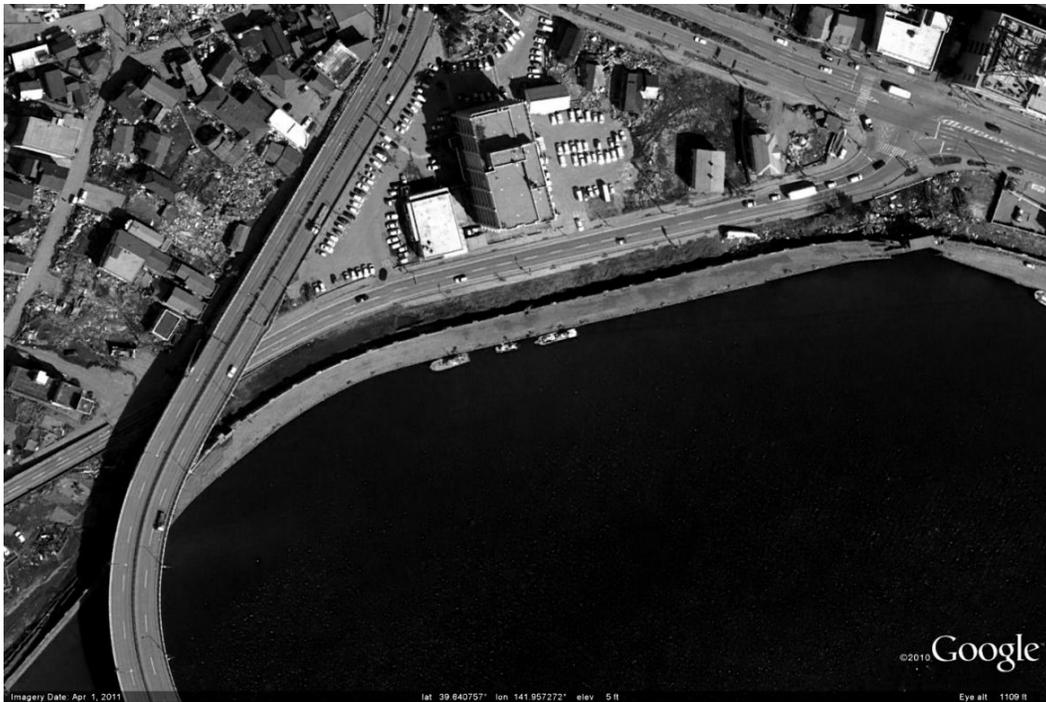
The tsunami barrier in Miyako is among the most famous of the post-tsunami images and videos that have been posted on the Internet. The videos showed a wall of black water, including floating vehicles and boats, which cascaded over the wall like flow over a spillway, subsequently rushing into town as the wall was overtopped (Figure 10-4 and Figure 10-5).

Figure 10-4: Aerial view of Miyako flood wall (© 2011 Google)

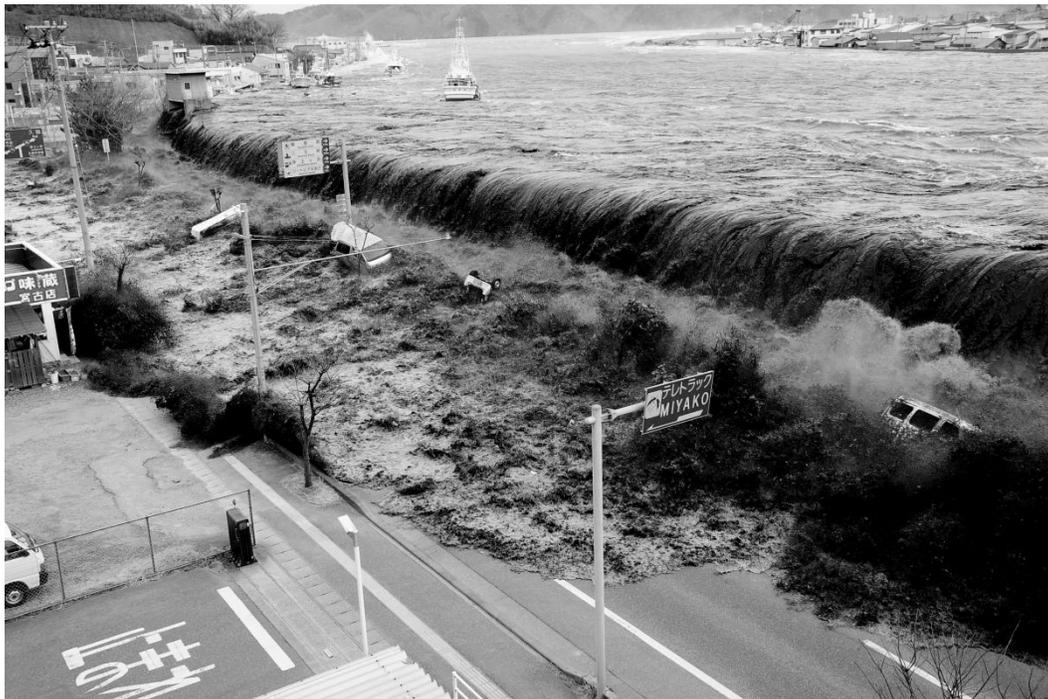
Figure 10-5: Tsunami crashing over Miyako City seawall (©Mainichi / AFLO)

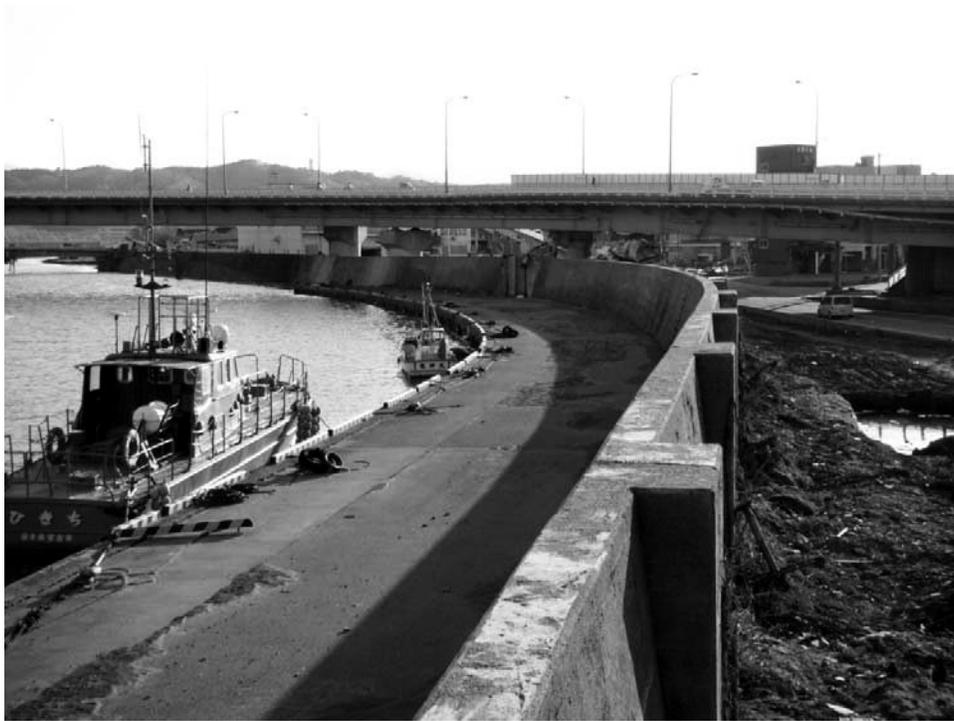
The Miyako barrier survived in most locations with little visible damage (Figure 10-6). The barrier design is a vertical concrete wall 40 cm wide with vertical supports spaced every 10 m along the length of the wall. Despite the formation of a long scour trench on the landward side, extending about 1 m deep in places, critical foundation details could not be seen. The concrete quay fronting the barrier remained intact so that the foundation was not exposed on the seaward side. The scour trench formed 2–3 m landward of the rear of the wall, and the wall did not overturn or slide as a result of the scour (Figure 10-7 and Figure 10-8).

Figure 10-6: View of Miyako seawall (Kriebel)

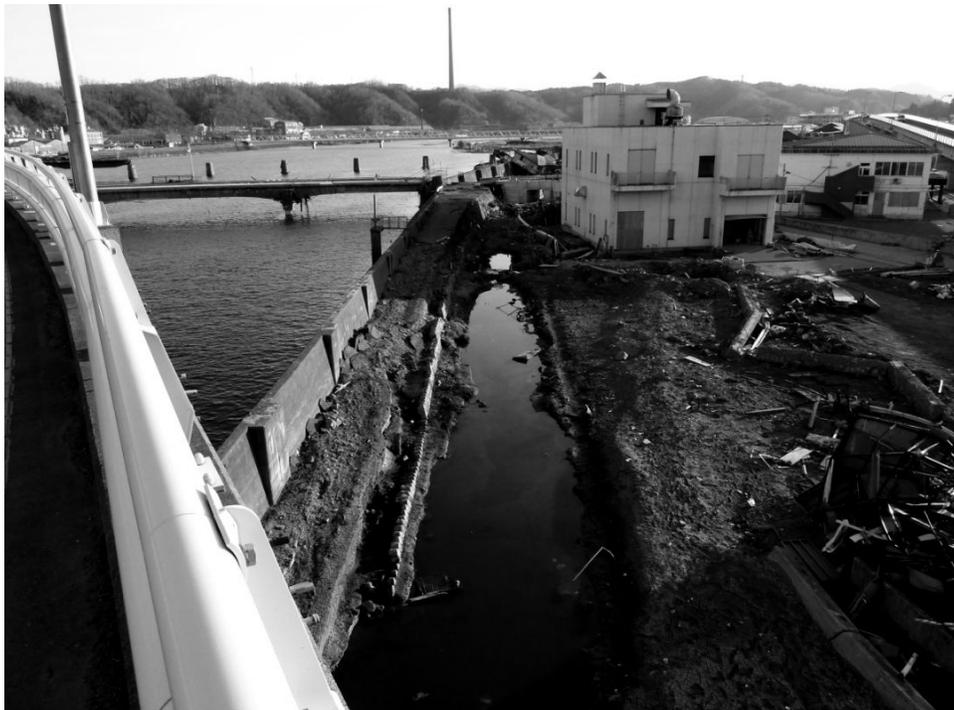
Figure 10-7: View of scour trench landward of Miyako flood wall (Robertson)

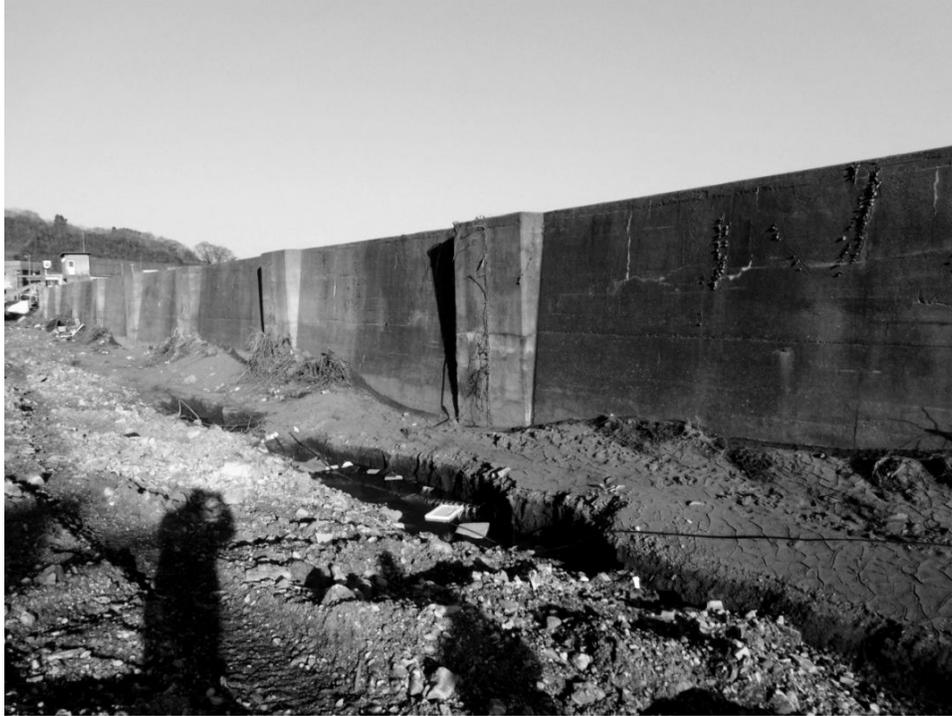
Figure 10-8: Additional view of scour trench behind Miyako flood wall (Kriebel)

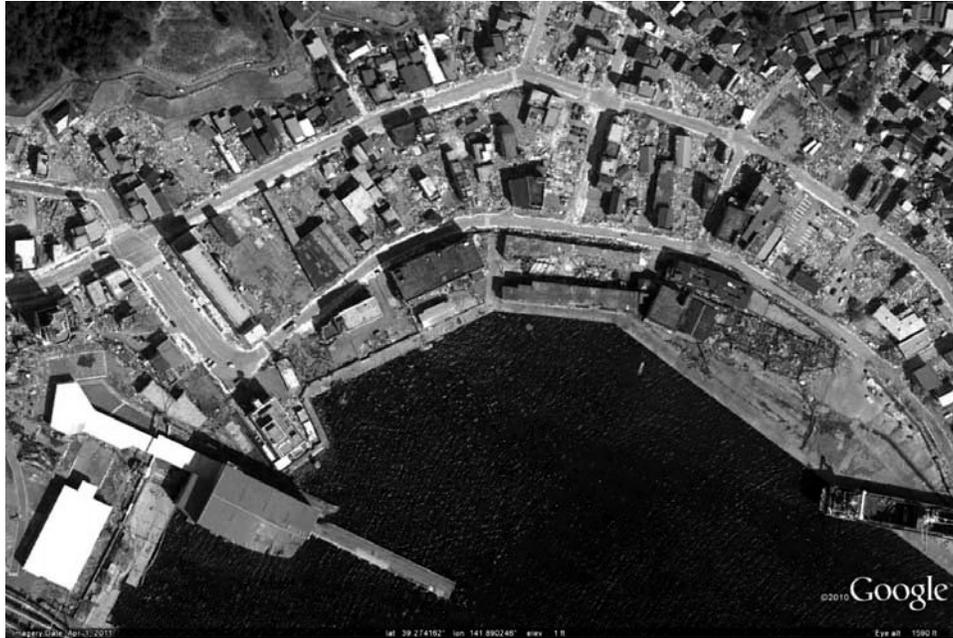
Kamaishi had the lowest seawall of any town visited. The seawall was a vertical concrete structure with a top elevation of 2.1 m above sea level (Figure 10-9 and Figure 10-10). There was notable subsidence, and the harbor quay/wharf seaward of the seawall was awash (Figure 10-11). As a result, it seems likely that the original wall elevation was about 3 m. Inundation on the buildings immediately behind the wall was measured at 8.4 m above sea level. As a result, the wall was submerged by more than 6.3 m of water at one time. In general, the wall remained in functional shape with little to no scour (Figure 10-12).

Figure 10-9: Aerial view of Kamaishi flood wall (© 2011 Google)

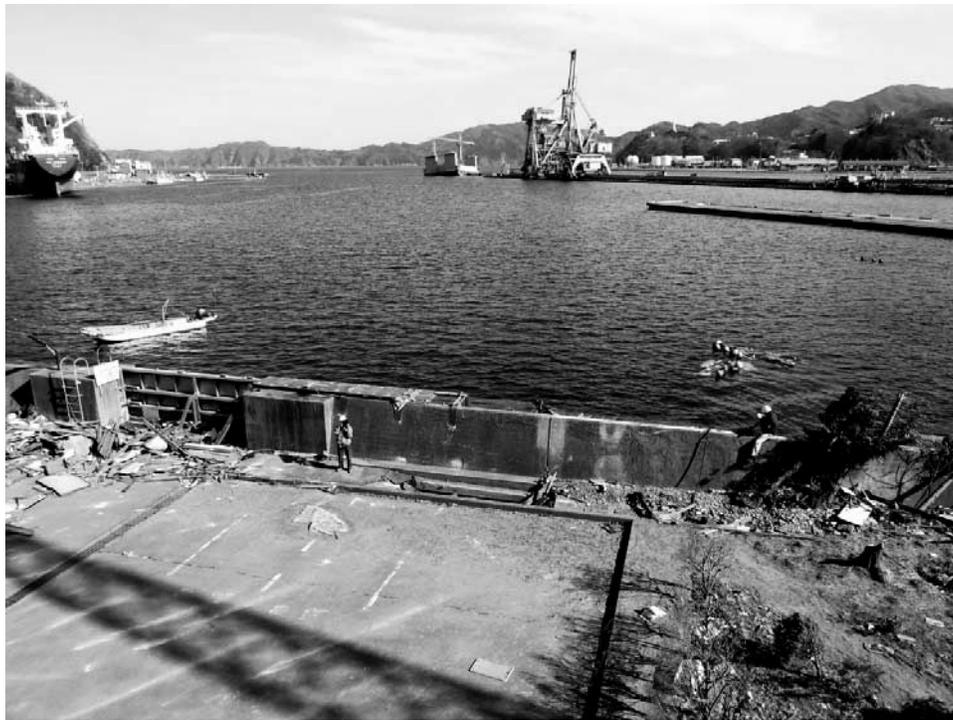
Figure 10-10: View of Kamaishi flood wall (Robertson)
