Harnessing Advanced Inspection Technologies to Assess Metallic Water Transmission Mains

Victor Bernal Chimal¹; Brandon Hildebrandt, P.Eng.²; and Justin Hebner³

In October 2019, the City of Vancouver teamed with Pure Technologies, a Xylem brand (Pure) to perform a condition assessment on a section of the Charles Street Transmission Main. The project utilized a high-resolution ultrasonic condition assessment tool that inspects the pipeline while still in service, identifying areas of wall thickness loss, and assessing lining and out-of-roundness. The condition assessment tool is free-swimming, which allowed this critical transmission main to remain in service during the inspection. The inspection was completed on a 2.9-km section of the 800-mm riveted steel Charles Street Transmission Main, installed in 1912. As part of the project, Pure also inspected this section of pipeline using other technology as a prescreening acoustic tool to locate leaks and pockets of trapped air. While the prescreening inspection did not detect acoustic events characteristic of leaks, the free-swimming ultrasonic condition assessment tool identified five pipe sections with wall loss anomalies. Pure provi

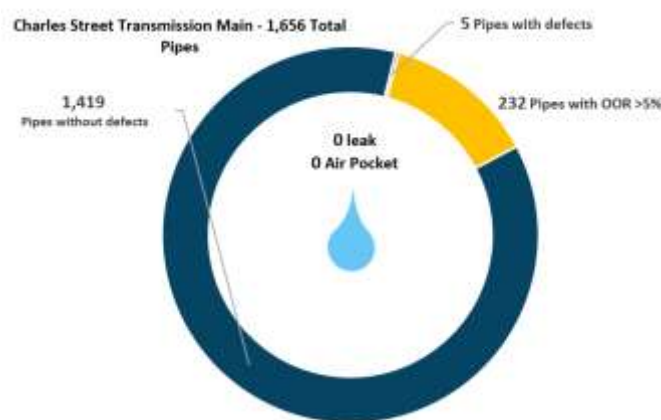
Upon data analysis, the acoustic inspection tool did not detect acoustic events characteristic of leaks or gas pockets. From a total of 1,656 pipe sections inspected with the ultrasonic condition assessment tool, only five (5) were identified with defects with wall loss ranging from 4% to 24% based on the as-built average nominal pipe wall thickness of 7.94 mm and 9.53 mm, all of the reported defects with wall loss occurred along a 100m section of the pipeline. Figure 6 summarizes the inspections results.

Figure 6. Charles Street Transmission Main – PipeDiver® Ultra and SmartBall™ inspection results

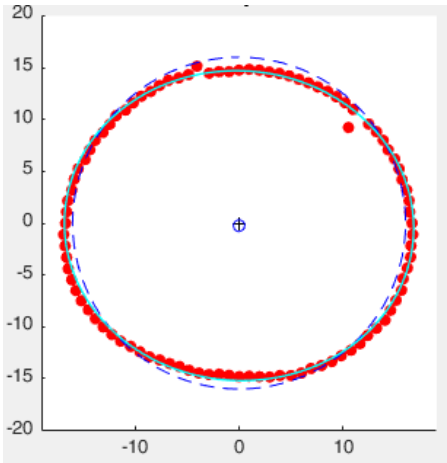
Additionally, 232 pipe sections were found to have out-of-roundness over 5%. The out-of-roundness data collected by the PipeDiver Ultra is demonstrated in Figure 7 below, the red dot line is the shape of the pipe cross-section, and the blue dash line is the desired circular shape of the pipeline.

Figure 7. Example of Out-of-Roundness data collected by the ultrasonic condition assessment tool

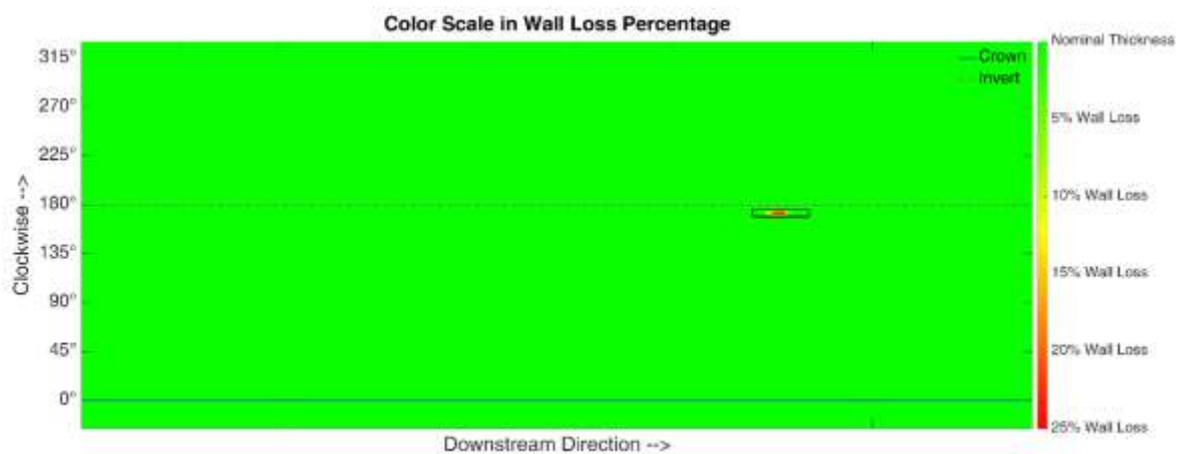
The City of Vancouver confirmed the reported wall loss defect; the defect was located at the invert of the pipe section as shown in Figure 9. During this examination, the City also observed many smaller diameter corrosion pits on the sides and, to a lesser extent, on the top of the pipe section as well. The corrosion pitting not detected by the ultrasonic condition assessment tool were smaller in size than the reported detection threshold for this tool. Pure Technologies is working on optimizing the analysis software utilizing machine learning algorithms that could improve detection and the reported detection thresholds in the future.

Figure 9. Heat map generated with the ultrasonic condition assessment tool data

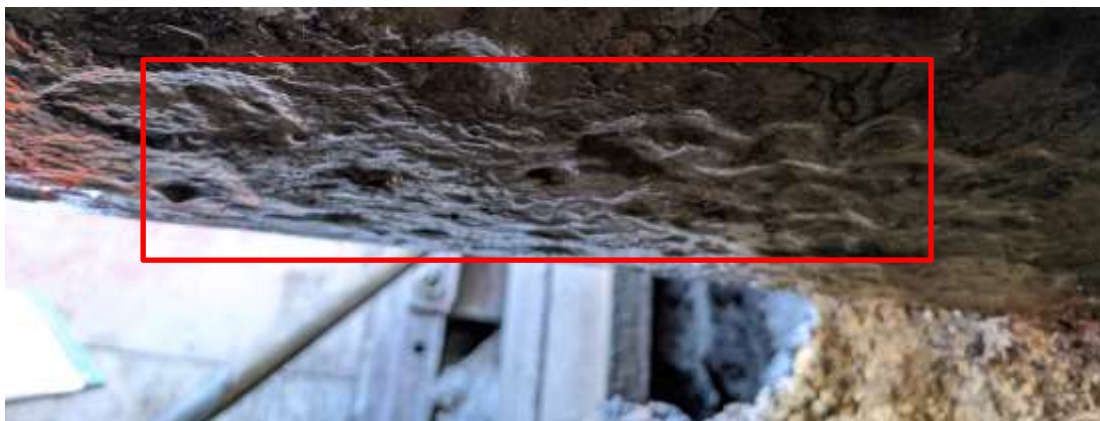
The City of Vancouver confirmed that the wall loss detected by the ultrasonic condition assessment tool ranged from 1-3 mm in depth (with some corrosion pits up to 6 mm in depth), but was more widespread compared to other reported wall loss areas and formed a large patch of corrosion approximately 45 cm x 15 cm (Figure 10). This large patch suggested that the corrosion was more uniform, or that smaller corrosion pits had bridged together, which increased the potential for a significant blowout failure.

Figure 10. Wall loss defect validated by the City of Vancouver

The City also noted that corrosion appeared to be limited laterally to the section identified by the ultrasonic condition assessment tool and adjacent pipes were in comparably good condition.

Due to the rivets on the pipe, it was not possible to install a repair clamp and instead the pipe exterior was coated with petrolatum tape to slow the progression of corrosion on the pipe until a more permanent repair can be completed.
