4.7 *Santa Maria Island*

4.8 *Caleta Tumbes*

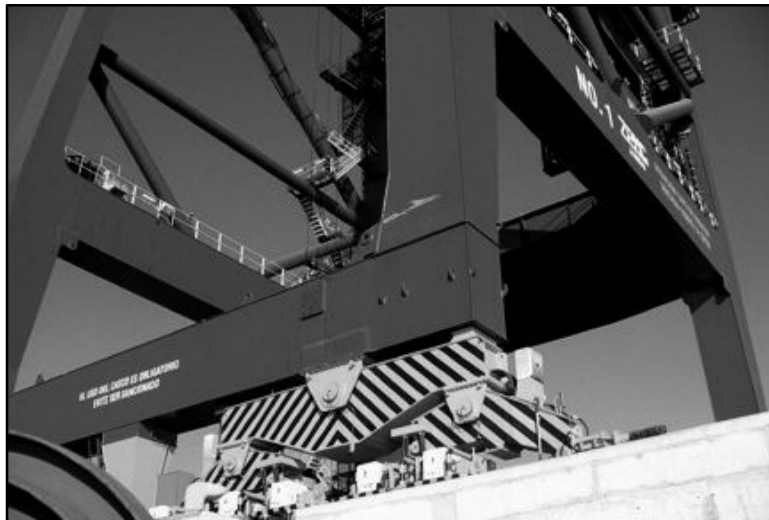
Figure 4.59 South Pier Container Crane with Impact Damage from Moored Vessel Impact (Vessel – Structure Interaction)

The new southern pier, with the base isolation configuration with square steel framing into the piles, and a waffle type concrete slab performed quite well. There was no evidence of permanent deformation and operations have resumed to full operational status. However, one container crane was slightly impacted by a moored vessel and experienced some repairable damage. This novel vessel-structure interaction due to earthquake loading should be studied in more depth and considered in future design of base-isolated marine structures.

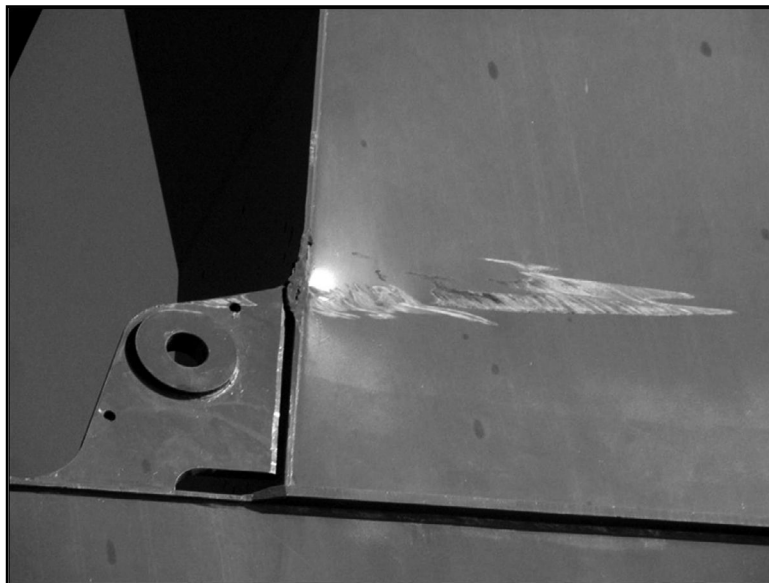
Figure 4.60 South Pier Close-up of Minor Dent / Scratch on Container Crane Due to Impact of Moored Vessel (Vessel-Structure Interaction)

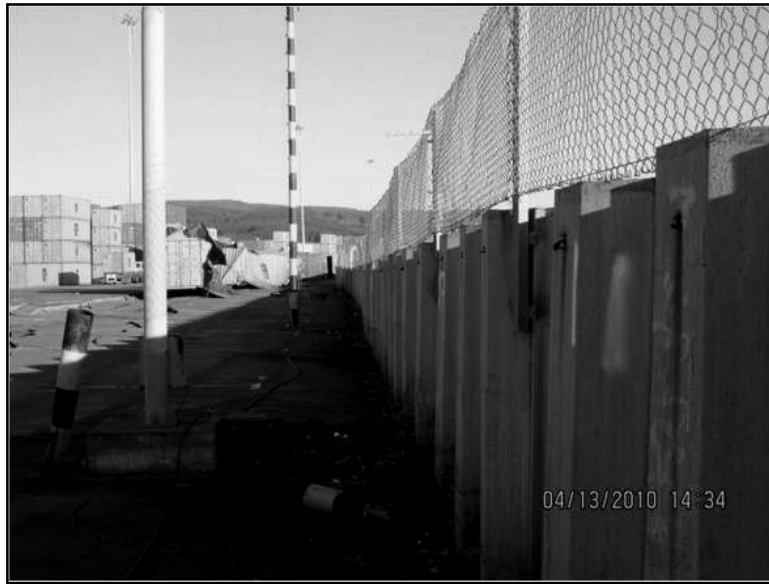
The yard between the north and south pier had lateral spreading adjacent to the sheet pile wall. Five stacked containers fell and ripped open. The lateral spreading and displaced direction of the north pier piles are believed to be an indication of kinematic soil motion having occurred. However, as shown in Figure 4.61 and Figure 4.62 the steel sheet piles along the beach at the shore side of the lateral spreading showed no tilt or displacement, possibly indicating that the entire soil layer moved as one unit.

Figure 4.61 Steel Sheet Piles Adjacent to Beach with Lateral Spreading in Backlands

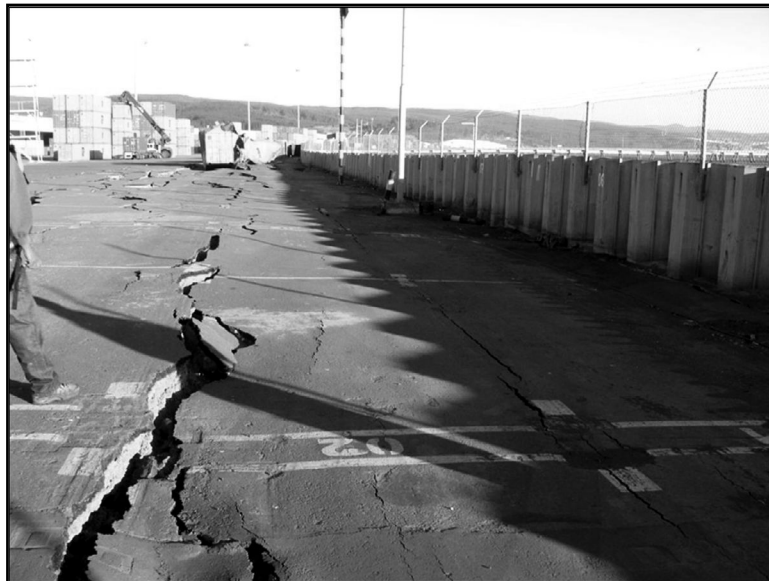
Figure 4.62 Lateral Spreading in the Backlands, Adjacent to the Beach Sheet Pile Structure

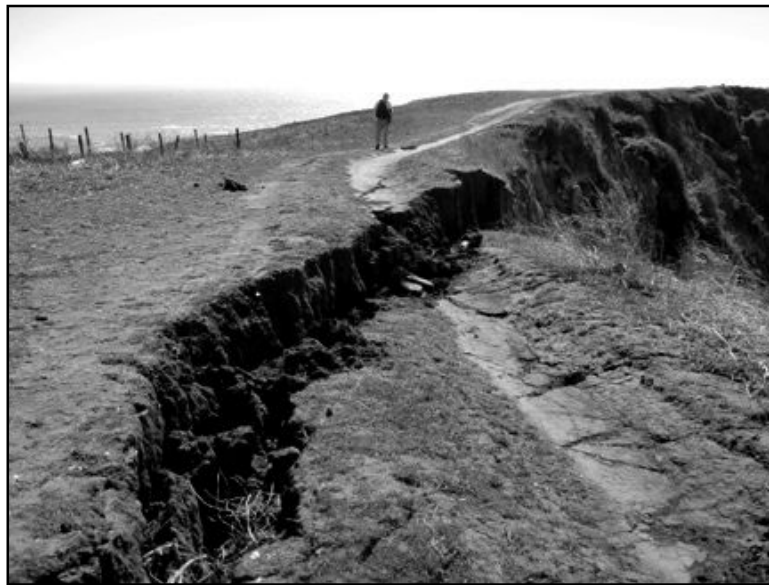
The general landform of the island varies from high bluffs on the western side of the island and falls to a wide coastal plain on the eastern side. Both the southern and southeastern points are growing from the material eroded from bluffs on the western side and the northern point of this island. Figure 4.64 shows a slump created by the earthquake at the northern point of the island within about 100m of the island's end. Similar slumping occurred on most of the western side of the island, shown in Figure 4.65.

Figure 4.64 Earth Slope Failure on the Island North Point, Looking North

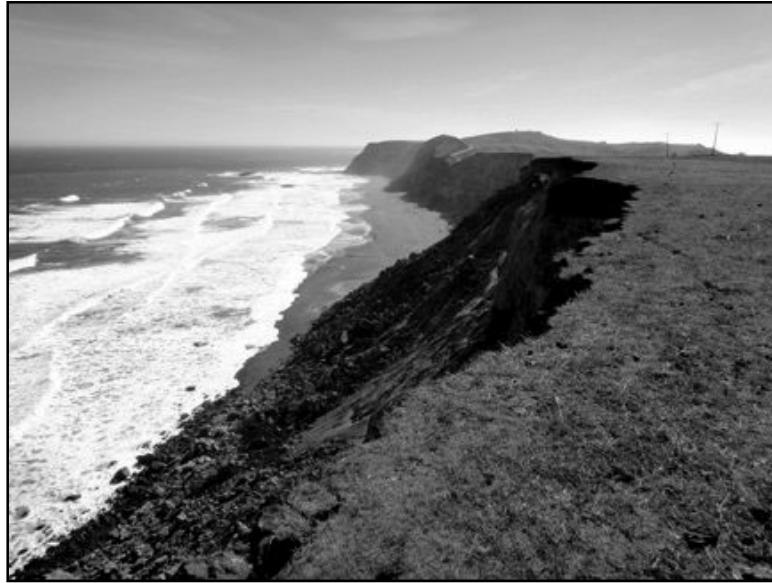
Figure 4.65 Failure on Western Side of Santa Maria Island

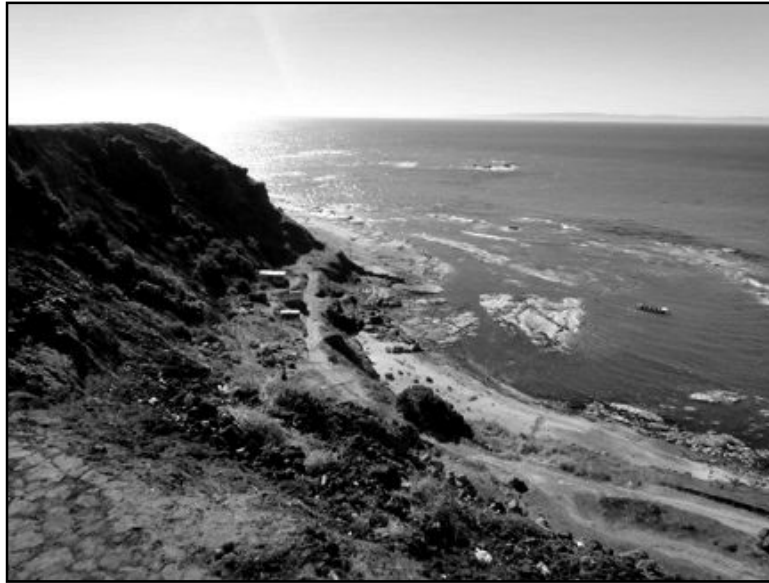
Figure 4.66 was taken before the earthquake of January 1, 2010 at 8:00 AM while Figure 4.67 was taken near high tide on April 13, 2010 at approximately 11:00 AM. Figure 4.67 shows the effect of the uplift is visible at the north end of the island. Notice that there are no exposed rocks in the surf in the earlier photo although it does appear that a wave is breaking over a shallow object. There is also a small jetty at the upper end of the beach. In Figure 4.67 there is no beach of sand as it has been washed away by the tsunami. In the surf zone there are many rocks now exposed and above the water. The evidence of the South American Tectonic Plate uplift and tsunami is obvious and the effect of this on the fishing community is apparent by the absence of the buildings and the boats.

Figure 4.67 North Point of Santa Maria Island After the Earthquake

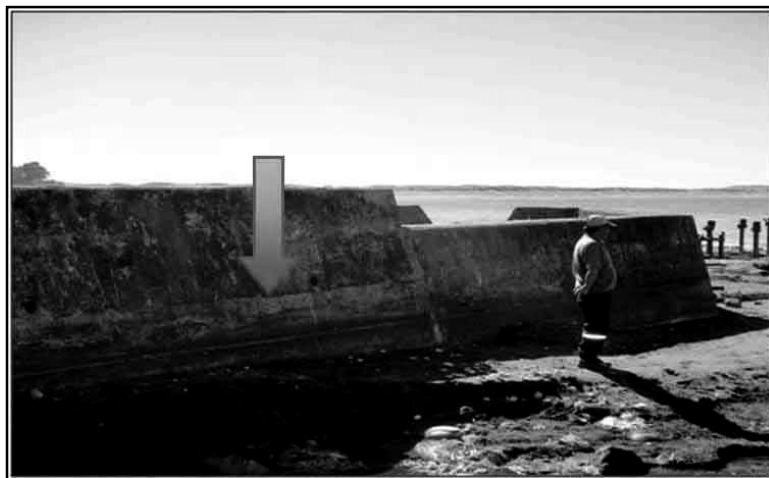
The area near the shoreline also indicates the significant rise of the island above the former sea level. The retaining wall shown in Figure 4.68 indicates the line or top of algae growing on the structure. At the south end of the island, the fishing community had approximately 200 fishing boats. After the tsunami, there were no more than 40 boats remaining. Figure 4.69 and Figure 4.70 show the effects of the earthquake and tsunami on the ramp used to launch the fishing boats. Figure 4.69 was taken before the earthquake on January 24, 2008 at 5:25 PM. The dark sand indicates the high tide condition. Figure 4.70 was taken April 13, 2010 at about 11:40 AM. It can be seen in this photograph that the wetted line of the sand on the right of the picture marks the location of high tide that occurred about 30 minutes before the photograph was taken. The difference in the high water lines from the two photos is estimated at approximately 2m.

Figure 4.68 Retaining Wall Showing the Former Line of Marine Algae

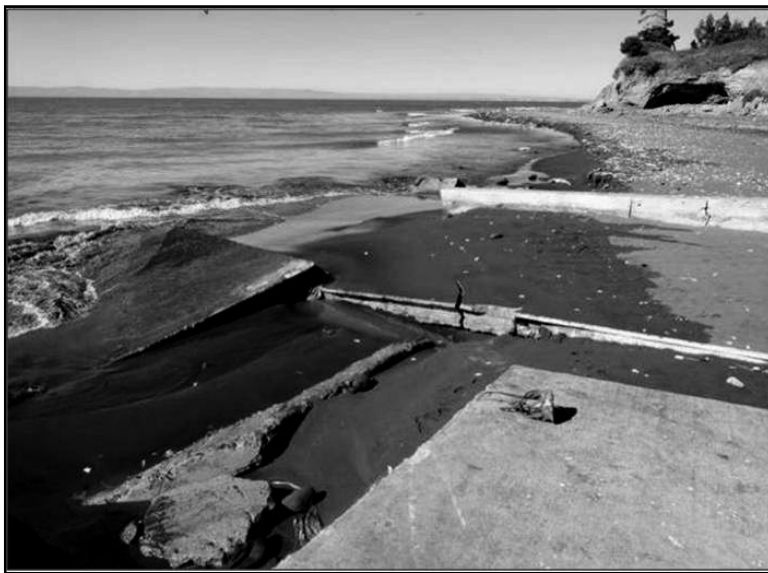
Figure 4.70 Fishing Boat Launching Ramp After the Earthquake

The destruction of the ramp is probably a combination of the earthquake and the scouring action of the tsunami. The fishing pier in the distance was destroyed by the tsunami, although many of the pilings remained. There are many species of sessile organisms and sea grass that are now dehydrated on the shoreline as shown in Figure 4.71 and Figure 4.72. The latter figure was taken from about 70m and it is not as clear as the former that was taken close by the rocks. Nevertheless, it is clear that the sea bed has risen and the exposed organisms are now dead and decaying.

Currently there is no launch facility since it no longer extends below sea level. Therefore all boats are launched through the surf. The fishing pier is not operational as it was destroyed by the tsunami. With a decrease in water depth at the pier, it will need to be extended to deep water before it can be restored to functionality.

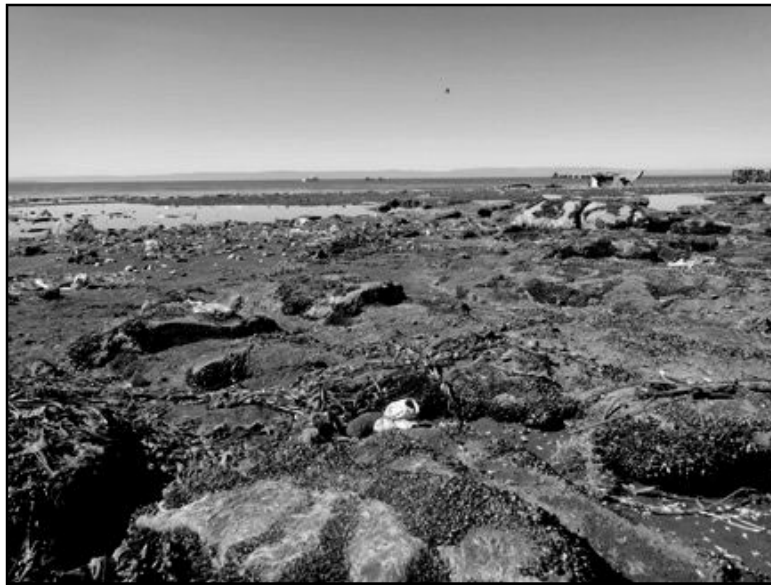
Figure 4.71 Area Formerly Underwater, Which is Now Nearly 2m Above Mean Sea Level

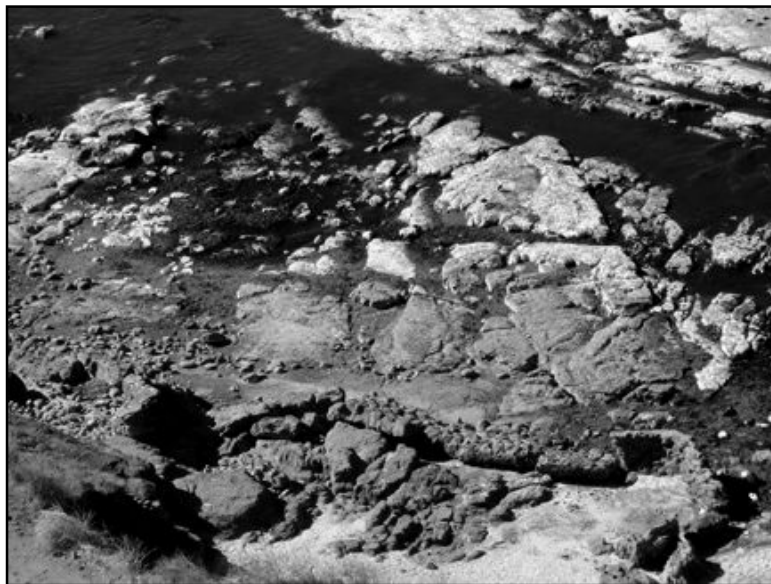
Figure 4.72 Exposed Marine Grass and Organisms on the Northwestern Side of the Island
