5.2 Water Distribution Pipes

6 WASTEWATER

7 ROADS AND BRIDGES

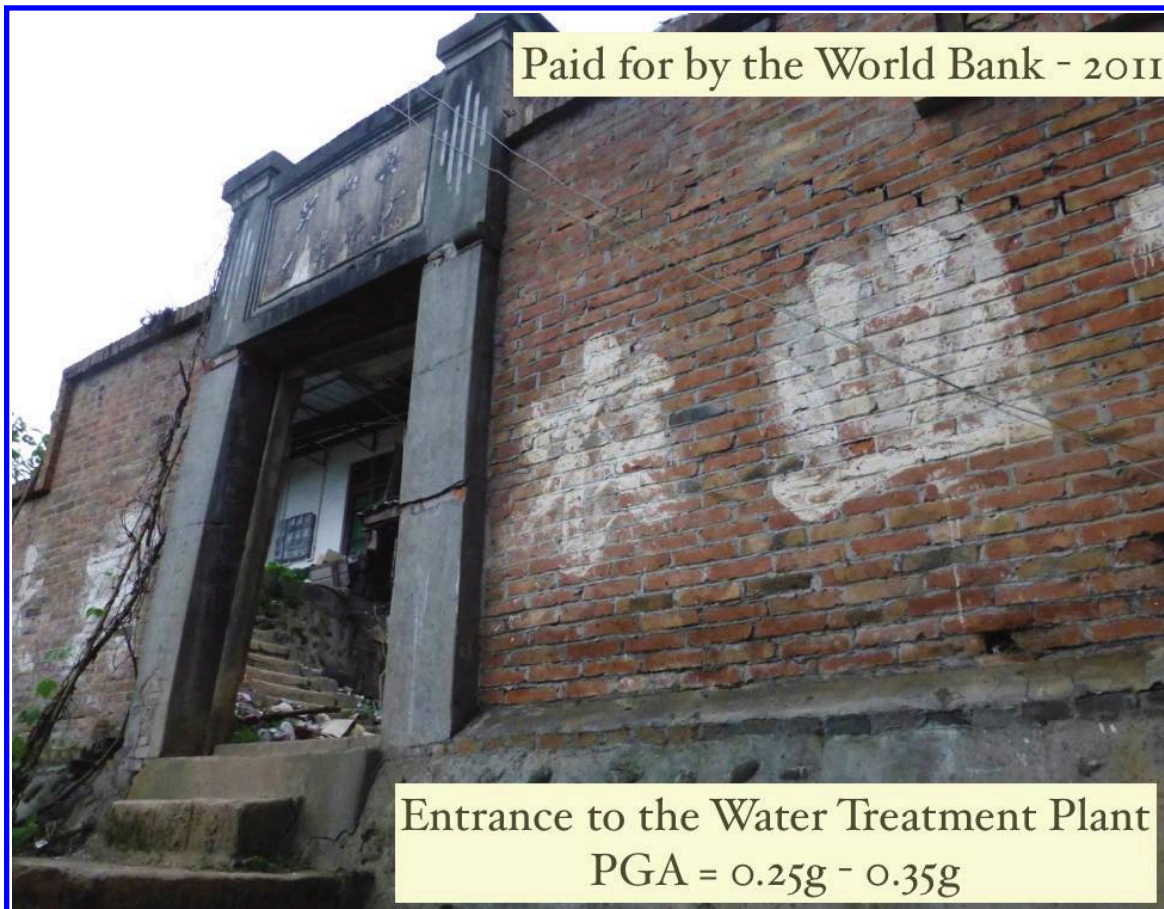
Figure 5-1. Entrance to Water Treatment Plant (ground motion estimated by field observations)

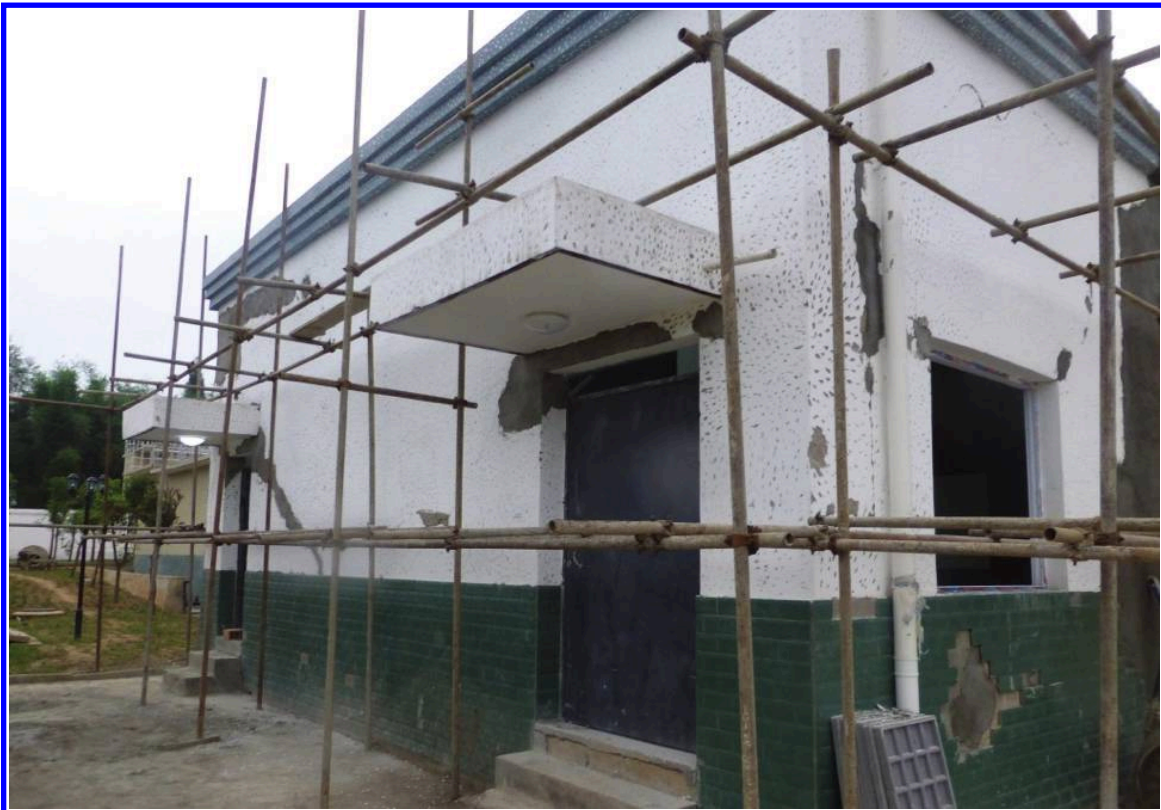
Figure 5-4. Damaged control building

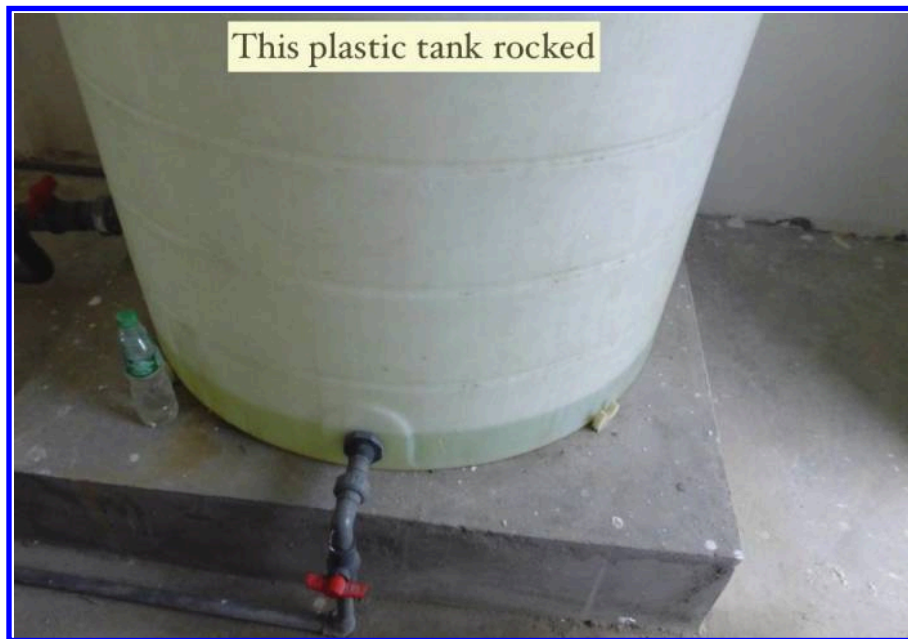
The chemical tanks rocked (Fig. 5-5), leading to damage of attached PVC pipes (Fig. 5-6). The four small plastic stops did restrain the tank from sliding, but not from rocking. The rocking led to damage of the attached restrained PVC pipe.

Figure 5-5. Plastic tank for chlorine dioxide disinfectant

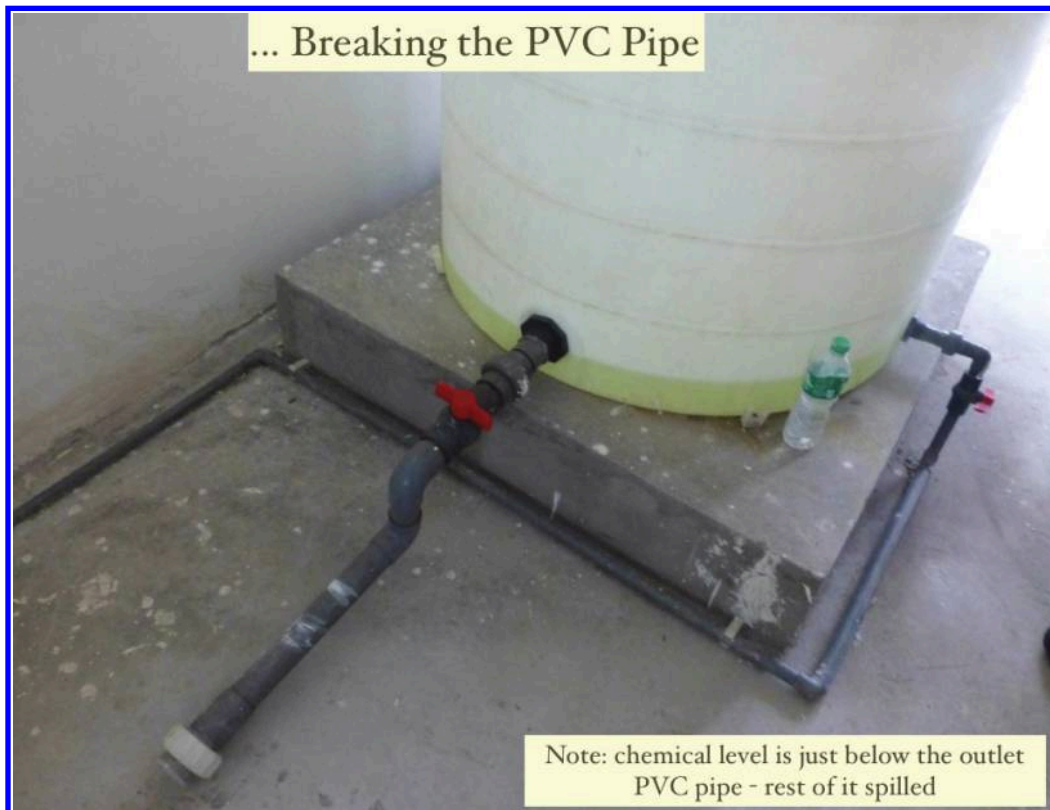
Figure 5-6. Broken PVC pipe (the motor and pump also broke and have been removed)

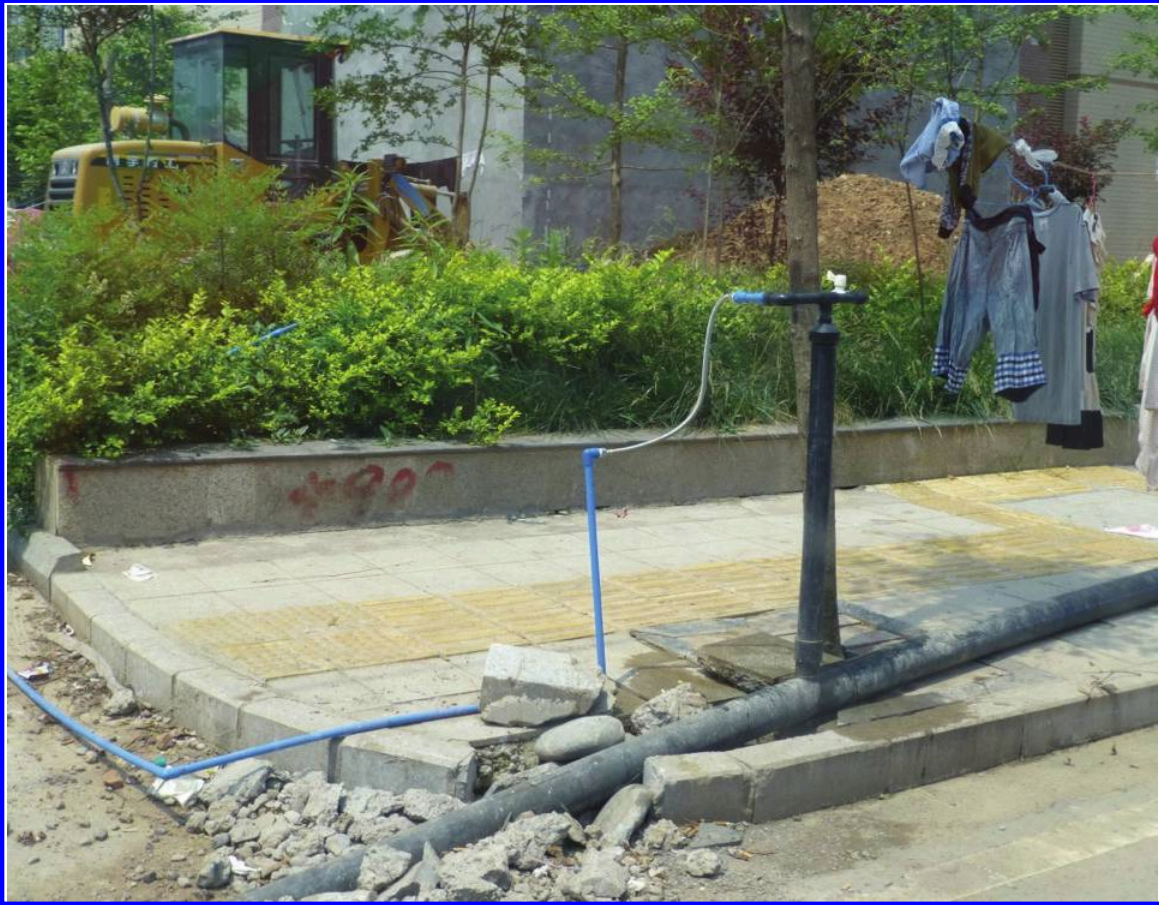
Figure 5-8. Above ground temporary water pipe

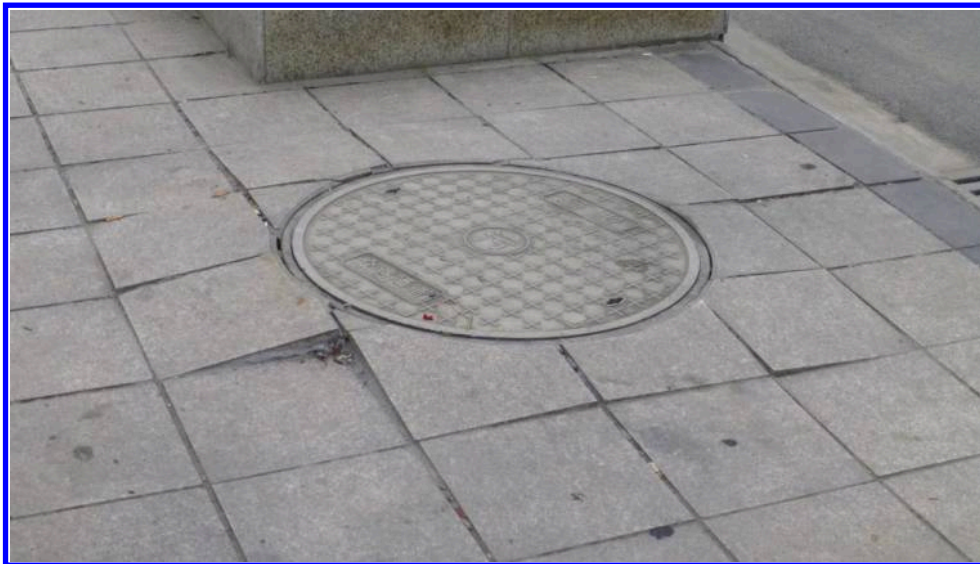
Several manholes were raised (floated) up to a few centimeters above the sidewalk level in the eastern New Town part of the city (Fig. 6-1). At one location, a set of portable pumps and a hose were being used to pump sewage between manholes, presumably due to a blockage.

Figure 6-1. Floated manhole

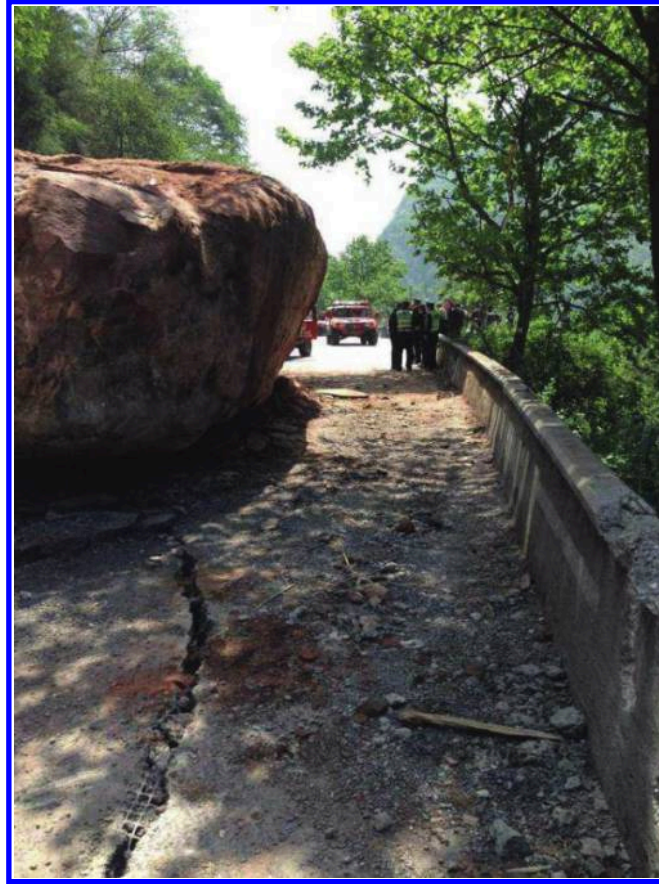
In addition, there were numerous damaged bridges, including serious damage to an arch bridge. Figure 7-3 shows damage to S210 Feixianguan (飞仙关) Road from large boulders.

Figure 7-3. S210 damage on Feixianguan (飞仙关) Road by large boulders (Courtesy Dr. LIU Aiwen of CEA)

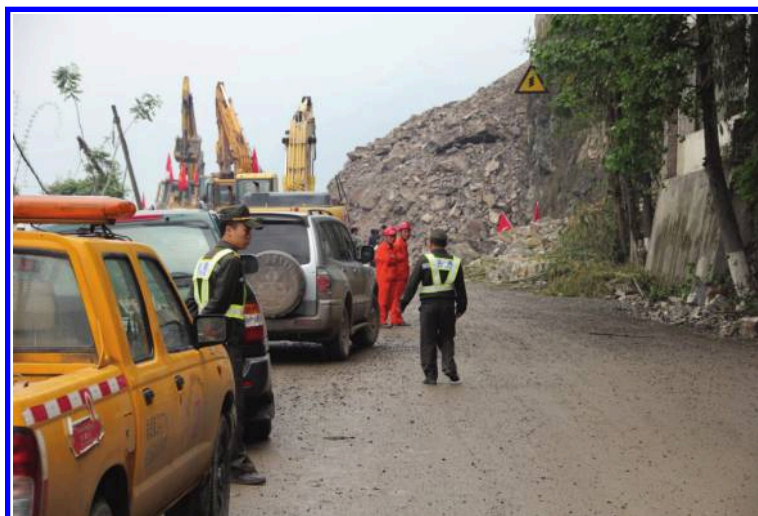
Figure 7-4 shows damage to S210 Ling Guan (灵关) Road from landslide debris sliding onto the roadway.

Figure 7-4. S210 Ling Guan Road damaged and blocked from landslide debris (Courtesy Dr. LIU Aiwen of CEA)
