#### **4.4 Distribution System**

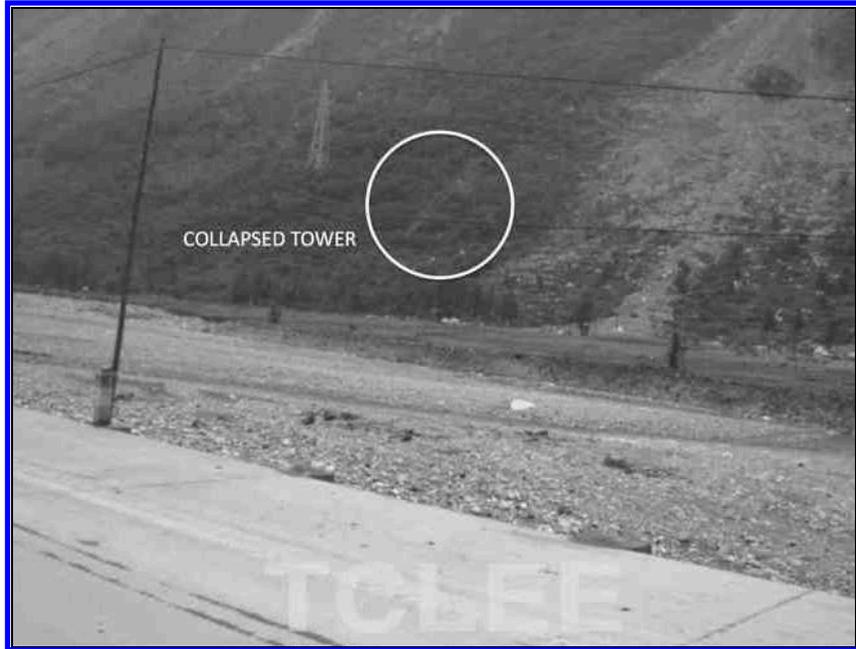
*Fig. 4.62. Collapsed 110 kV tower*

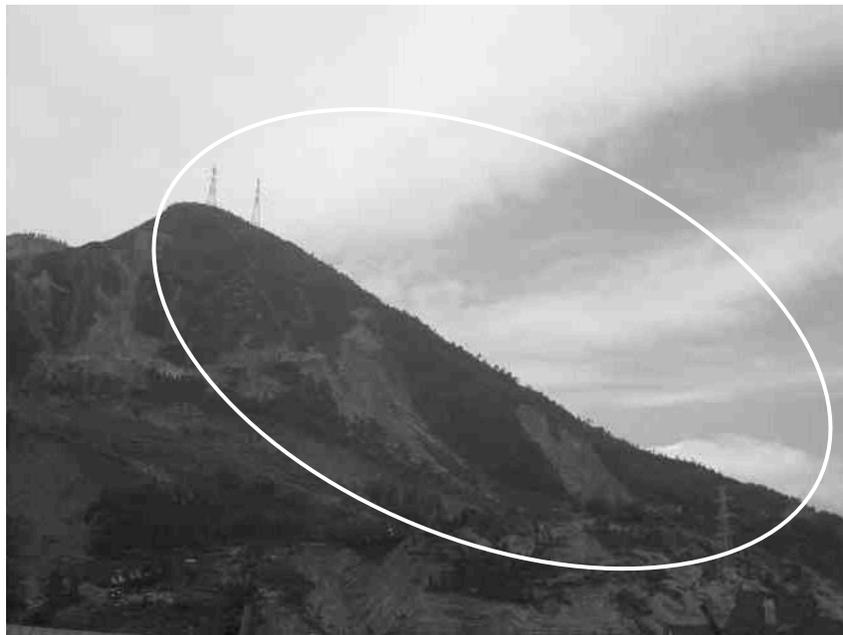
*Fig. 4.63. Collapsed 10 kV line*

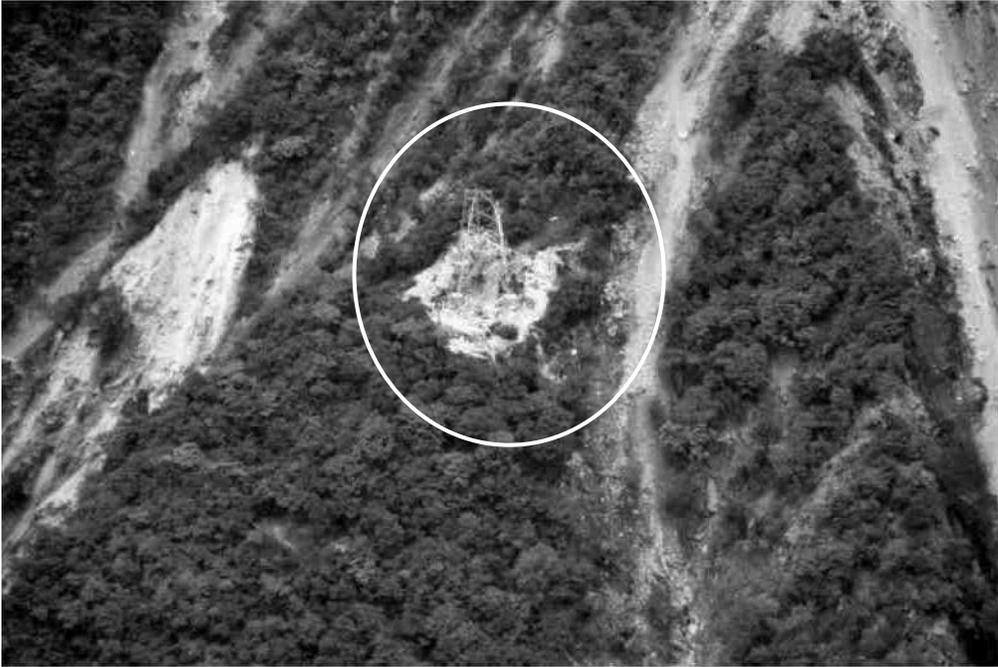
*Fig. 4.64. Collapsed tower*

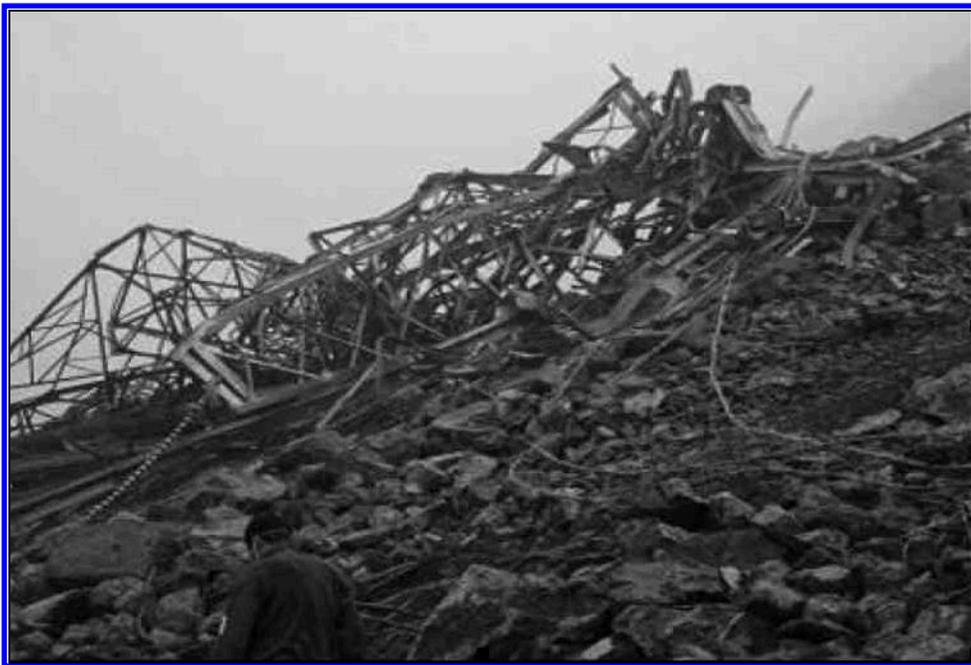
*Fig. 4.65. Collapsed tower, #123, 500 Maotan line*

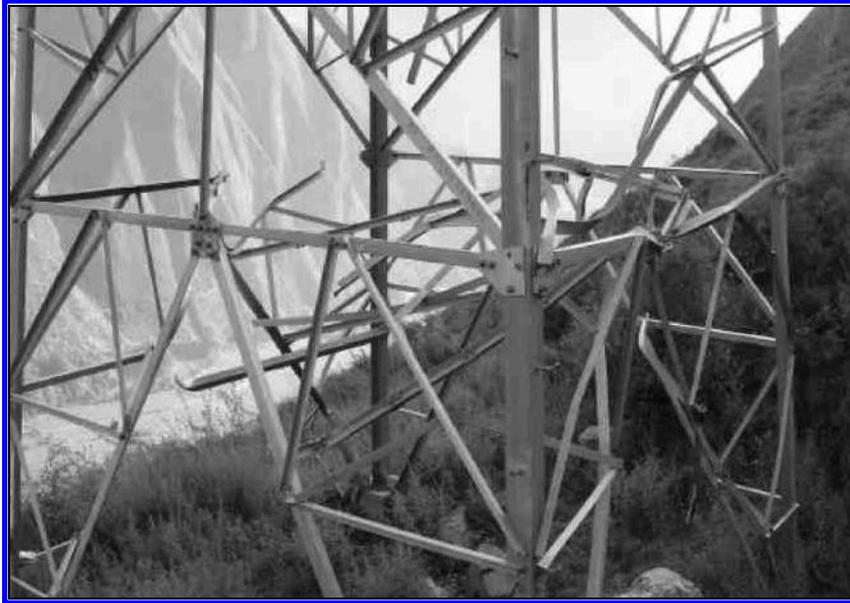
*Fig. 4.66. Rack fall-impacted tower, #123, Hongxue line of Yingxiu Town*

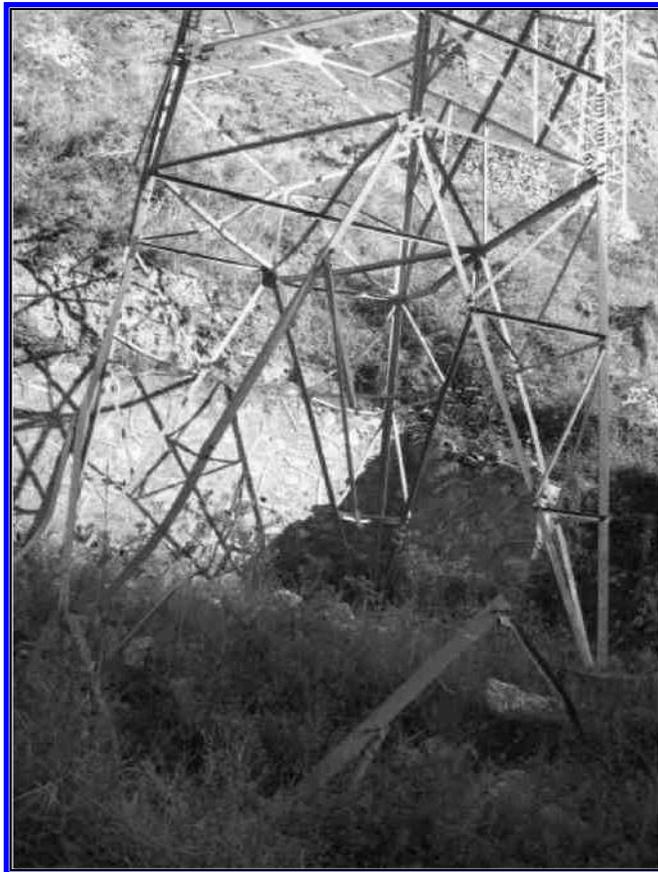
*Fig. 4.67. Rock fall-impacted tower, #79, Zhouman line*

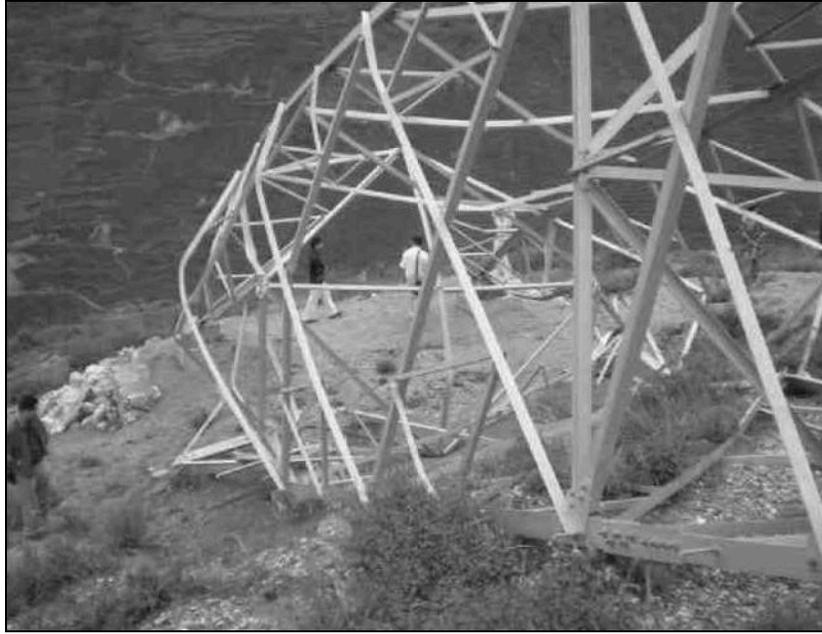
*Fig. 4.68. Collapsed Tower, #13, Jiangsang line*

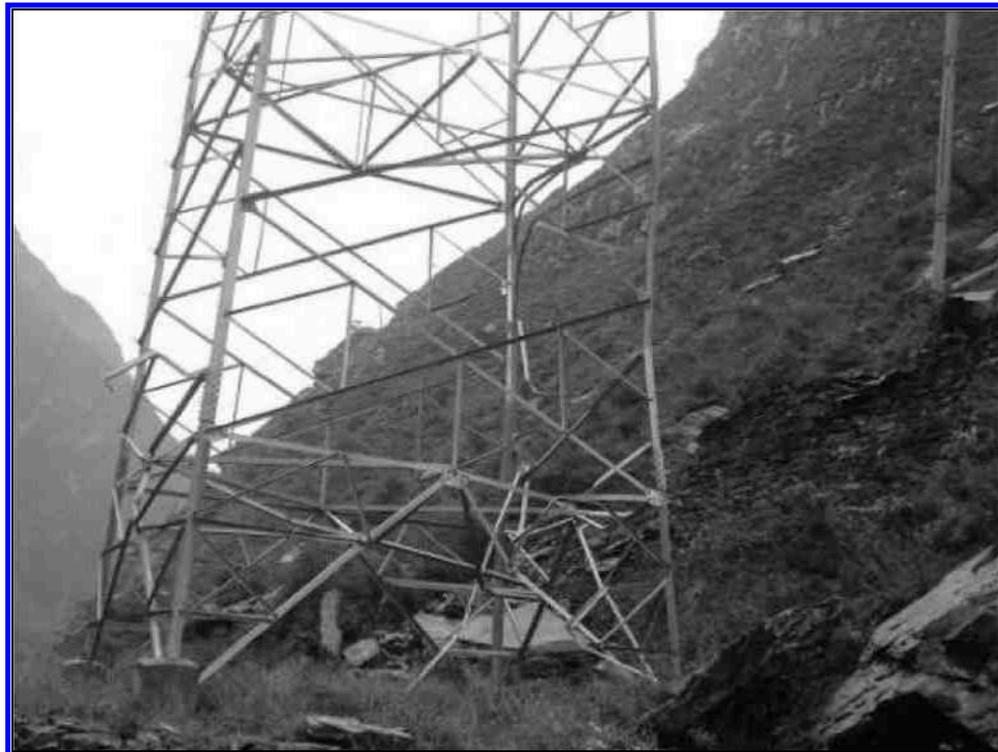
*Fig. 4.69. Rockfall impacted tower, #14, Tianjin line, Jinlong Lake area, Wenchuan*

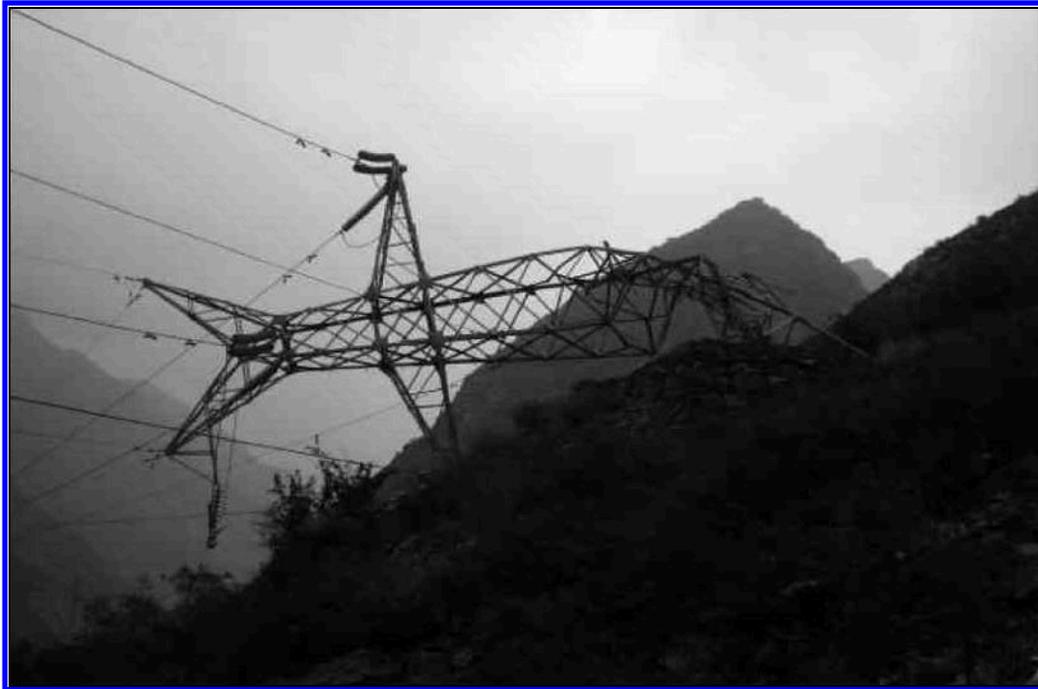
*Fig. 4.70. Collapsed tower, #11, Tianjin line, Jinlong Lake Area, Wenchuan*

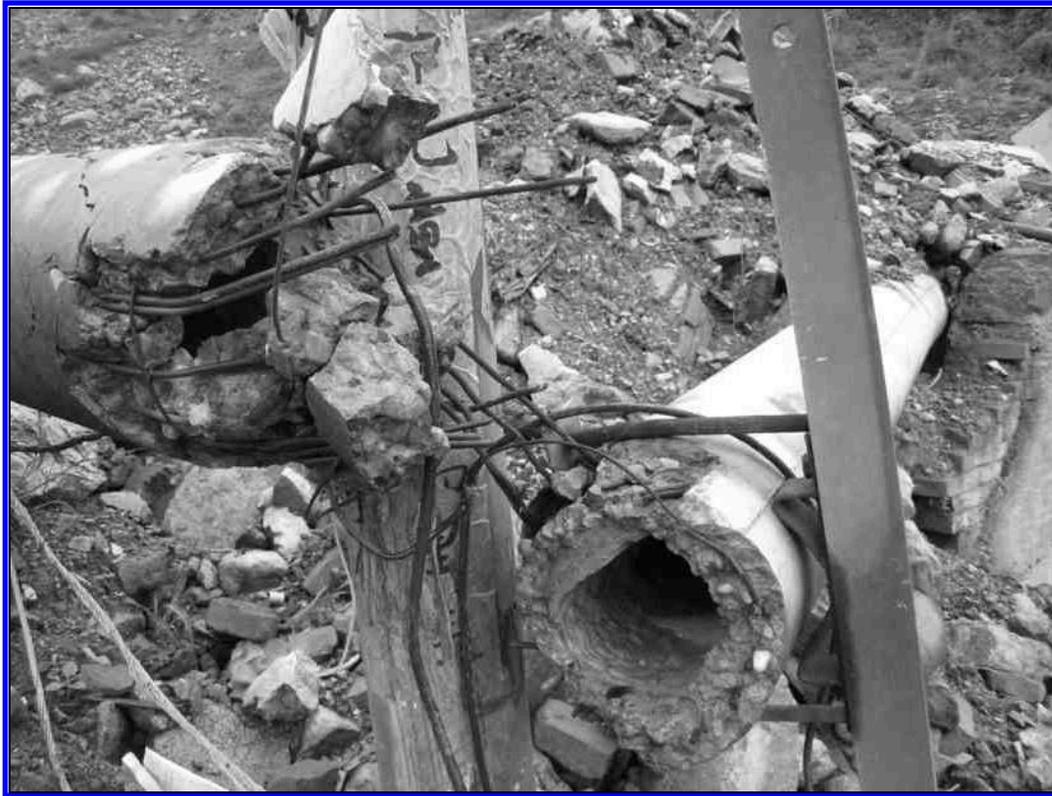
Overhead distribution (4 kV – 34.5 kV) is common in cities and towns in China. The most common pole style is a concrete tube. These concrete tubes appeared to have no shear steel (Fig. 4.71), and high bending/shear induced failures occurred where there were pulldown forces. Many dead-end frames at substations also use this construction, albeit oriented into an A-frame assembly. Several of these collapsed at a number of 110 kV and 220 kV substations with  $PGA > 0.4$  g, (Fig. 4.30, 4.36, 4.48) due to a combination of inertial loading coupled with cable line dynamic loading (not landslide), leading to gross damage to yard equipment below.

*Fig. 4.71. Collapsed 10 kV distribution pole (10-in. diameter, 2.5-in. wall thickness)*

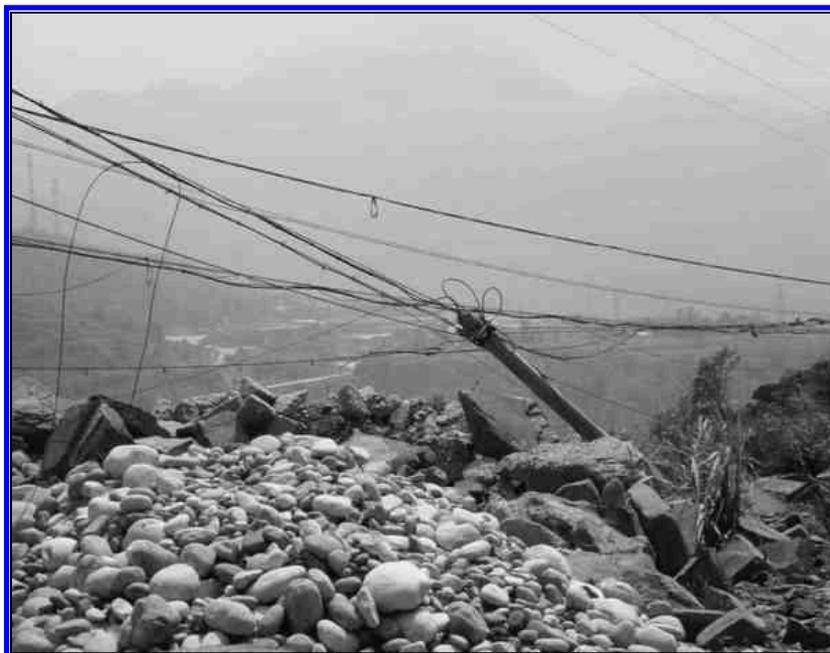
Landslides and rock falls caused loss of poles in many areas (Fig. 4.72).

*Fig. 4.72. Pull down of power and telecom distribution due to landslide*

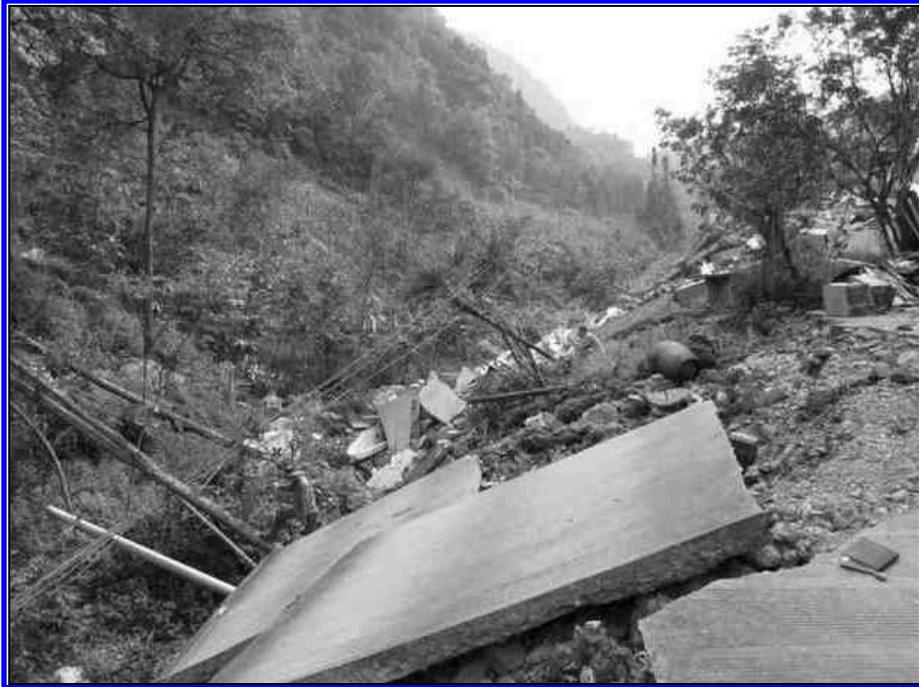
At Shenxigou village, we observed rockfalls that were likely triggered by the first rupture, followed by surface faulting of more than 3 m thrust upwards and 4 m lateral (some of this might have been induced landslide) that toppled power poles and caused power lines to come to rest atop the rock fall debris.

*Fig. 4.73. Surface faulting uplift of about 3 m and lateral shift of about 4 m with damaged road and tilted distribution poles*

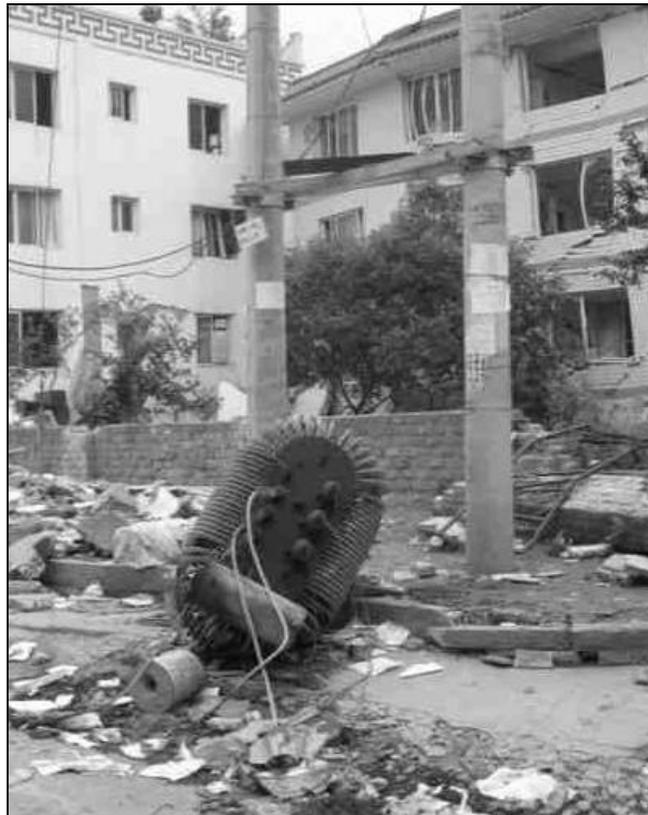
Platform-mounted transformers were observed. Figures 4.74 and 4.75 show two such examples. This type of damage was observed in a California earthquake in 1952, and since then, power distribution companies in California have all but eliminated the placement of unanchored transformers on elevated platforms for new installations. We recommend similar retrofits be adopted in China as a high priority in all high-seismic regions of the country.

*Fig. 4.74. Fallen distribution transformer*

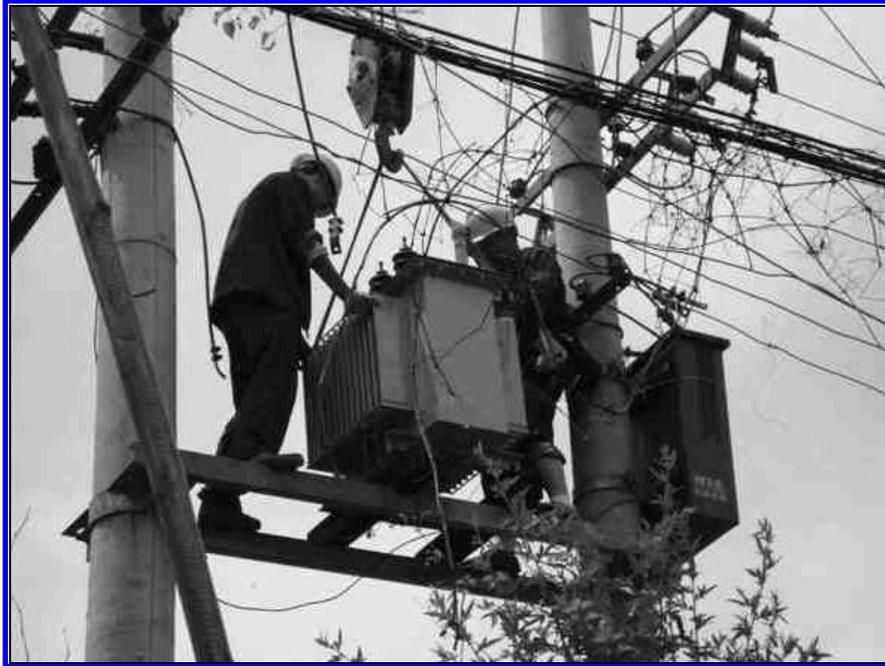
*Fig. 4.75. Distribution system transformer (10 kV) being replaced (Hongkou),  
July 16 2008*

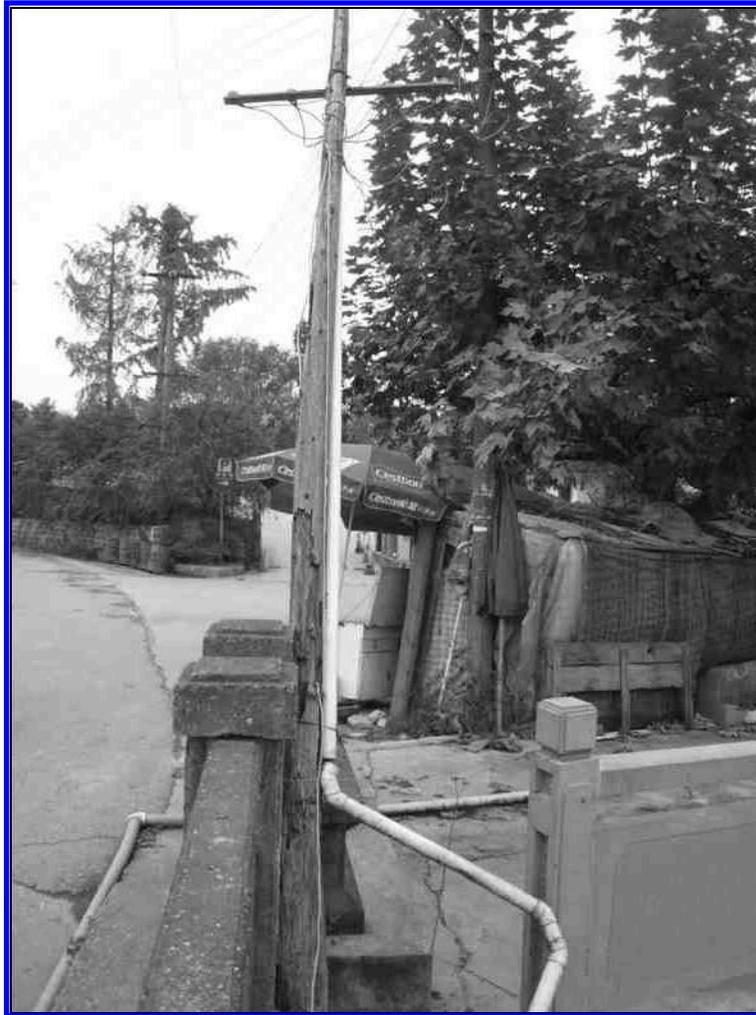
Figure 4.76 shows the failure of a low-voltage (10 kV) power cable crossing a bridge at Dujiangyan. The movement of the bridge embankment by a few inches resulted in the non-ductile failure of the PVC pipe at two locations and one location at the other abutment. It is likely that the power remained in service because it appears that the cables did not break at the PVC failure points and there was no new power line observed.

*Fig. 4.76. Damage to low-voltage power conduit at bridge abutments*
