Repairing a Damaged House by Watering Foundations: The MACH Project

David Mathon¹

Abstract

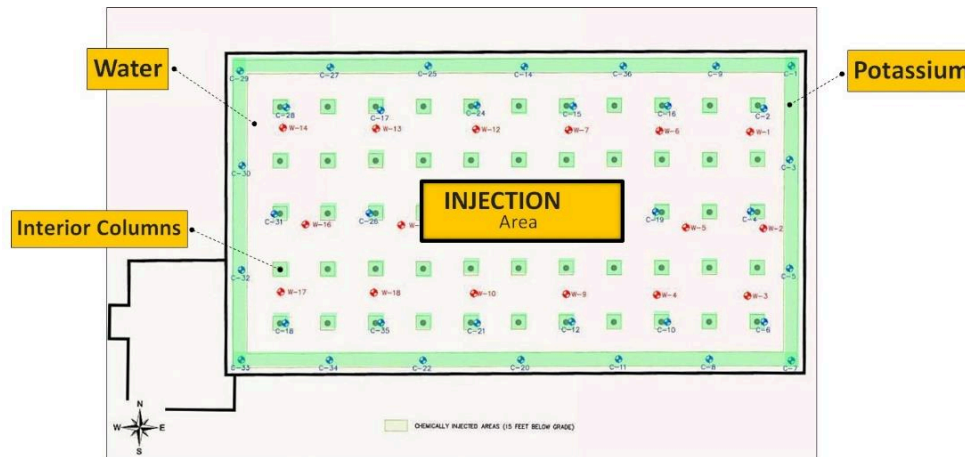
Figure 18. Plan drawing showing where water and potassium injection was performed.

This remedial warehouse project differs from the previous two jobs by the fact that the building slab experienced heave due to expansive soils rather than from shrinkage. However, the soil under this building had not reached its ultimate swell potential and was continuously causing distress to the floor slab. As a remediation plan, it was decided that the floor slab needed to be removed (due to excessive distress), and a combination of chemical soil injection and water injection used to limit the future movement of the soils under the floor slab (Figure 18).

The potassium solution was injected in a five feet wide strip around the perimeter of the inside of the warehouse, and in a ten by ten feet area at each column locations as shown in Figure 17. Injection was performed using a mast mounted on a dozer with four injection rods on two feet centers (Figure 19).

Water was not used around the foundation piers due to the possible damaging of the column and perimeter footings. As mentioned previously, potassium and ammonium satisfy the clay particles' charge without causing the hydration that results in swelling pressure and, thus, surface heave. As a quality control measurement, a daily site progress report was completed which included areas treated each day along with the amount of material injected per area. Post injection swell test results (Fig. 19) showed a good improvement which resulted in the swell being reduced to less than 1% as shown in Figure 20.

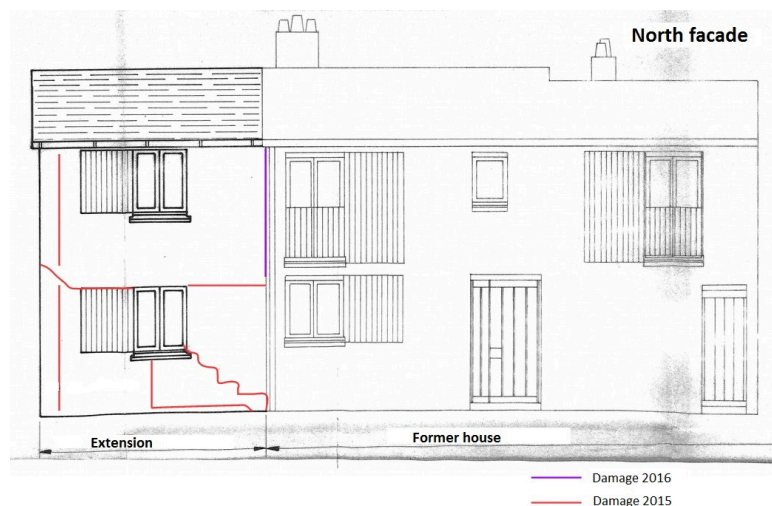
Figure 3: Noticed damage survey in 2015 and 2016

After Summer 2015, the damages were noted only on the extension part of the house. Major cracks were drawn on figure 3. It was found out that the extension is tilting to the East.

Inside the house, the floor did not settle at all. However, the tiled floor is broken at the junction of the former construction and the extension. The tilting phenomenon induced damages on the interior finishing (cracks on partition and doubling walls, offset of windows panels, doors which doesn't close or open...). These damages reduced during Winter 2015/2016 and increased during Summer and Fall 2016.

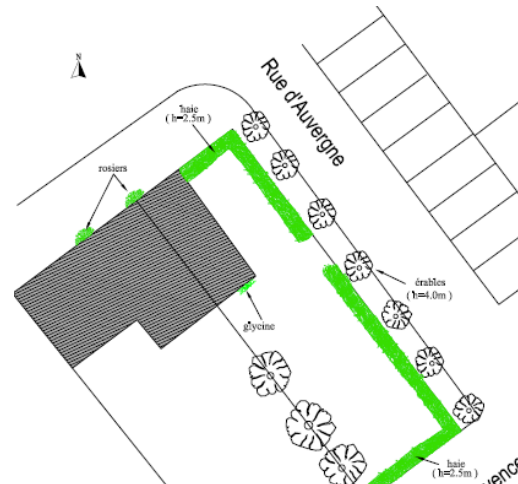
Figure 5: vegetation survey

Every shrubs or trees are transcribed on a plan (figure 5). A cotoneaster hedge is located just in front of the damaged gable of the MACH. A wisteria is also noted on the south facade.

The conclusion of the geotechnical survey is that early 2015 hydric deficit induced a severe drying of the clays located under the footing of the house. The hedge of cotoneaster was an

aggravating factor for the shrinkage phenomenon. This heavy drying caused settlement of the footing and lead to cracking the east gable of the house.

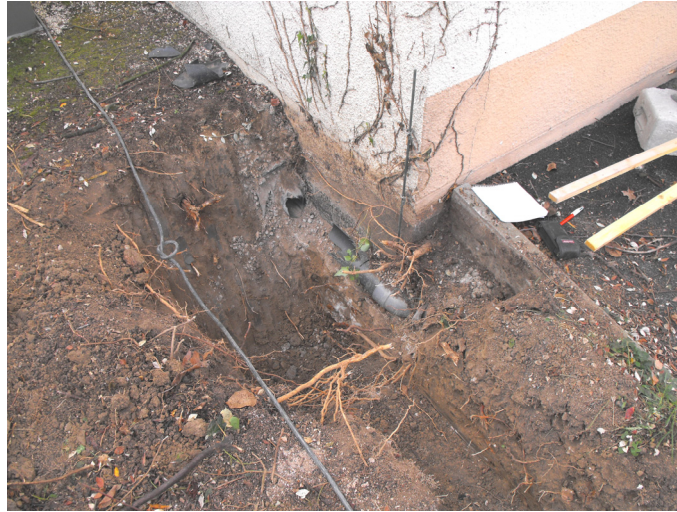
Figure 6: excavator drilling (with numerous roots)

An excavator drilling was realized in front of the most damaged edge of the house. It shows that the foundation system, which is an 85 cm deep footing, is set on the soft and plastic clay. The footing is 35 cm thick. Numerous roots are observed in the excavation (see figure 6).
