## **Rapid Reactivation of a Large Composite Earth Slide - Earth Flow**

### ***Abstract***

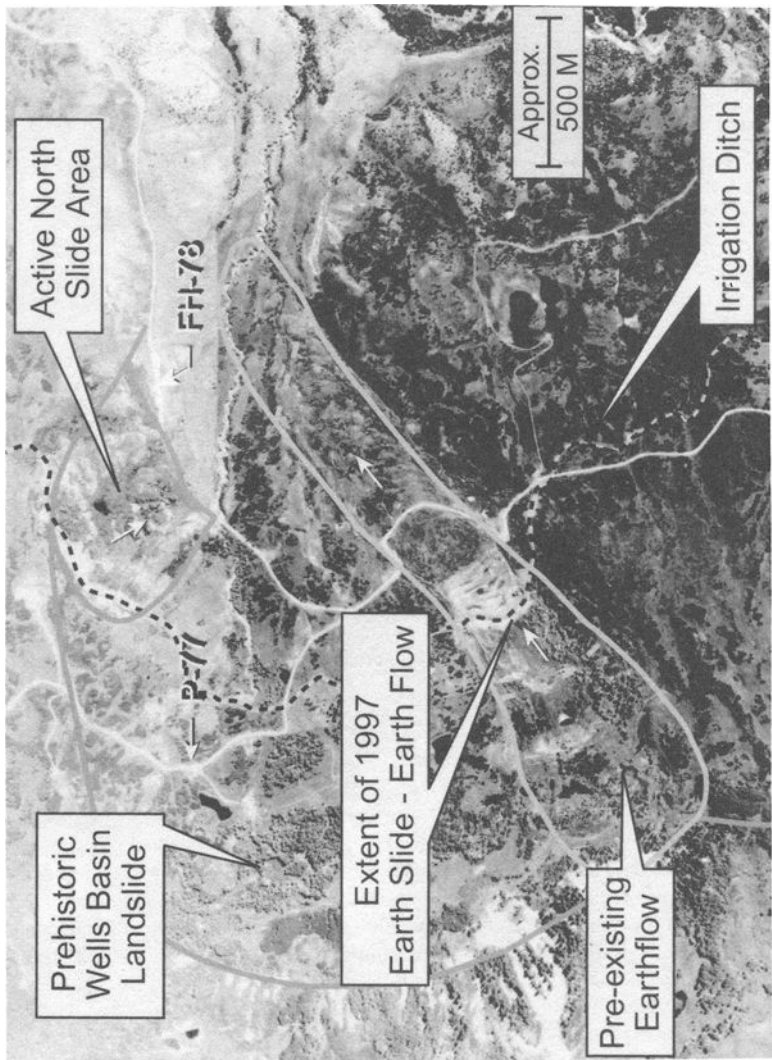
Figure 1. Wells Basin Landslide in 1998. Arrows show direction of movement.

Wells Basin developed its basin-like morphology as the result of prehistoric landsliding, which is shown on Figures 1 and 2. As identified on Figure 1, the most recent landslide activity is along the lateral margins of the prehistoric landslide. The North Slide Area has experienced some movement in recent years, requiring maintenance to the irrigation ditch that crosses near the headscarp. There has been no recent impact to the Forest Highway (FH-78) that passes along the toe of the slide area.

The Pre-existing Earth Flow identified on Figure 1 along the southern margin of the prehistoric landslide is apparently not active over its full length. However, the distinct earth flow morphology of this feature suggests it is more recent than other inactive parts of the prehistoric landslide. The central 1200 m portion of the older earth flow is the area that reactivated in 1997; the reactivation included the entire width but not the entire length of the older earth flow.

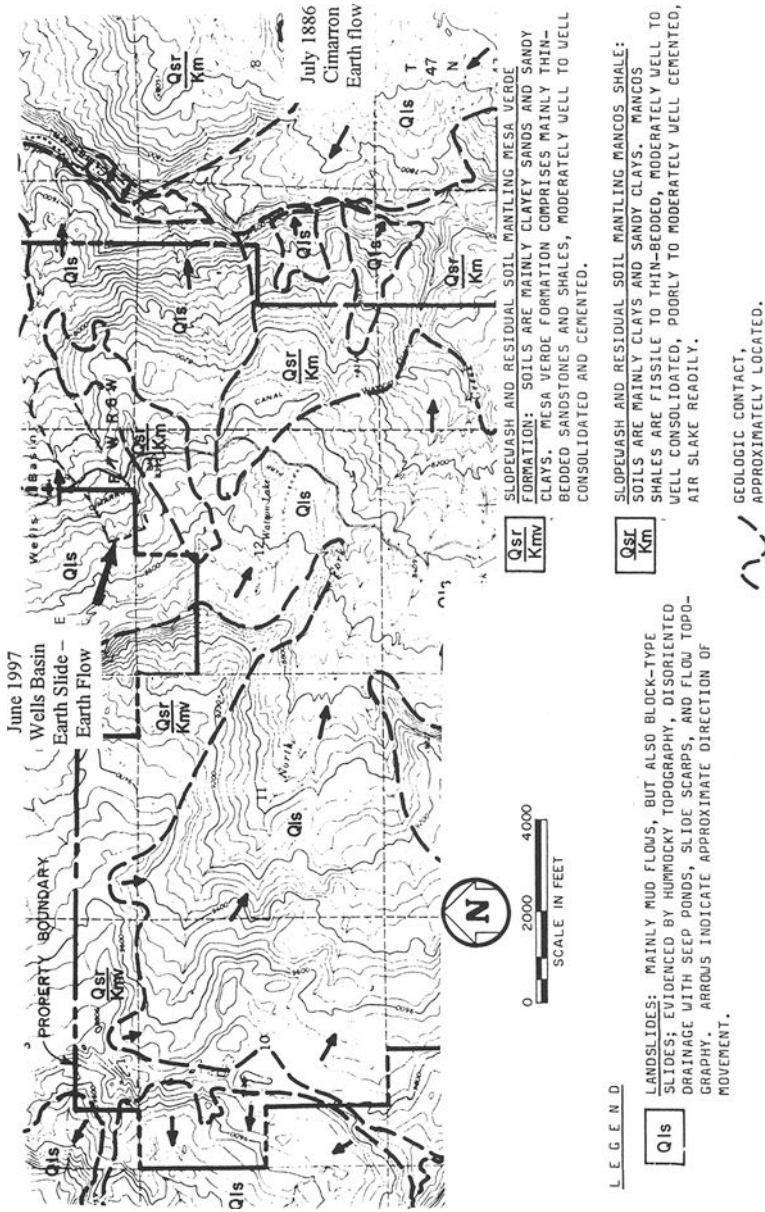
Aside from the general reference to landslide features such as hummocky ground, closed drainage basins, sag ponds, and dead trees covering a large part of the valley, Cross made no reference of movement at the site of the pre-existing Wells Basin earth flow. Based on observations of Yeend (1961), the initial earth flow episode at Wells Basin apparently predates the 1886 Cimarron earth flow visited by Cross. Given the thoroughness of Cross's observations the fact that he would have practically had to traverse the Wells Basin site to get to the Cimarron earth flow, and the lack of reference to the Wells Basin site, it seems probable that the pre-existing earth flow at Wells Basin was not active during 1886. The close proximity of the Wells Basin earth flow and the Cimarron earth flow (same site as the 1997 earth slide-earth flow) is shown on Figure 2.

Figure 2. Geologic Map of part of the Cimarron River Valley showing the Cimarron earth flow and Wells Basin earth slide - earth flow (URSGWC, 1973).

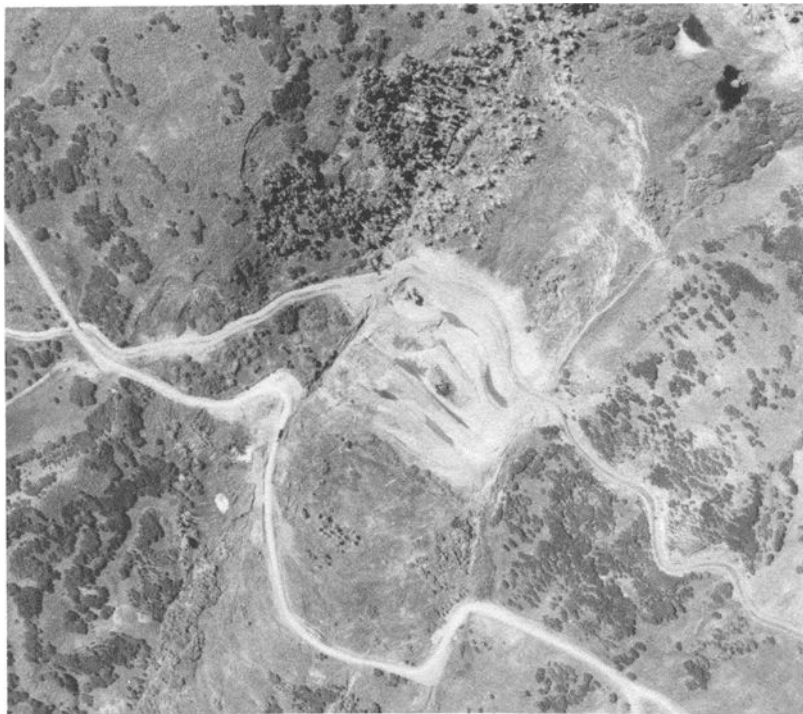
Figure 3. Portion of reactivated earth slide - earth flow showing multiple abandoned canal sections, cracking, and sag ponds. Note 18-wheel truck on road for scale. Movement is from top right to bottom left of photograph.
