The Michigan Ditch Landslide and Tunnel Case History and Unique Delivery Method

Robin Dornfest, P.G., C.P.G., M.ASCE¹; John Beckos²; Owen Randall, P.E., M.ASCE³; Don Silar, P.E., M.ASCE⁴; and Nathan Soule, P.E., P.G., M.ASCE⁵

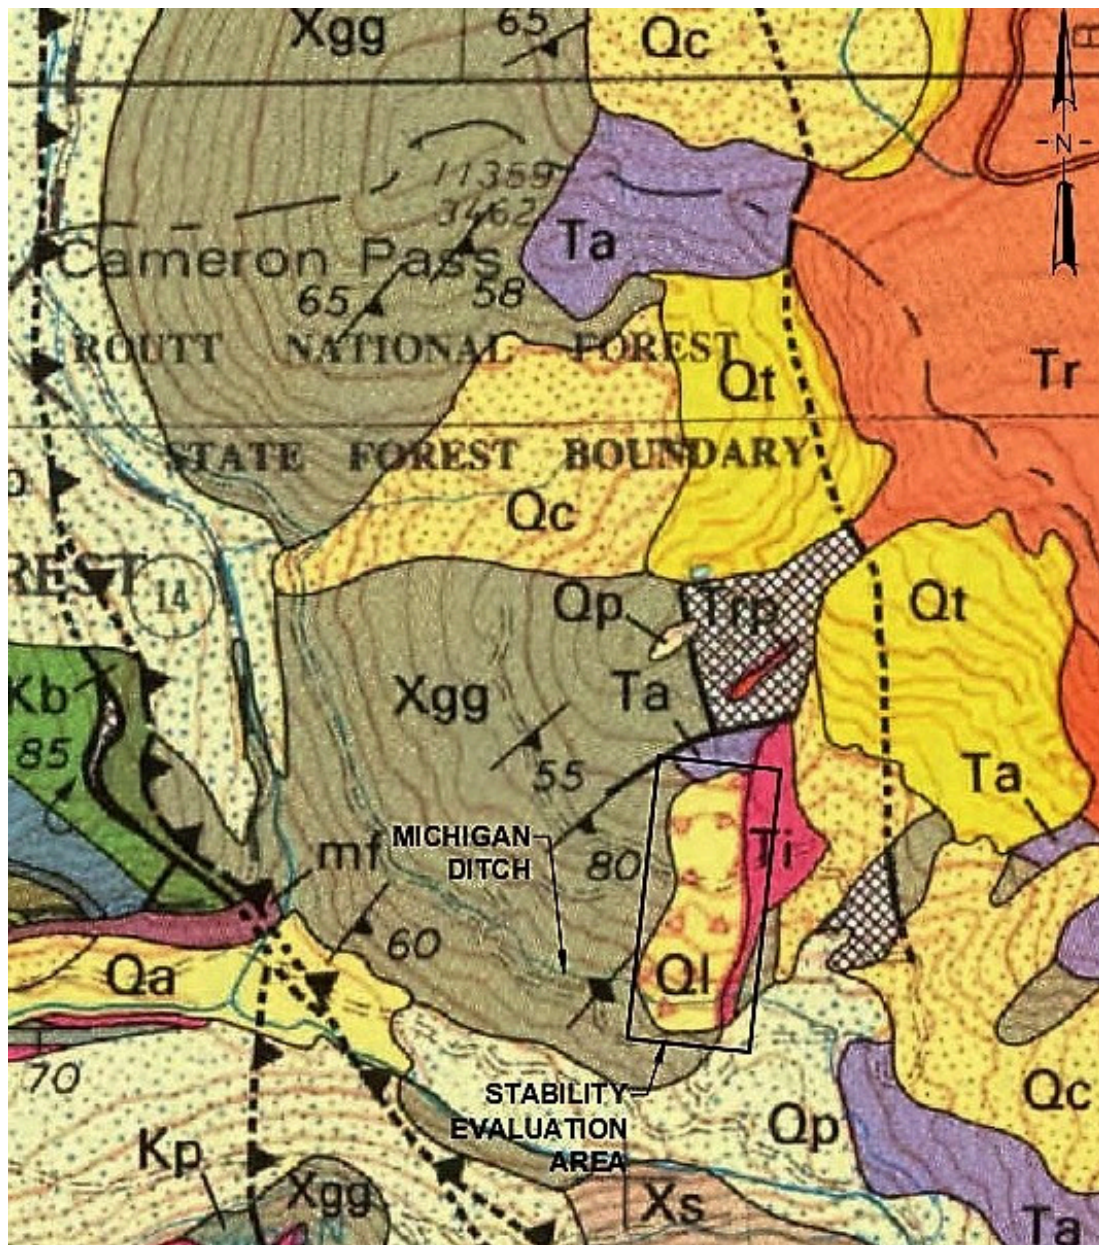
FIG. 2. Geologic Map Showing Mudslide (Ql) Area, Braddock and Cole, 1990.

The Mudslide is a mapped geologic feature (Braddock and Cole, 1990) (Figure 2). The mapped or historic landslide is approximately 2,200 ft long, up to 800 ft wide, with approximately 660 ft of vertical relief. The total area of the historic mapped landslide is just over 32 acres. The average slope of the ground surface along the axis of the landslide is 30 percent; however, portions of the landslide are flat while other areas of the slide have near vertical slopes. Photograph 3 is of the Mudslide taken from across the valley, only the lower portion of the landslide can be seen.

Geologic mapping conducted in 2011 revealed approximately 60 percent of the historic landslide is active. Refined geologic mapping revealed the active landslide is 2,340 ft long, up to 565 ft wide, with approximately 730 ft of vertical relief. The area of the active landslide is estimated at 19 acres. Geologic mapping conducted in 2011 revealed the active portion of the landslide extends approximately 300 ft further downslope than the mapped historic slide (Figure 4). A geotechnical investigation conducted in 2011, revealed the landslide deposit was up to 90 ft thick and included woody debris at the base of the slide deposit. This was later confirmed during a second geotechnical investigation in 2015.

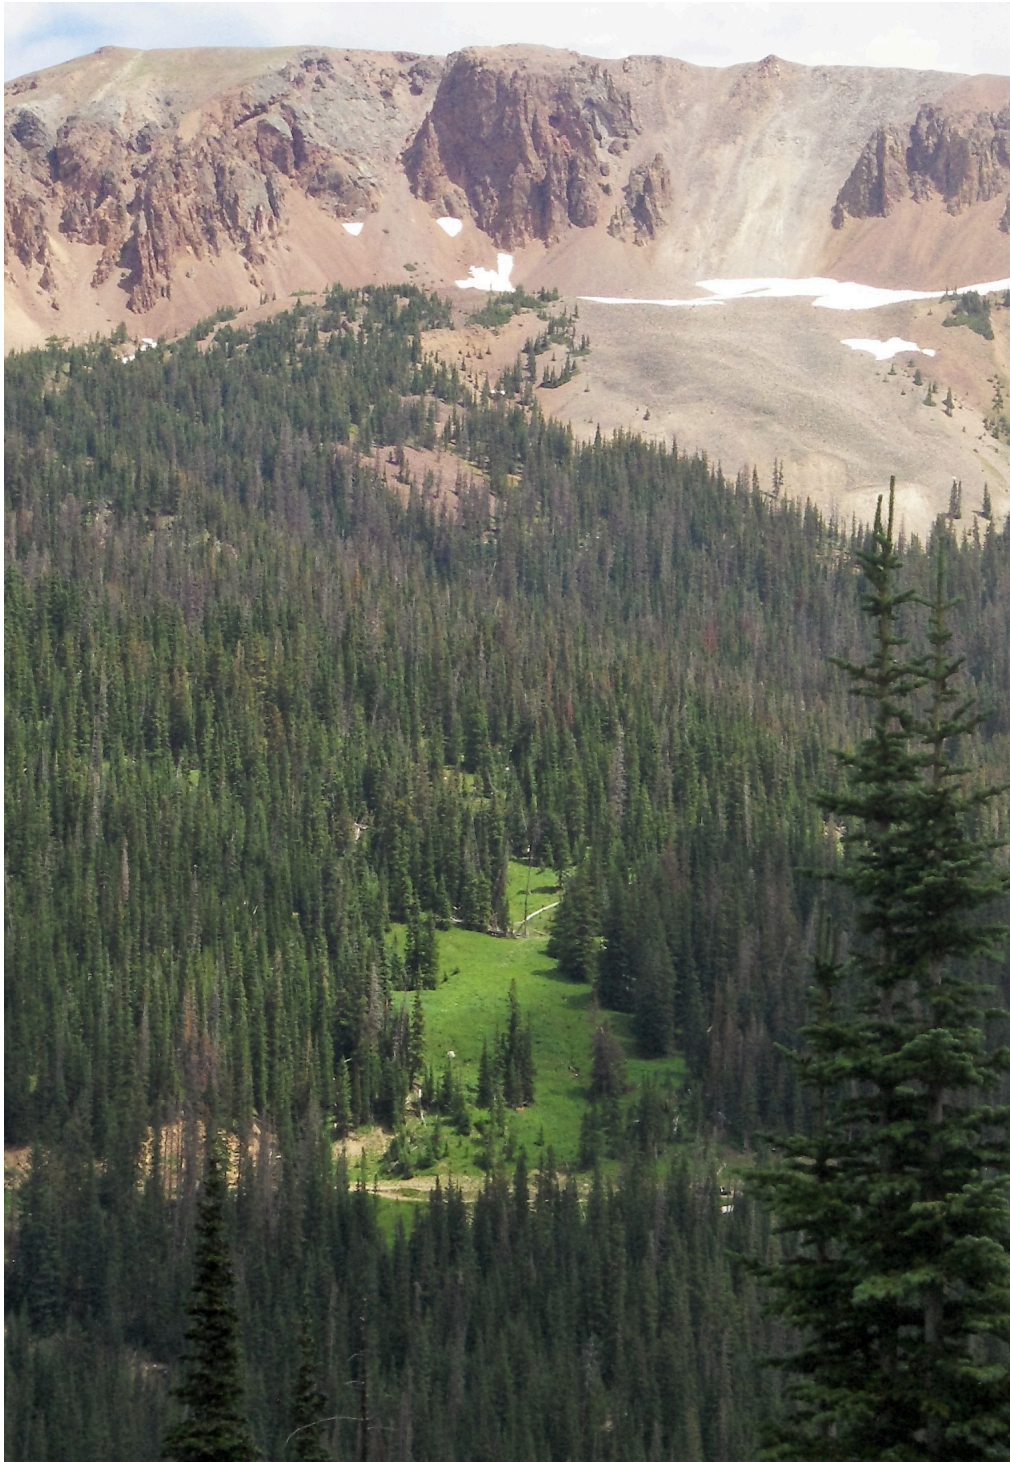
PHOTOGRAPH 1. Mudslide From Across the Valley.
