CONDITION RATINGS OF THE ELEMENTS OF THE ALBION RIVER BRIDGE

Table 1. Inspection Ratings of All Albion River Bridge Elements

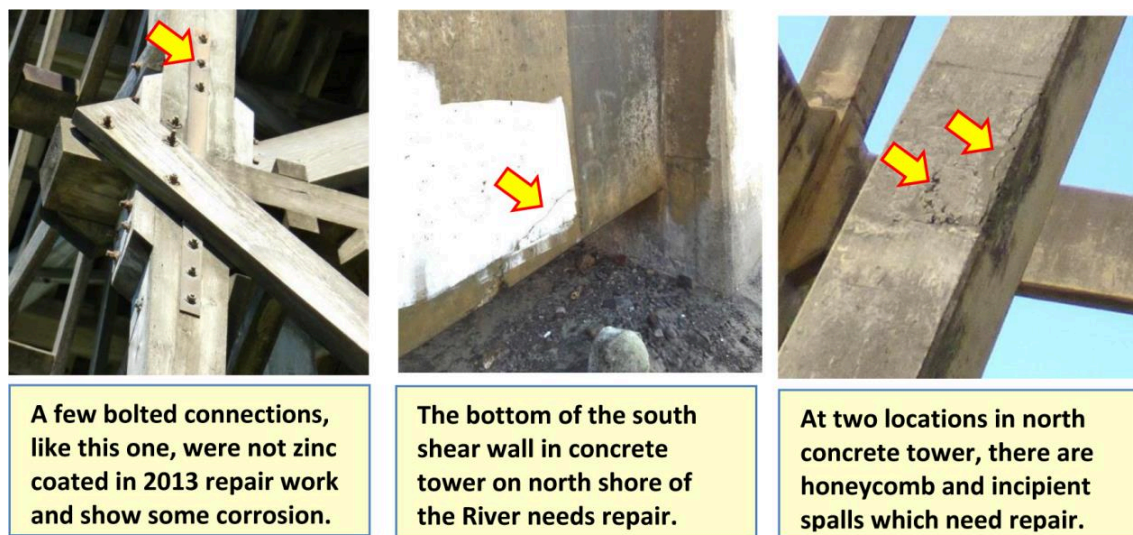
Figure 4. Areas of the bridge that need repair.
Photos by A. Astaneh-Asl.

A few bolted connections, like this one, were not zinc coated in 2013 repair work and show some corrosion.

The bottom of the south shear wall in concrete tower on north shore of the River needs repair.

At two locations in north concrete tower, there are honeycomb and incipient spalls which need repair.

Although much of the bridge is structurally sound, as Figure 4 suggests, a few areas require repair or maintenance. However, none of these areas currently affect the integrity or safety of the bridge.

^a One of the reinforced concrete columns in Bent 14 has an incipient spall as shown in the right side photo in Figure 4. The damage must be investigated for structural ramifications and be repaired.

^b One of the reinforced concrete pier walls in Bent 13 has a crack at the bottom as shown in the middle photo in Figure 4. This defect is not mentioned in the Caltrans 2015 Routine Inspection Report and is noted by the author. The damage must be repaired.

^c One of the reinforced concrete pier walls in Bent 13 has an incipient spall at the corner, which is not mentioned in the Caltrans 2015 Routine Inspection Report. The damage must be investigated for structural ramifications and be repaired.

Table 1 demonstrates that all the timber and steel elements of the Albion River Bridge are in “State 1: Good” condition. The only minor areas of damage are a reinforced concrete column and pier wall, which show a crack at one location and incipient spalls at two others. All three damaged areas must be investigated structurally and appropriate repair plans must be developed and implemented. After these repairs, all elements of the Albion River Bridge will have a current condition rating of good.

suggested that Caltrans, in consultation with the bolt manufacturers, use galvanized threaded rods, washers, and nuts and protect the bolt heads and nuts by using plastic or metallic non-corroding caps and covers, which are commonly utilized in bolted structures subjected to corrosion.
