SOUTH CLEAR WELL ROOF COLLAPSE: Hydraulic Uplift or Excessive Construction Loading ?

C. Roarty, Jr., P.E. ¹, J. Sivak, P.E. ², P. Vogel, P.E. ³, and K.V. Ramachandran, P.E. ⁴

Abstract: This paper presents a failure investigation case history of a partial roof collapse of a below-grade water storage facility during rehabilitation. The evaluation considers the original design and maintenance of the facility, rehabilitation design, and construction sequencing. The cause of the roof collapse was the failure of selected columns under approved construction equipment loading. The columns that failed were initially damaged by hydrostatic uplift of the base slab during a severe rainfall event and subsequently loaded repetitively by construction operations. Hydraulic and structural models developed during the evaluation accurately predicted the response of hydraulic systems, general crack patterns and specific crack locations; thereby confirming the failure mechanism.

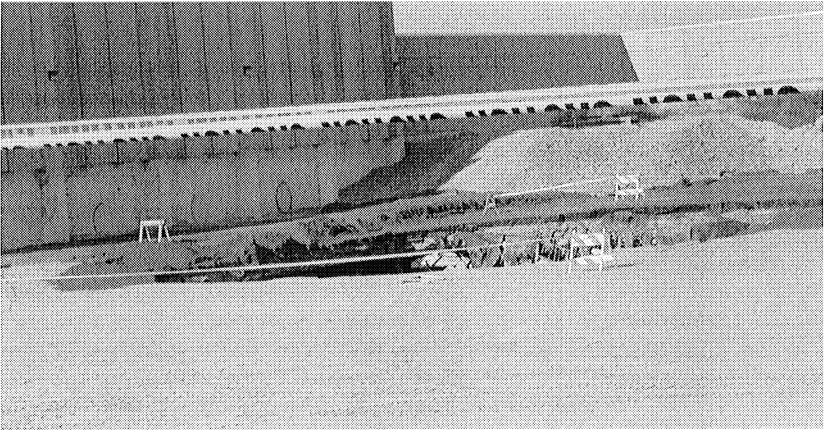
Figure 1. View of collapsed roof section

Initial Inspection - The team noted that six columns had collapsed under the failed roof section. All six collapsed columns appeared to have broken off at the connection between the column and the capitals/pedestals. The column capitals and pedestals were still connected to the roof and floor slabs, respectively.

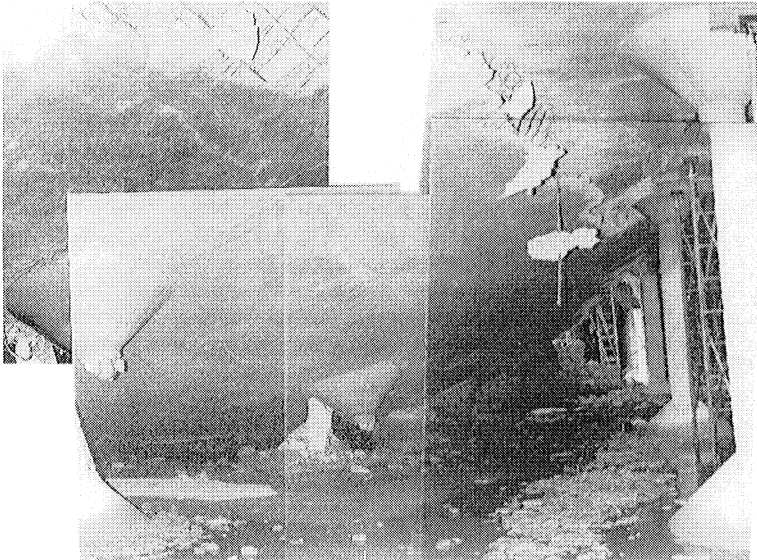
- The collapsed portion of the roof had separated from the clear well on the east, north, and west sides and was still connected on the south edge north of column line 6f (See Fig. 2). The remaining roof slab on the north edge of the collapsed area lines up with a family of previously grouted roof cracks approximately four feet from the face of the beam and post supported section (See Fig. 3). The remaining roof slab on the east and west edges of the collapsed area extends from the edge of column capital up to four feet from the capitals. The lower mat of roof reinforcing bars were stripped from the underside of the remaining slab in the east, north and west sides (See Fig. 4). It appears the northern edge of the collapsed roof section broke free and encountered the clear well floor first.

Fig 2. Hinge formed at south edge of collapsed roof section at column line 6f

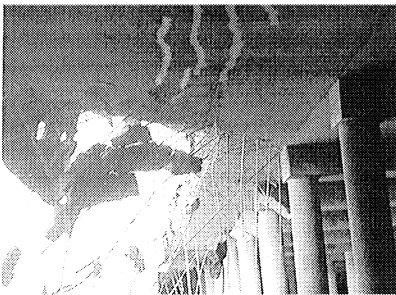
Fig 3. Collapse along existing cracks

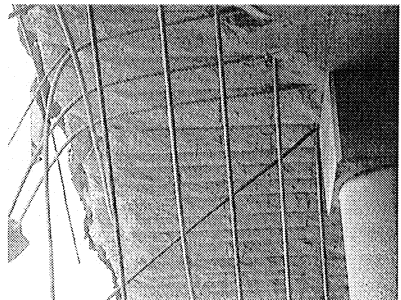
Fig 4. Roof slab steel stripped
