Board of Inquiry of Investigation

Methodology of Investigation

Findings

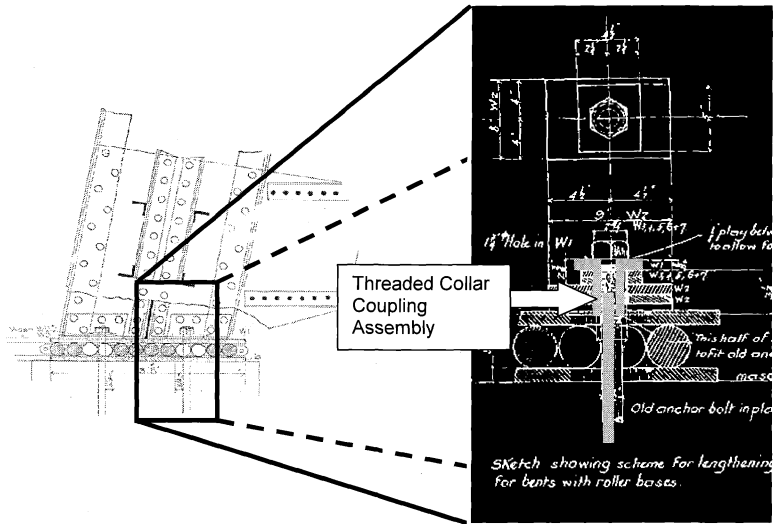
with roller expansion bearings so that the structure could expand laterally in response to temperature. Because the existing wrought iron anchor bolts were too short to accommodate the fitted expansion bearings used in the new design, the wrought iron anchor bolts were spliced to steel anchor bolt extensions by means of threaded, steel collar coupling assemblies. (Grimm 1901) The collar coupling assemblies were encapsulated by large diameter circular washers, and were consequently obstructed from view prior to the collapse. (Figure 1)

Figure 1 – Wrought Iron Anchor Bolt Extension via Threaded Collar Coupling Assembly

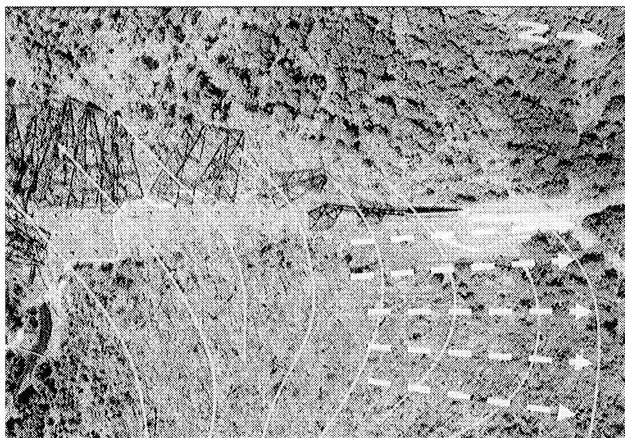
Directional markers – including both the direction of fallen trees and collapsed towers. (Figure 2) Directional markers were evident through high resolution photography and revealed wind directed in two orthogonal directions (initially from the east, then from the south). The observation of these markers confirmed the sequence of collapse as well as the contribution of both “vortex leading edge” (easterly) winds accompanied by “inflow” (southerly) winds occurring in rapid sequence in this extreme weather event.

Figure 2 – Depiction of Wind Streamlines (Directional Markers) with “leading edge” wind streamlines – directed westward; and “inflow” wind streamlines – directed northward

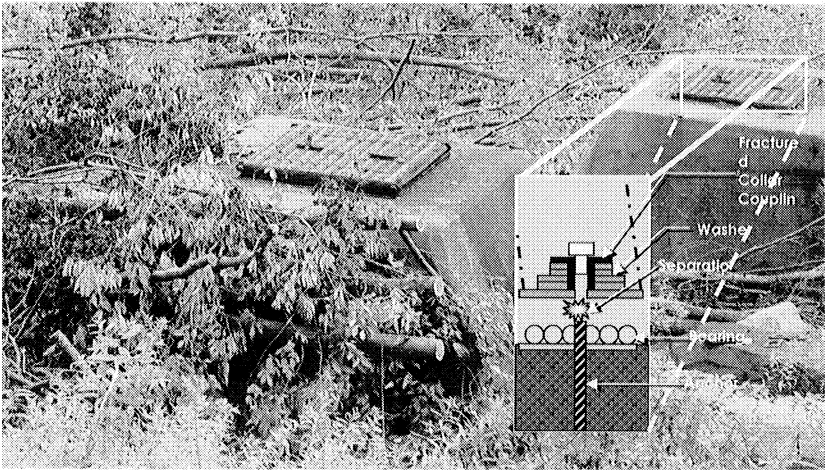
Separation markers – including all evidences of “clean” breaks. (Figure 3) During the field investigative phase, it was apparent to the investigative team that the initiation of failure occurred at boundary between superstructure (of trestle bent configuration) and substructure, most likely at the specific boundary of the 1882 (original construction) and the 1901 (reconstruction).

At this boundary, the original wrought iron anchor bolts and masonry were preserved in the reconstruction. Fractures were observed within certain wrought iron anchor bolts (1882 construction) and a majority of expansion bearing, steel collar coupling assemblies (1901 construction), that provided connectivity between the original masonry and reconstructed superstructure. Consistently “clean breaks” were observed at the interface of the 1882 and 1901 construction. The separation markers were observed during the field inspection. The separation markers evidenced distinctive separation of the superstructure from its roller bearing assembly at the base of the superstructure for all eleven collapsed towers.

Figure 3 – Illustration of separation failure at substructure/superstructure interface

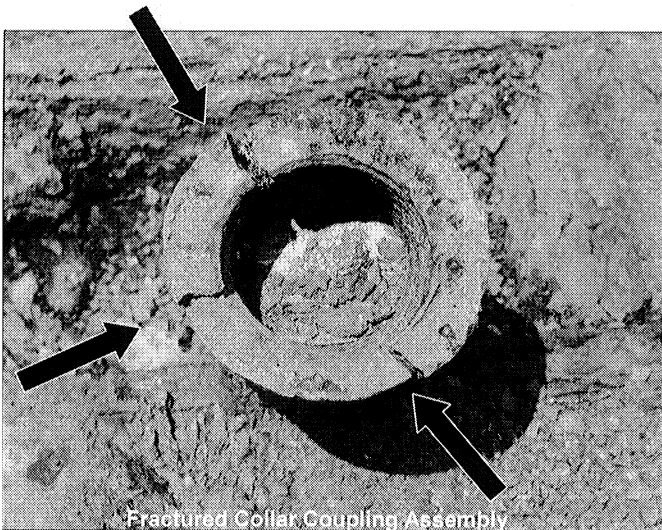
Fracture markers – including steel evidence of consistent patterns of small sub-critical fractures within members. (Photograph 3) Consistently, small sub-critical fractures were observed in the steel collar couplings connecting the 1882 construction and the 1901 construction on the windward side of the towers. Subsequent fractographic examination using a light microscope and microscopic examination using a scanning electron microscope, revealed evidence of long term fatigue crack propagation. The visual appearance of the fractures was characteristic of fatigue fracture with a flat, smooth surface without any evidence of plastic deformation in the fracture region. Microscopically, the fracture morphology also appeared fatigue-like with smooth featureless regions, typically found in high sulfur steels. (Photograph 4) No evidence of fatigue beach marks or striations were observed in these regions, however, the absence of evidence of brittle fracture by a cleavage mechanism or ductile fracture mechanism by dimple fracture suggested that the flat regions were most likely the result of stable crack propagation by a fatigue mechanism.

Based on the four forensic markers and subsequent analysis, the *Board of Inquiry* investigation concluded that failure initiated at the “weak-link” of the system – the anchor bolt system on the eastern faces, which was initially installed in the 1882 construction and subsequently modified in the 1901 construction. The 1901 construction provided a collar coupling assembly which included a series of washers that surrounded the anchor bolts and couplings. Consequently, the through wall-cracking of the collar couplings was hidden from view during routine condition inspections.

Photograph 3 – Delineating Through-Wall Cracking

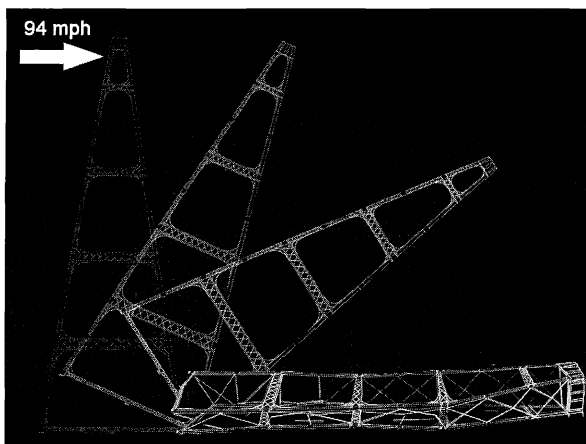
All eleven collapsed towers were fitted in the 1901 reconstruction with expansion bearings secured to the existing masonry via (1882) wrought iron bolts and (1902) collar coupling assemblies. Based on site observation that for the majority of these locations, three out of four of the anchor bolt assemblies at each tower leg displayed complete separation of the superstructure from the substructure at the collar coupling connection, the immediate failure at the expansion bearings may be characterized as a separation failure. As this separation failure resulted in a rotational failure of each tower about the fixed (or opposite) tower bearings, a back calculation of the force effects necessary to overturn the structure became the basis for prediction of the limiting wind velocity. (Figure 4) This back calculation derived uplift capacity based on the fracture of one anchor bolt out of four (with no strength attributed to the remaining three anchor bolts within a typical four bolt tower location) and utilized limit strengths derived from specimen samples. This back calculation subsequently derived an applied wind velocity of 42 m/s (94 mph) accompanied by a wind pressure of 1.9 kPa (39 psf) and recognized two distinct modes of failure of the anchor bolt system.

Figure 4 – Illustration of Rotational Failure Mechanism

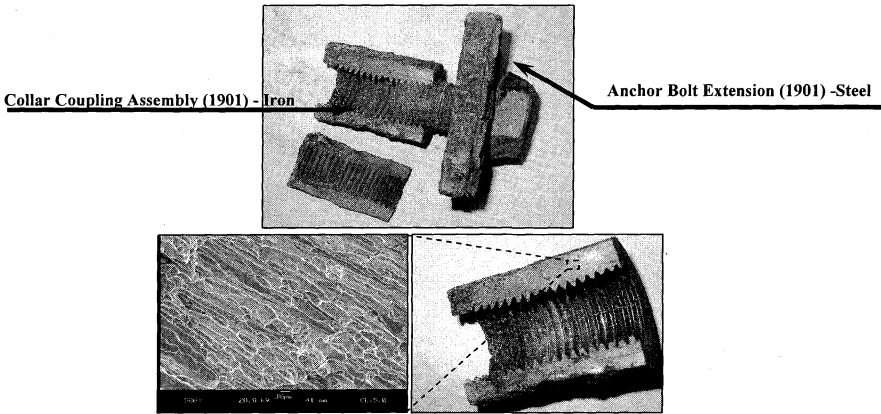
Failure Mode 1 – Coupling Failure at the Boundary of 1882 and 1901 Construction – Expansion Bearing Anchor Bolt Collar Coupling. This mode accounts for approximately 3/4 of observed separation failures. All collar couplings observed at the site exhibited a radial cracking pattern, along with multiple longitudinal “splits” within the anchorages. The equiangular “splits” completely penetrated the collar couplings. The collar couplings found throughout the debris field exhibited similar fracture indications. Coupling failures showed evidence of fatigue fracture with secondary fractures occurring by overload presumably during the collapse. (Photograph 4) The *Board of Inquiry* investigation concluded that the couplings, which separated from the bearing assemblies and which were strewn within the debris field, experienced long term fatigue crack propagation prior to the time of the collapse incident. Because the cracks propagated through the entire thickness of the coupling, these collar couplings were judged to be ineffective for the transmission of uplift forces to the substructure. (Kaufmann and Connor 2003)

Photograph 4 – Laboratory Investigation of Through-Wall Cracking
(demonstrating long term fatigue crack propagation)

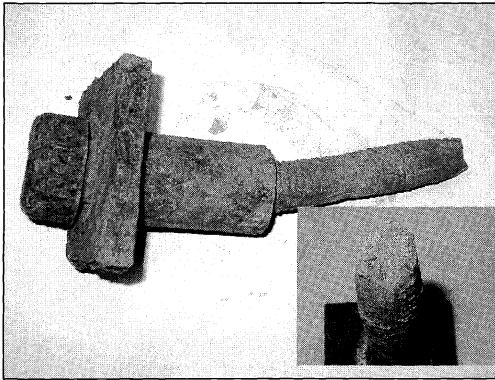
Mode 2 – Ductile Failure within the existing 1882 anchor bolts – Expansion Anchor Bolts. (Photograph 5) This mode accounts for approximately 1/4 of observed failures. Fractographic examination of fractured original 1882 anchor bolts showed that the fracture resulted from tensile overload and was a fully ductile fracture. (Kaufmann and Connor 2003) The estimated tensile capacity of a single (1882), 31.75 mm (1-1/4 in) anchor bolt at failure, considering a 20% corrosion loss, was determined to be 13 kN (30 tons) based on Brinell Hardness evaluation. Based on the observed, 3:1 ratio of collar coupling failure to ductile anchor bolt failures, an uplift capacity of 13 kN (30 tons) was attributed to each tower. This capacity established a lower bound, critical wind speed of 42 m/s (94 mph), which was sufficient to initiate failure. (Leech et al. 2003) The failure was sudden and catastrophic.

Photograph 5 – Wrought Iron Anchor Bolt – Ductile Fracture

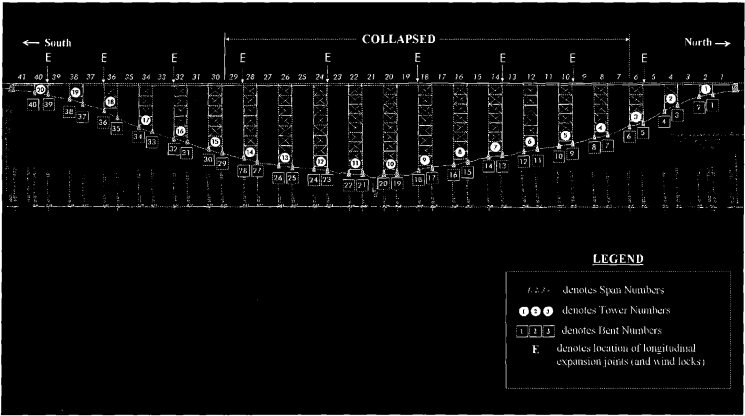
The collapse of eleven supporting towers and twenty-three of the forty-one structure spans was rapid and proceeded in three distinct and separate episodes as illustrated on the accompanying figures. All girders and towers between towers 3 and 15 collapsed. Separation of the structure into three distinct collapsing segments is attributable to the arrangement of the wind locks within the girder system and to the nature of the wind event. (Figure 5) The 1901 design introduced expansion joints (and accompanying wind locks) at irregular locations within the structure. The collapse of the structure in three distinct episodes was controlled by the location of these wind locks.

Figure 5 – Structure Elevation View Demonstrating Wind Lock Location

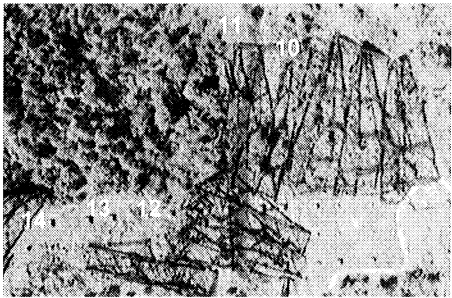
1. Tornado touched down – easterly (or “vortex leading edge”) winds grew rapidly – local wind speeds (from the east) exceeded 40 m/s (90 mph) – as wind speeds grew, the towers oscillated laterally in response to their natural frequency.
2. “Separation” failures occurred within the “expansion” anchor bolt system of Towers 10, 11, 12, 13 and 14.
3. Rotational failure accompanied by collapse of Towers 10 and 11 and adjoining spans occurred.
4. Towers 12, 13 and 14 initially become airborne and “jumped” a small distance north and westward. Towers 12, 13 & 14 momentarily came to rest in the upright position on the ground, not initially collapsing. The rails and wooden decking for a brief period of time remained affixed to several spans and held the three towers in a vertical position, initially preventing immediate catastrophic collapse.

Photograph 6 - Debris Field – Episode 1 – tower numbers indicated

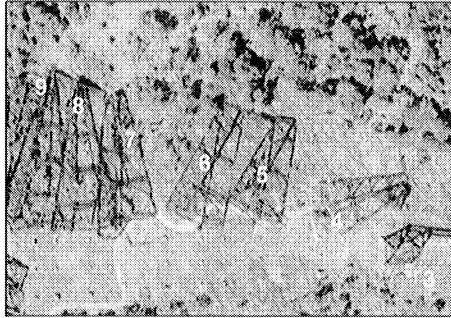
1. Tornado moved northward – easterly (“vortex leading edge”) winds grew rapidly – local wind speeds (from the east) exceeded 40 m/s (90 mph). As wind speeds grew, all towers oscillated laterally in response to their respective natural lateral frequencies.
2. Wooden decking and rails (spans 1 – 18) separated from the structure.
3. “Separation” failure occurred in sequence within the “expansion” bearings of Towers 9, 8, 7, 6, 5 and 4.
4. In sequence, rotational failure of Tower 9 occurred, shortly, followed by rotational failure of Towers 8, 7, 6, and 5. Collapse was progressive from South to North.
5. Tower 4 was initially restrained by Tower 3 and the connecting girder span. However, after elongation of the girder span’s connection to Tower 3, rapid collapse and clockwise twist of the tower occurred. Tower 3, although standing, was visibly distorted.

Photograph 7 - Debris Field – Episode 2 – tower numbers indicated
