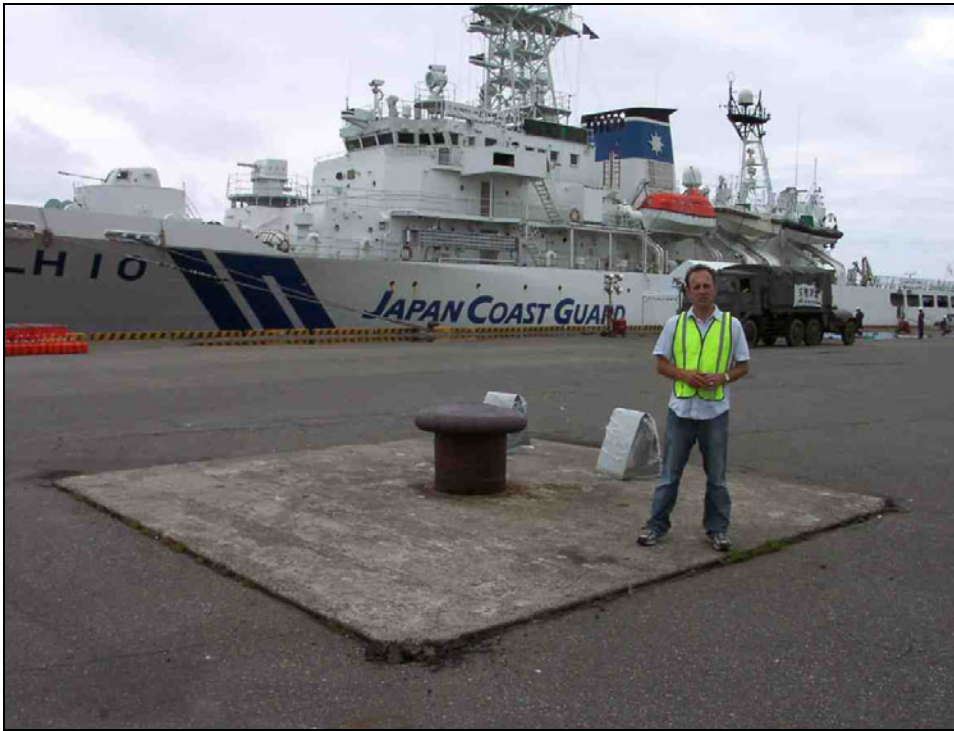
*Fig. 3.174. Kashiwazaki Port—eastern berth. Evidence of minor settlement adjacent to a pile-supported (?) bollard anchorage located along the northern face of the terminal (N37.36680° E138.53825°).*

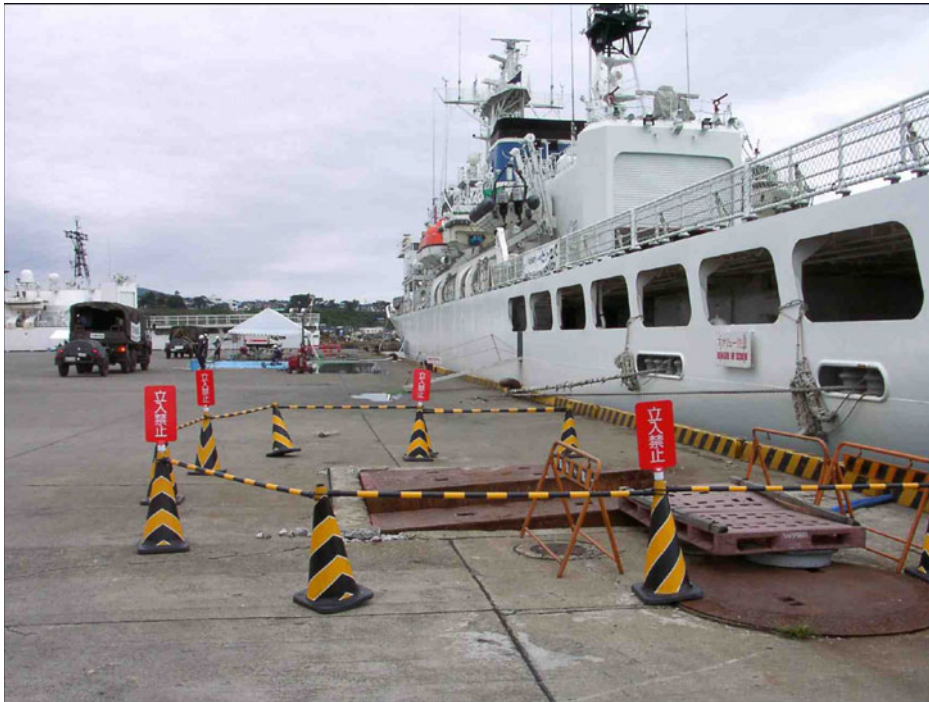
*Fig. 3.175. Kashiwazaki Port—eastern berth. Evidence of very minor lateral movement of quay walls and minor settlement located along the northern face of the terminal (approximately N37.36680° E138.53825°).*

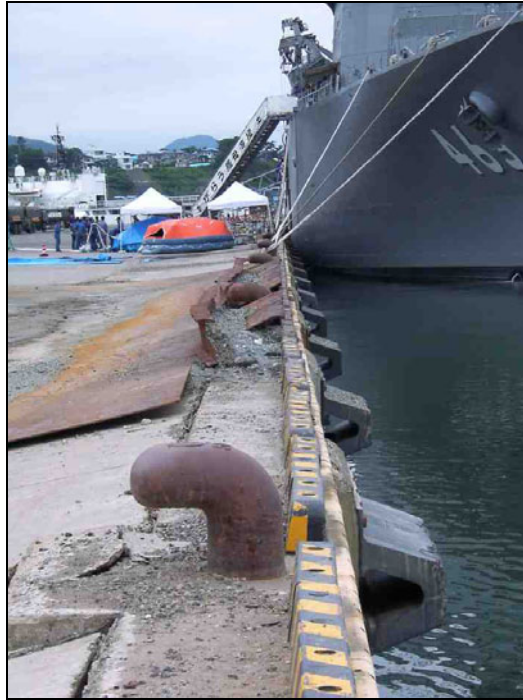
*Fig. 3.176. Kashiwazaki Port—eastern berth. Evidence of more extensive lateral quay wall displacement and ground settlement located along the eastern end of the terminal (approximately  $N37.36680^{\circ} E138.53825^{\circ}$ ).*

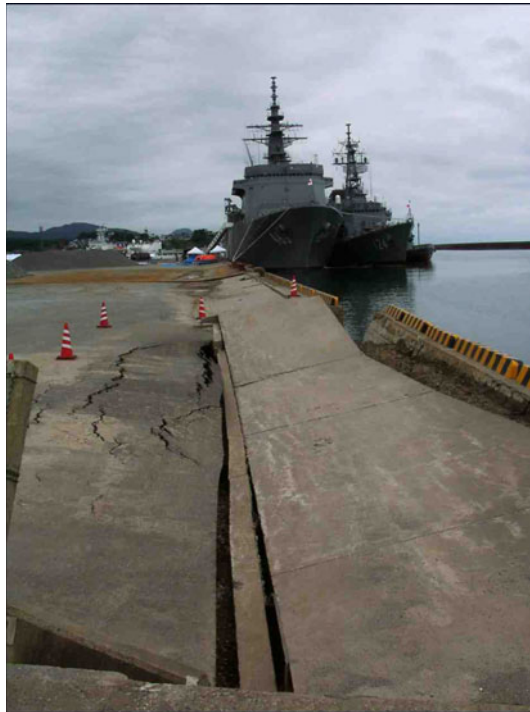
*Fig. 3.177. Kashiwazaki Port—eastern berth. Significant liquefaction-related damage to the quay walls located at the eastern edge of the terminal adjacent to the mouth of the U River (approximately  $N37.36680^{\circ} E138.53825^{\circ}$ ).*

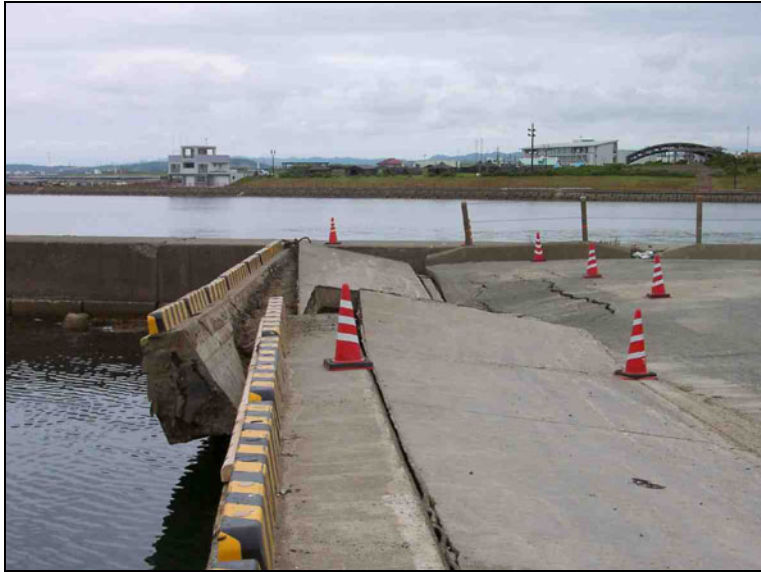
*Fig. 3.178. Kashiwazaki Port—eastern berth. Significant liquefaction-related damage to the quay walls located adjacent to the U River (approximately N37.36680° E138.53825°).*

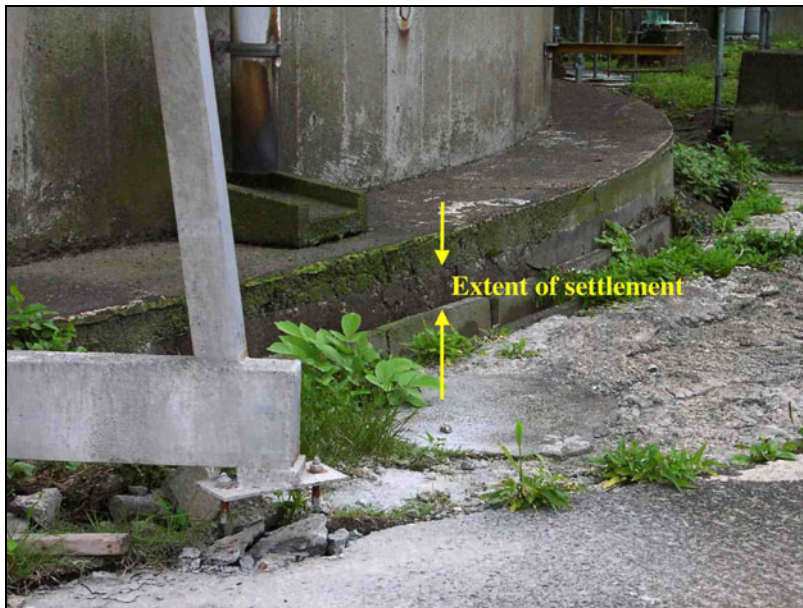
**Taiheiyo Cement Tanks.** This facility is located in the backland portion of the eastern berth terminal. The issue of business interruption at the port was considered by the reconnaissance team. Because of the regional need for concrete in restoration efforts following the earthquake, the operation of this facility is important. Inspection of the tank foundations revealed minor ground settlement of 5 cm to 12 cm adjacent to the tank foundations (Figures 3.179 and 3.180). Liquefaction effects were negligible in this area. The tanks and appurtenant piping appeared to be in good shape with negligible damage; however, the facility was not in operation at the time of the investigation.

*Fig. 3.179. Kashiwazaki Port (Taiheiyo Cement Facility)—Evidence of minor settlement of sandy fill adjacent to one of the large diameter tanks (approximately N37.36665° E138.53983°).*

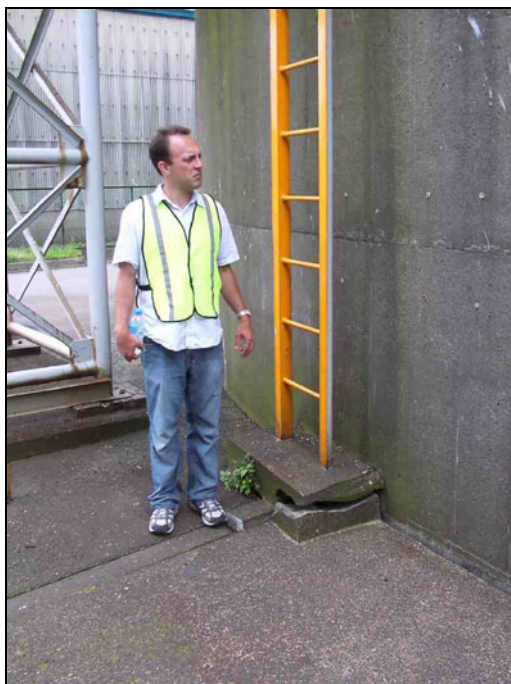
*Fig. 3.180. Kashiwazaki Port (Taiheiyo Cement Facility)—Evidence of minor settlement of sandy fill adjacent to one of the large diameter tanks (approximately N37.36665° E138.53983°).*

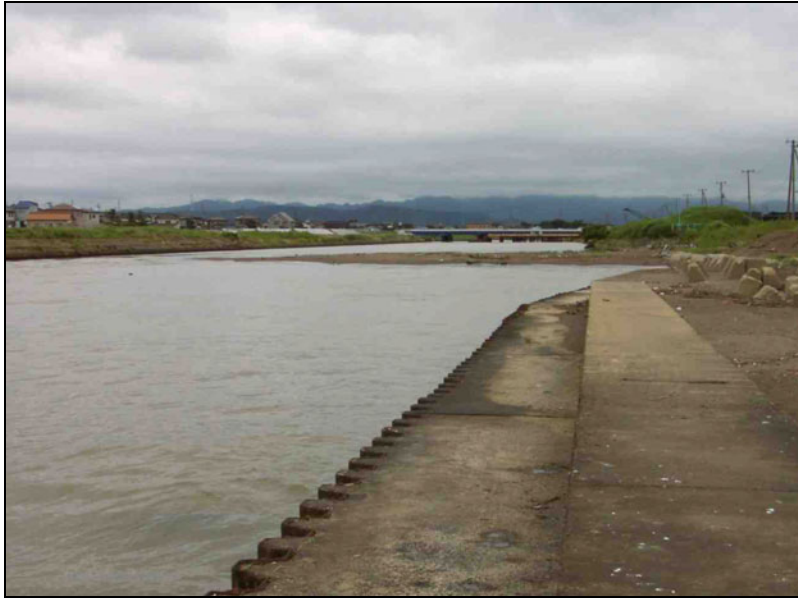
The mouth of the Sabaishi River is protected along its southwest bank by a wall constructed of sheetpiles with concrete filling (Fig. 3.181). Negligible lateral movement of the riverfront wall was noted and roughly 5 cm to 7 cm of settlement was noted adjacent to the sheetpile wall. Evidence of approximately 30 cm of lateral spreading in the sand deposits behind the sheetpile shore protection was also observed. In addition, minor lateral deformation and damage to the concrete slope armor panels was observed across the river from this site. The extent of lateral spreading at this location was considerably less than what would be anticipated for a waterfront site where shaking in the underlying firm soils was likely in excess of 0.30g, indicating that the sheetpile and concrete wall restrained the adjacent soil mass from moving.

*Fig. 3.181. Mouth of the Sabaishi River showing the channelization and erosion control measures (approximately N37.38868° E138.56508°). The Ansei Bridge is visible in the background.*

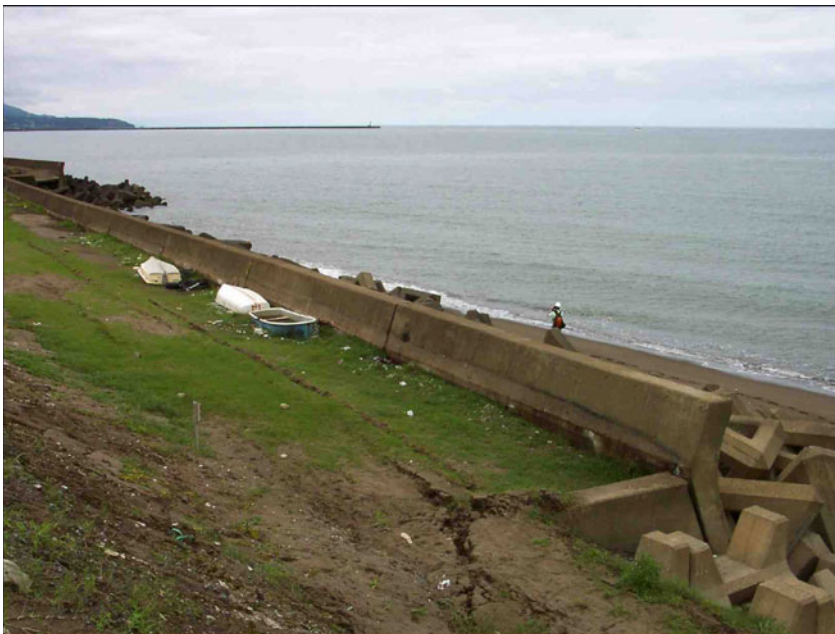
*Fig. 3.182. Eastern end of the seawall located near the mouth of the Sabaishi River (approximately N37.38868° E138.56413°). Lateral spreading behind the wave armor units, as well as ground settlement and minor sea wall damage was widespread.*

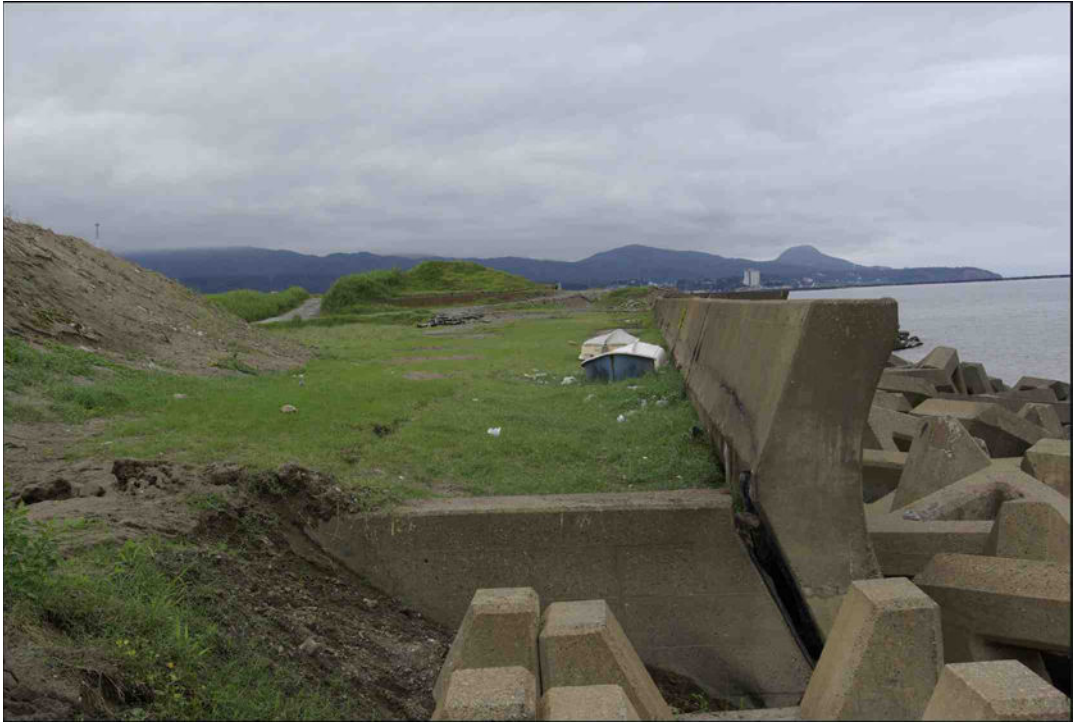
Along the waterfront to the southwest of the Sabaishi River and transverse to the riverfront sheetpile wall in Figure 3.182 is a seawall that extends southwest roughly 2.0 km toward the Minatomachi Seaside Park. This seawall was inspected for more than a 1-km length. Observations were made from the mouth of the Sabaishi River southwest to an armored rockfill breakwater located roughly 1.2 km to the southwest. The initial portion of the seawall is located along a narrow beach with wave armor units. This portion of the seawall exhibited lateral deformation, rotation, and structural damage along the counterfort ends of several of the individual wall sections (Fig. 3.183).

*Fig. 3.183. Lateral displacement of the seawall located near the mouth of the Sabaishi River (approximately N37.38868° E138.56413°).*

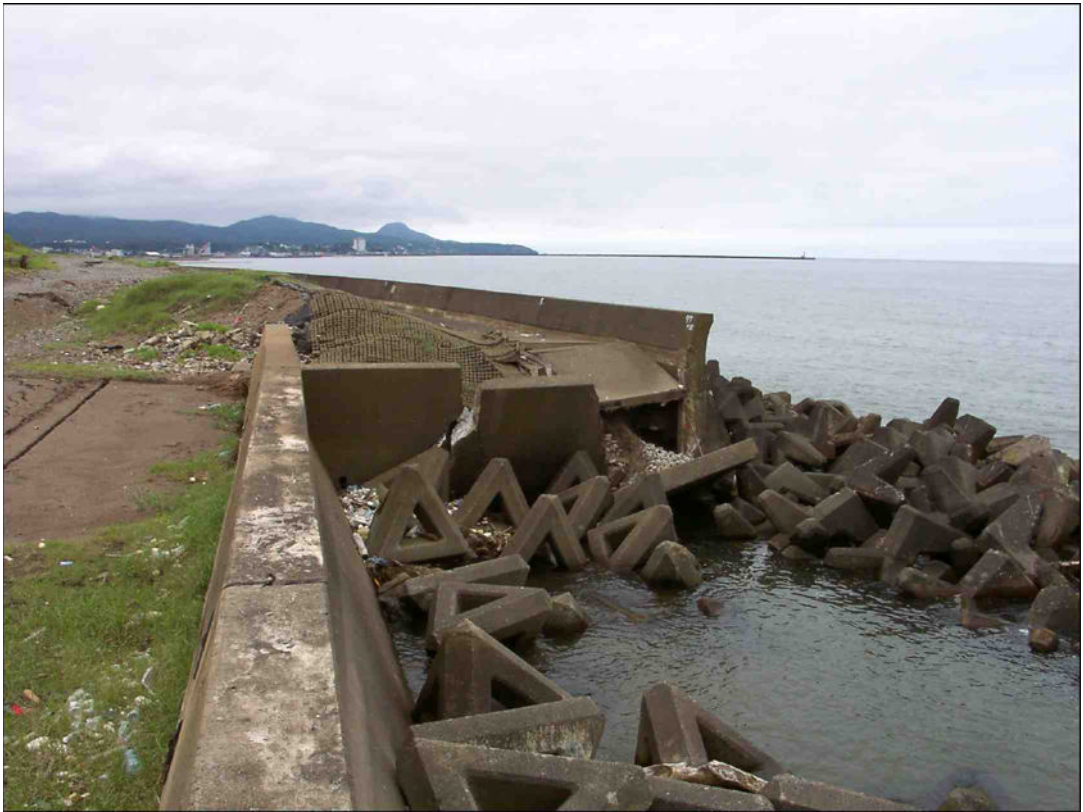
Approximately 120 m to the southwest, there is a seaward step in the seawall. This point was the location of a seawall failure that included a collapsed section of wall, significant settlement and cracking of the backfill, and settlement of the concrete panels located behind the seawall (Fig. 3.184). The backfill adjacent to the seawall is composed of clean, rounded cobbles (diameter > 15 cm) (Fig. 7.185). The lateral wall movement in this area was roughly 0.6 m.

*Fig. 3.184. Partial collapse of a portion of the seawall (approximately N37.38868° E138.56413°).*

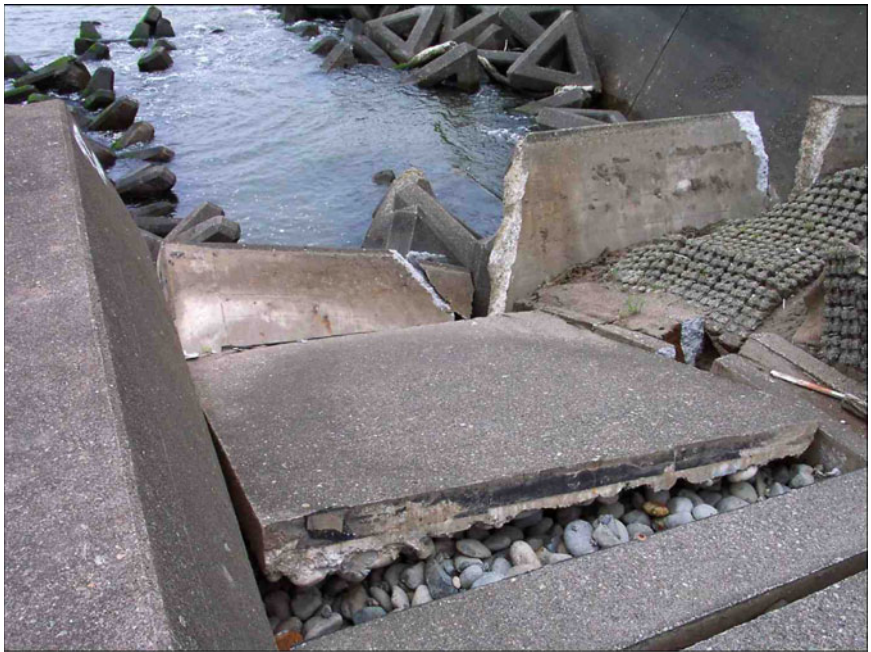
*Fig. 3.185. Close-up of the collapsed portion of the seawall showing the clean cobble backfill (N37.38868° E138.56413°).*

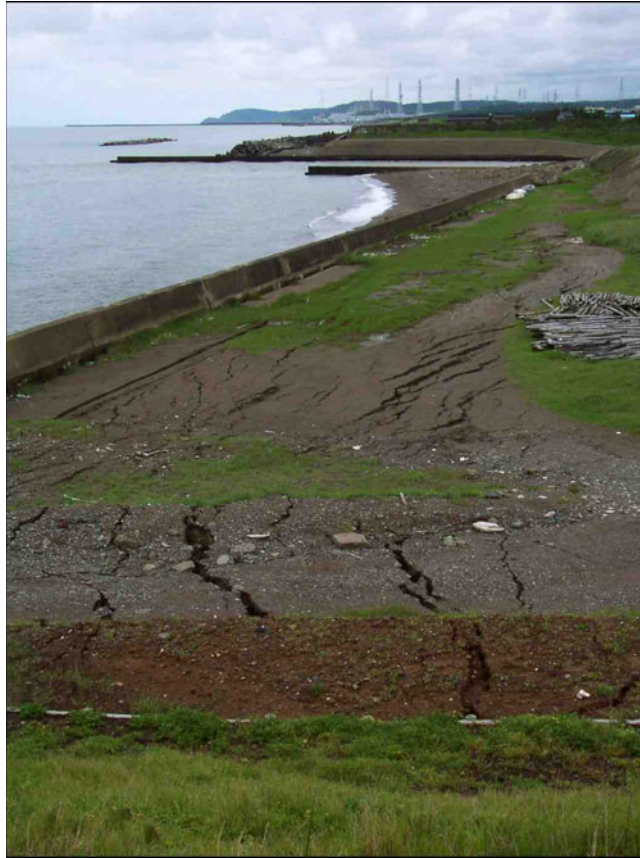
The use of cobble backfill was observed over much of the 1 km length of the seawall that was inspected, and this fill was roughly 3 m to 4 m wide in most areas. The fill placed adjacent to the cobbles is predominantly sand with areas of sandy clay and clayey sand. For most of the reach between the Sabaishi River and Minatomachi Park a large embankment fill has been placed. The placement of the long embankment imposes static shear stresses in the foundation adjacent to the seawall. It is, therefore, likely that the additional seismic loading and associated seismic shear stresses were sufficient to induce widespread failures in the embankment and foundation, thereby, affecting the seawall (Fig. 3.186).

*Fig. 3.186. Extensive ground failures in proximity to the seawall located near the mouth of the Sabaishi River (approximately N37.38868° E138.56413°).*

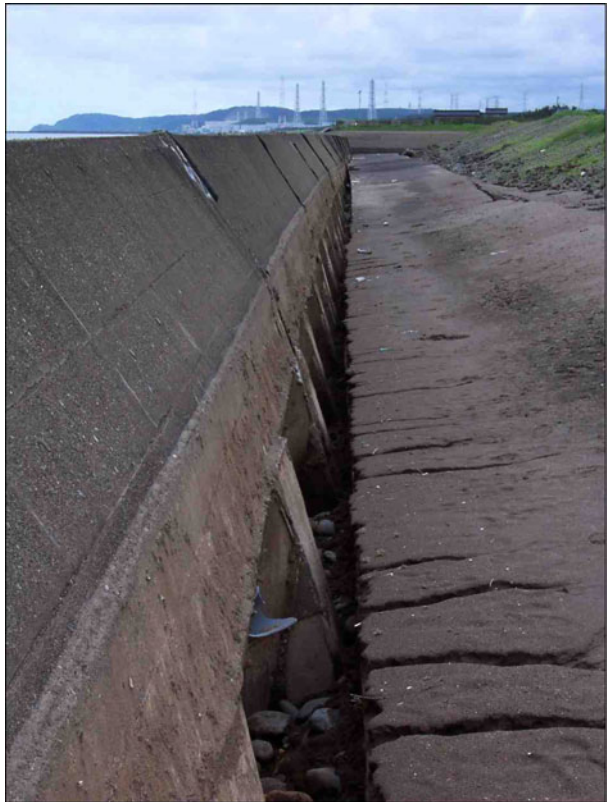
*Fig. 3.187. Evidence of seawall rotation, ground settlement, and lateral spreading at the toe of the benched embankment.*

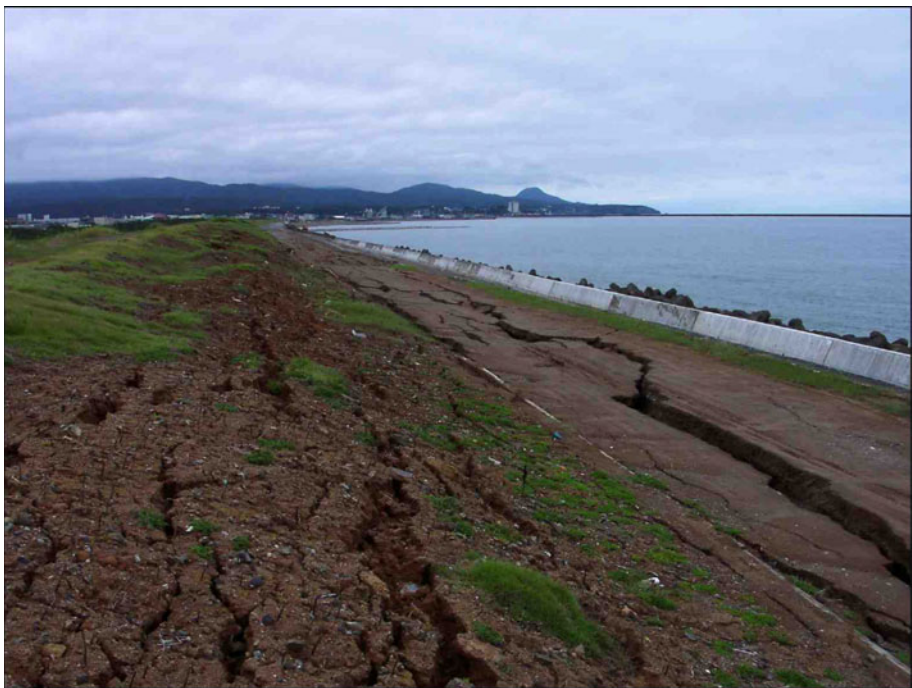
*Fig. 3.188. Representative ground cracking and lateral displacement of the clayey earth embankment adjacent to the seawall.*

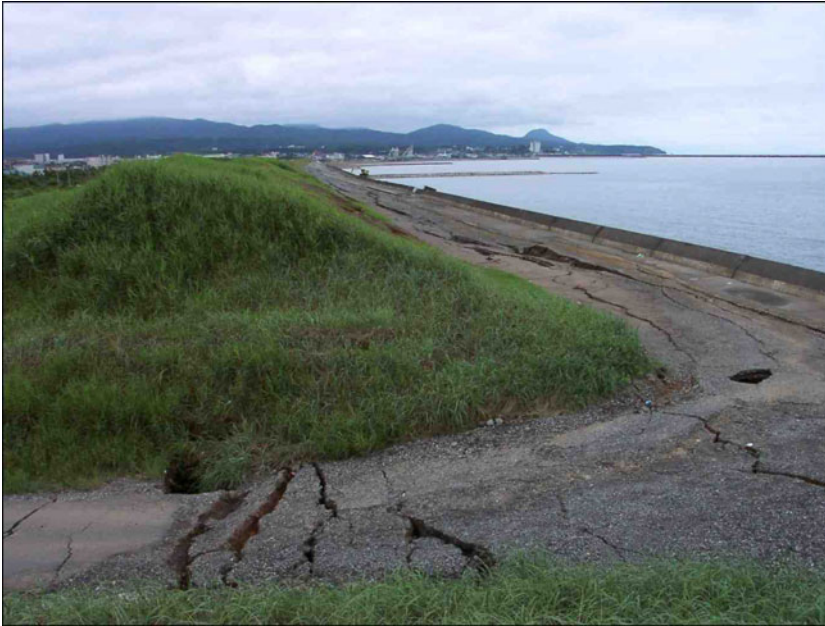
*Fig. 3.189. Extensive ground deformations adjacent to the embankment and seawall.*

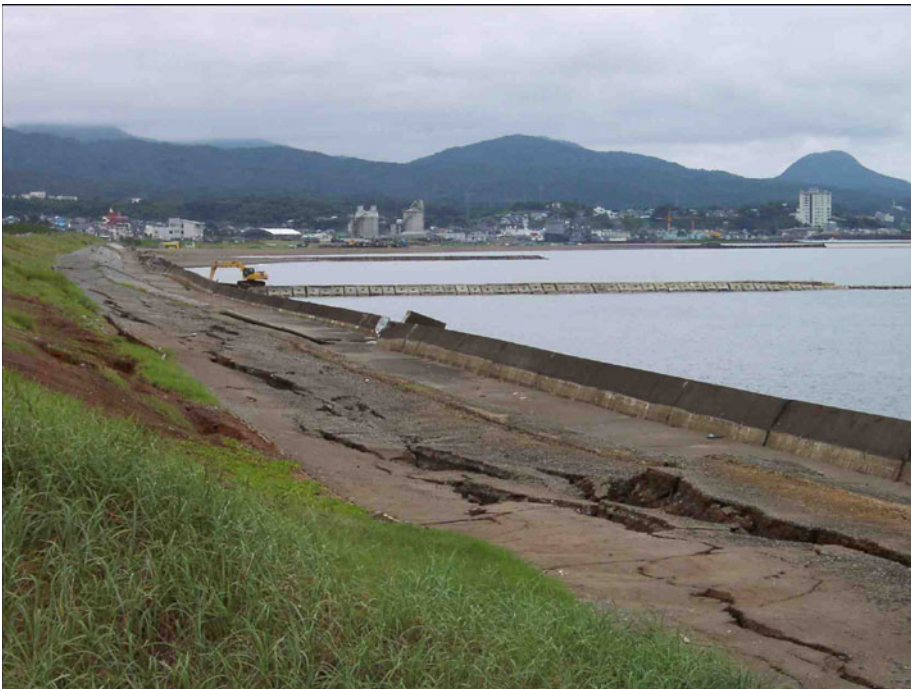
The lateral ground deformation associated with these embankment and foundation failures impacted the seawall and contributed to the development of larger displacements (Fig. 3.190). At one location near the southwestern end of this area, ground settlement and lateral movement of the seawall was accompanied by the failure of the top of the wall (Fig. 3.191). The inspection of the seawall was terminated at an armored groin structure (possibly an outfall structure). At that time a track-hoe was being used to move rockfill between the seawall and the concrete armor blocks that overlie the rockfill offshore (Fig. 3.192).

*Fig. 3.190. Ground deformations adjacent to the embankment and seawall.*
