Sayreville Relief Force Main: 10 Years of Monitoring and Proactive Management

Edward A. Padewski III, P.E., M.ASCE¹; Donato J. Tanzi, P.E.²; and Geanine Castaldi, EIT, A.M.ASCE³

Abstract

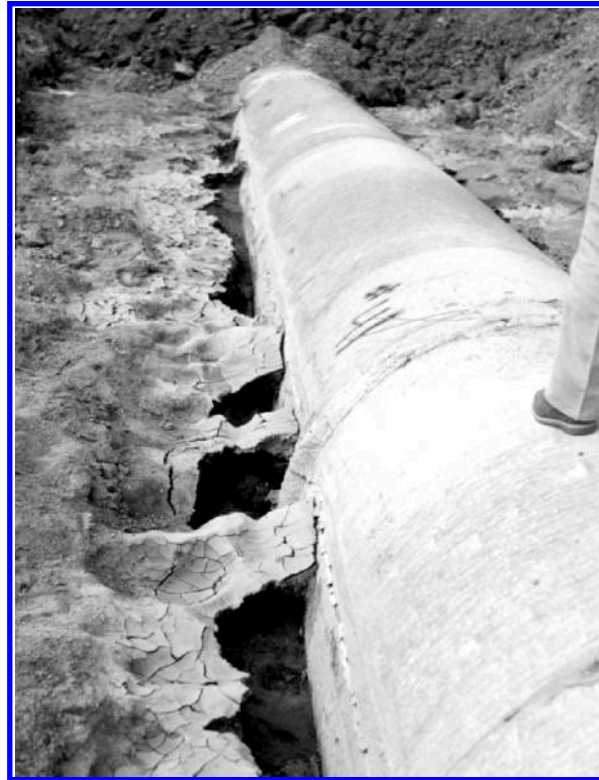
The results of the first attempt by a contractor inexperienced with saturation and vibration is shown in Figure 6. There were too many fines in the soil used as evident by the crust on the surface. The contractor ordered the material appropriately with 5% fines or less. However the aggregate processing plant sent the wrong material. Once the correct soil was being used, he successfully completed the job.

Figure 6 Too Many Fines for Saturation and Vibration

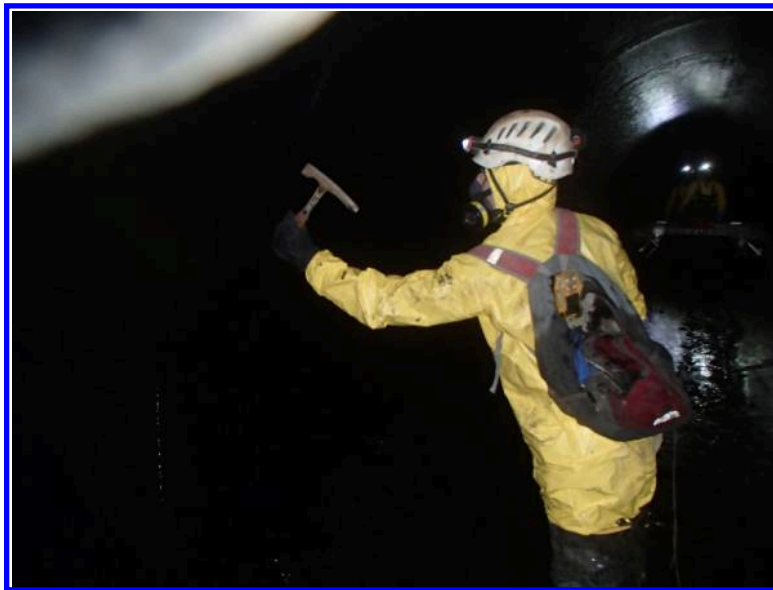
Figure 1. Inspector Sounding the 102-inch Force Main

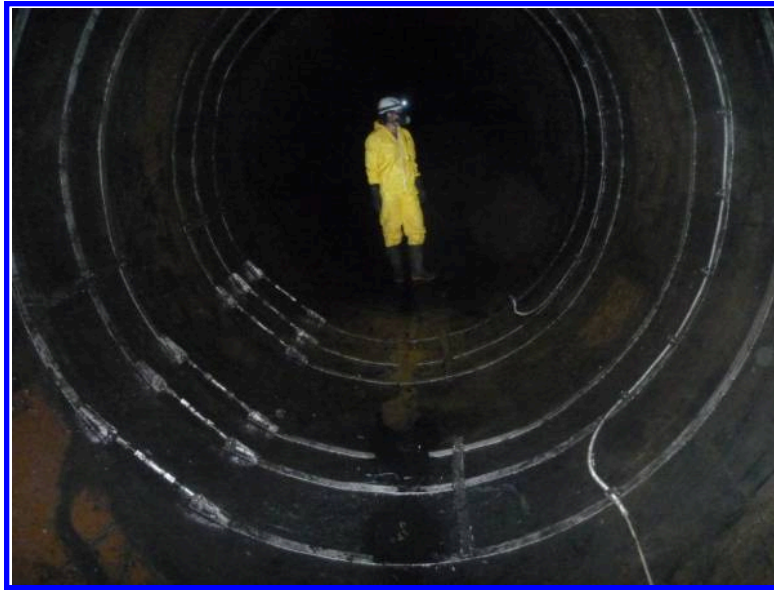
Figure 2a. Internal AFO Splice Point at MCUA

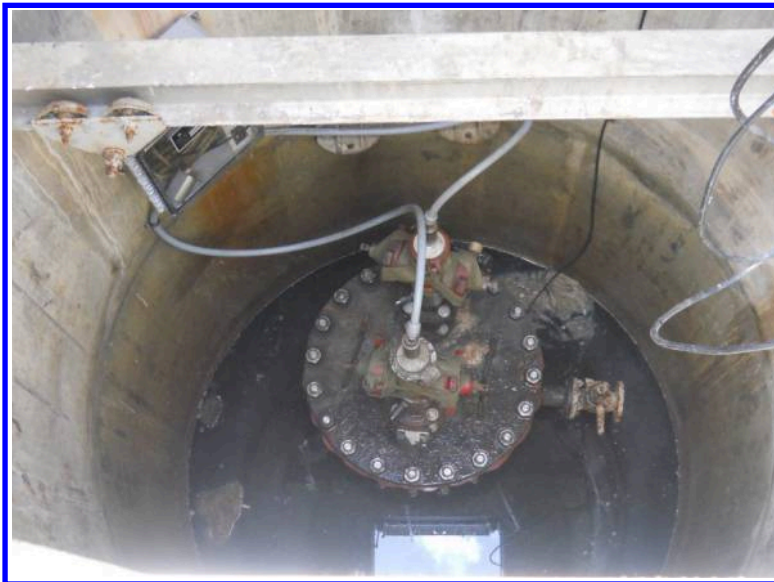
Figure 2b. External AFO Splice Point at MCUA

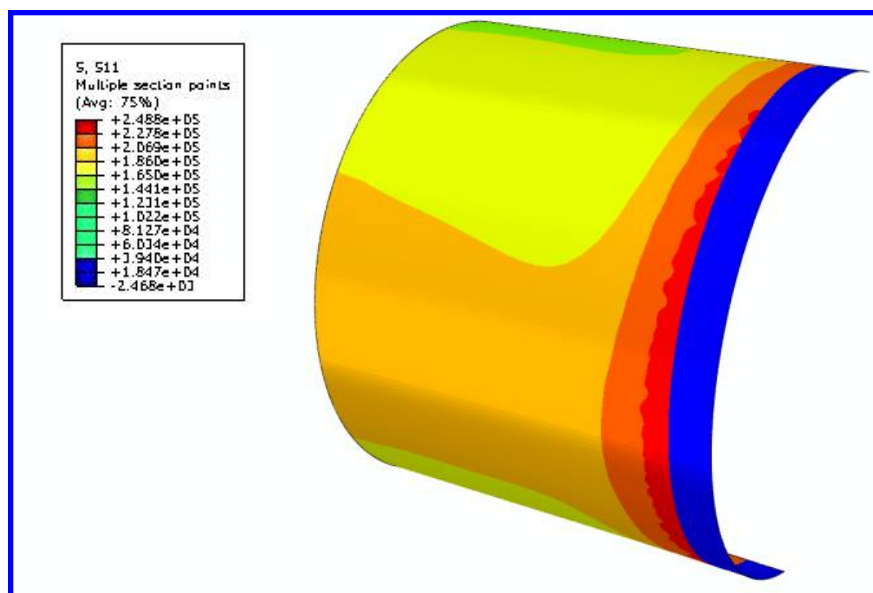
Since the initial structural evaluations, advancements in computer processing capabilities led to the use of comprehensive three-dimensional, nonlinear finite element modeling of the 102-inch ECP designs used in the Sayreville Relief Force Main. In these evaluations, the PCCP design could be modeled as a pipe, with each of the cross section components acting as a layer in a composite element. The pipe that is ultimately modeled is a collection of thousands of individual elements. Figure 3 shows the hoop stresses developed in the prestressing wire layer of a 102-inch PCCP with 35 broken wire wraps.

Figure 3. Hoop Stresses Developed in the Prestressing Wire Layer
