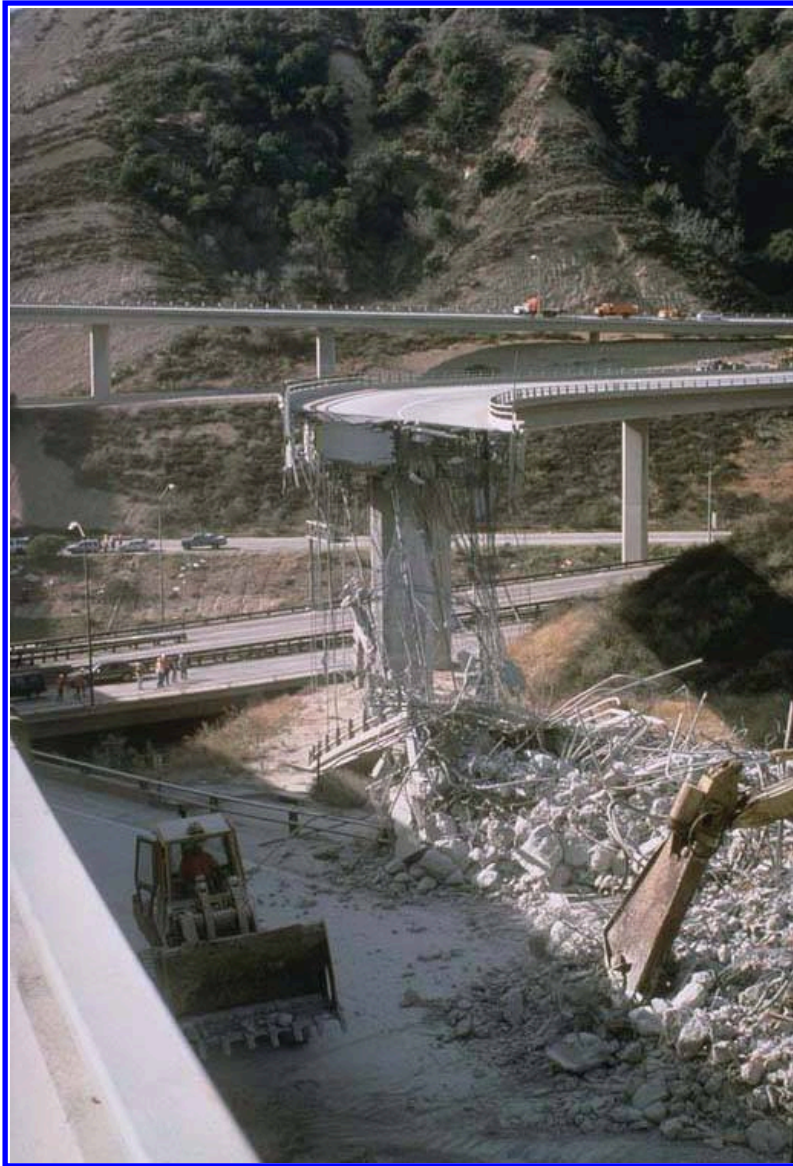
On January 17, 1994, the Richter Magnitude 6.4 Northridge earthquake again caused failure of portions of this interchange (Figure 4-1). On this second occasion,

some of the most severe damage occurred to sections that had been repaired following the 1971 earthquake and in other instances spans that had been under construction in 1971 failed this time. The fact that some spans were supported on columns of greatly dissimilar heights was thought to have contributed to the failures. The shorter columns, being much stiffer, were considered to have attracted disproportionately large shear forces resulting in their being overloaded with an inevitable subsequent domino effect. Also inadequate seat lengths at the ends of several spans contributed to collapse. Apparently the interchange had been scheduled for a seismic upgrade but the 1994 earthquake occurred before this had been started.

**Figure 4-1. Antelope Valley – Interstate 5 Freeway Interchange Failure – 1994.**  
*Source: J. Dewey, USGS.*
