Chapter 5

Assessment of Abastible San Vicente Liquefied Petroleum Gas (LPG) Terminal

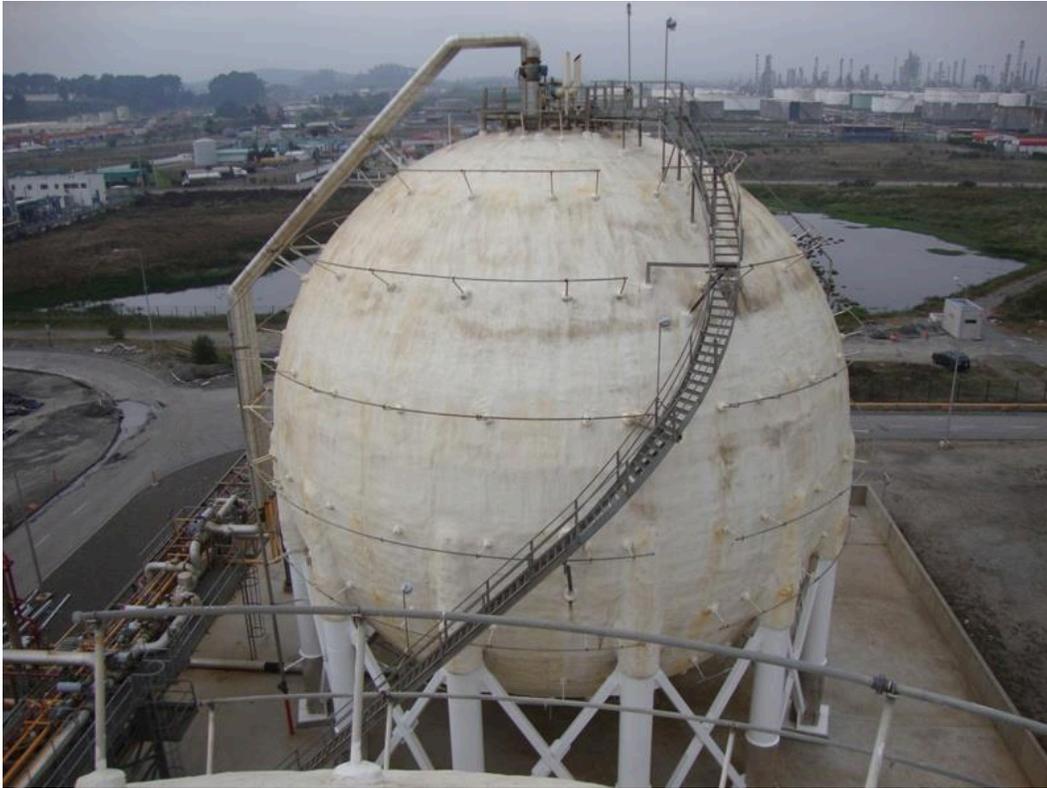
Figure 5-3: 73.5-ft diameter LPG sphere.

No damage of the LPG spheres, columns, bracing, or foundations were observed.

The seismic design forces and detailing used in the design of the LPG Spheres is very similar to what is currently specified in ASCE/SEI 7. Ordinary concentrically braced frames performed well during the seismic event. Therefore no code changes appear to be warranted based on the observed performance of the LPG Spheres.

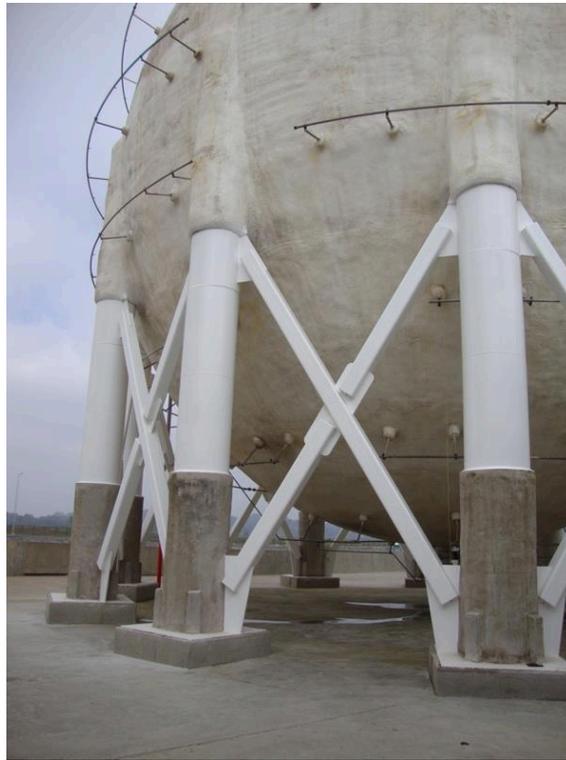
The bracing system is an ordinary concentrically braced frame. The bracing (Figure 5-5) is made up of built-up 12.8 in. x 5/8 in. thick square tubes fabricated from A572 Grade 50 steel plate. The wing plates are 1.25 in. thick and penetrate the tubular columns. The wingplates are welded to internal circular diaphragms in the columns (Figure 5-6).

Figure 5-5: Support columns and bracing.

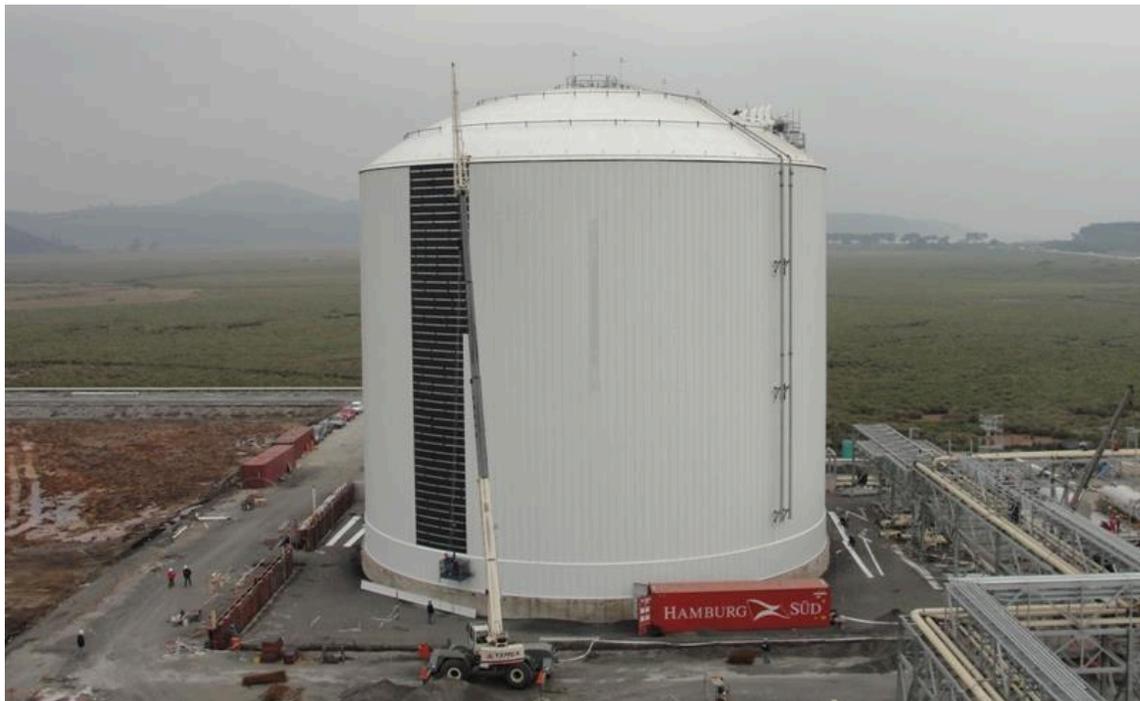
The Abastible LPG facility contains one 50,000 m³ refrigerated LPG tank (Figure 5-7) constructed in 2010. The LPG tank had just completed testing and was being insulated at the time of the seismic event. The LPG tank was empty at the time of the seismic event.

Figure 5-7: 123'4" diameter x 99'2" LPG tank (under construction).

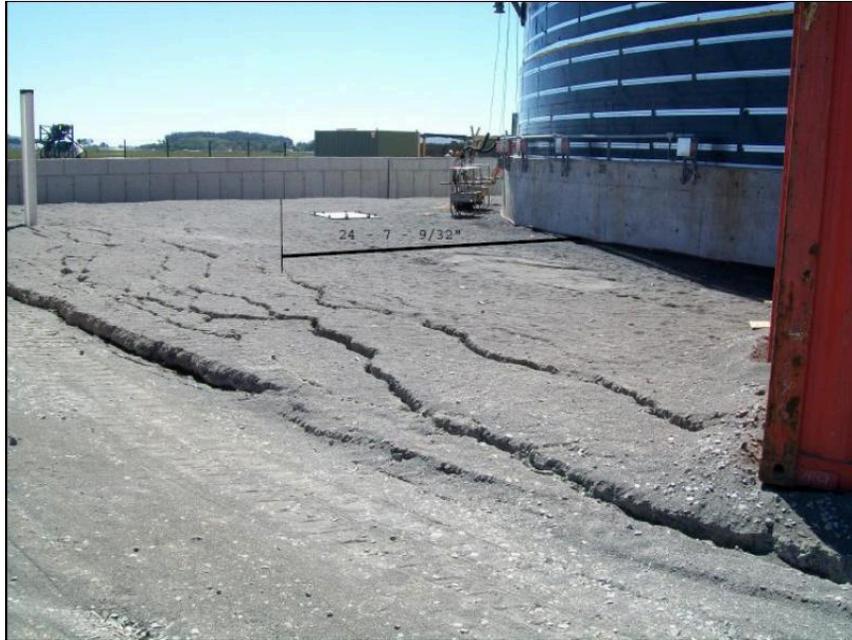
Because the LPG tank was empty at the time of the seismic event, no conclusions can be drawn on the possible seismic performance of the tank. However, the performance of the improved soil beneath the LPG tank can be evaluated. The Abastible facility sits on liquefiable soil. As can be seen in Figure 5-9, lateral spreading due to soil liquefaction did occur near the tank. The lateral spreading stopped at the point where the improved soil began. The soil improvement must be viewed as a success.

Figure 5-9: Lateral spreading near LPG tank arrested by improved soil. (Courtesy of CB&I Inc.)

The seismic design provisions in ASCE/SEI 7 and its referenced documents for nonbuilding structures, such as tanks and spheres, appear sound. Soil improvement to prevent damage from liquefaction performed well during the seismic event. Therefore, soil improvement should be one of the options considered to mitigate the effects of liquefaction.

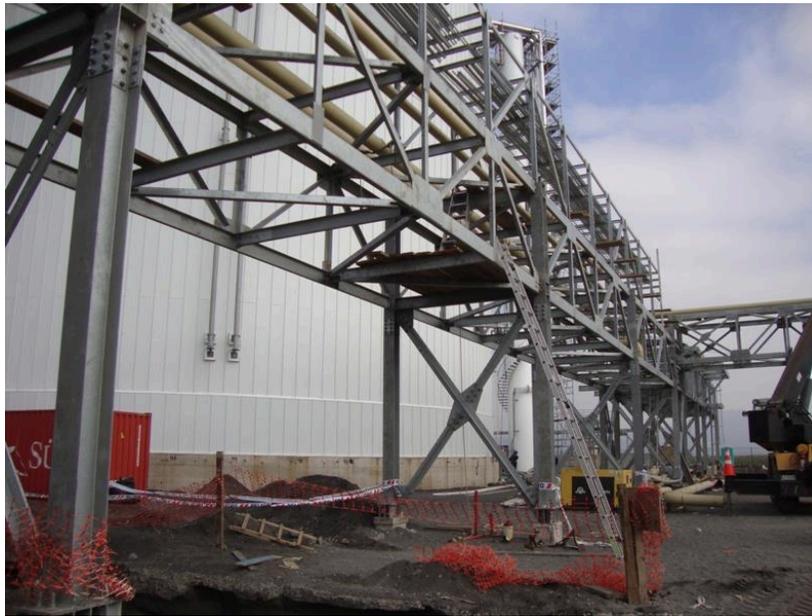
The pipe rack shown in Figure 5-10 was under construction at the time of the seismic event.

Figure 5-10: Pipe rack (under construction).

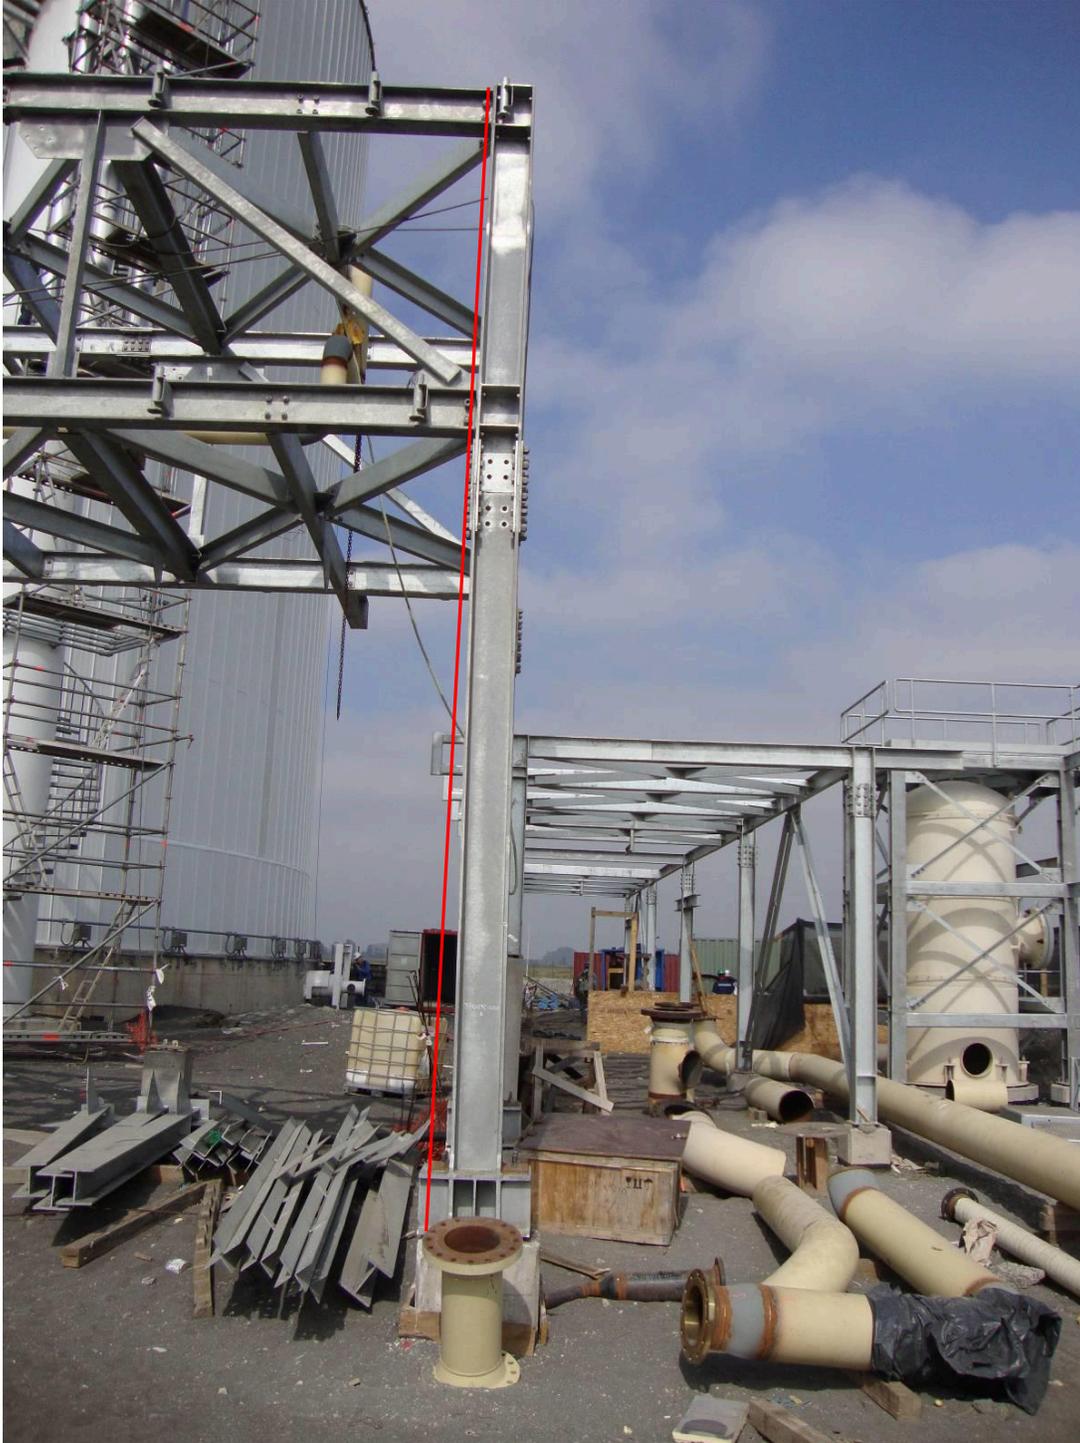
The pipe rack was constructed just beyond the outside edge of the improved soil of the tank area. The spread footing foundations of the support columns (Figure 5-11) of the pipe rack were observed to have laterally displaced several inches due to lateral spreading of the soil toward the adjacent

marsh areas. The lateral displacement was greater nearer the marsh, creating significant horizontal relative displacements between the pipe rack footings. Care must be taken to ensure that soil improvements cover the entire area of potential liquefaction that the structure is constructed upon.

Figure 5-11: Effect of lateral spreading on pipe rack column.

Evaluation of liquefaction potential is critical before a structure is sited or built. Also it appears the evaluation requirements of structures associated with the effects of liquefaction/lateral spreading need to be developed.

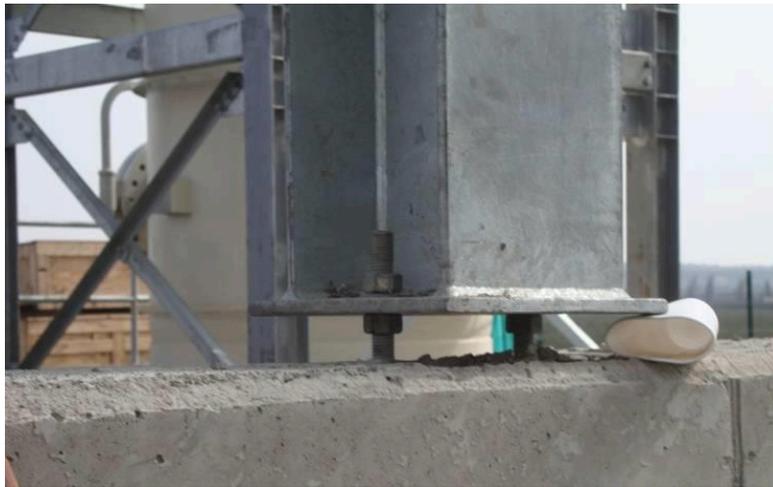
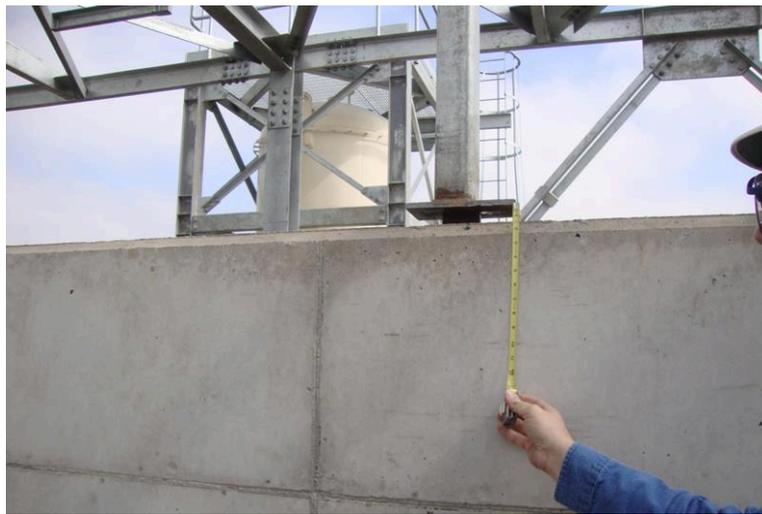
The wall was constructed near the outside edge of the improved soil of the tank area. Although not obvious in Figures 5-12 and 5-13, the wall was observed to have settled a few inches due to liquefaction of the soil. The pipe support structure settled with the wall.

Figure 5-12: Settlement of wall (under construction).

Figure 5-13: Settlement of wall (additional view).
