### **Stability of the Galveston Seawall**

### Sand-Filled Geotextile Tubes

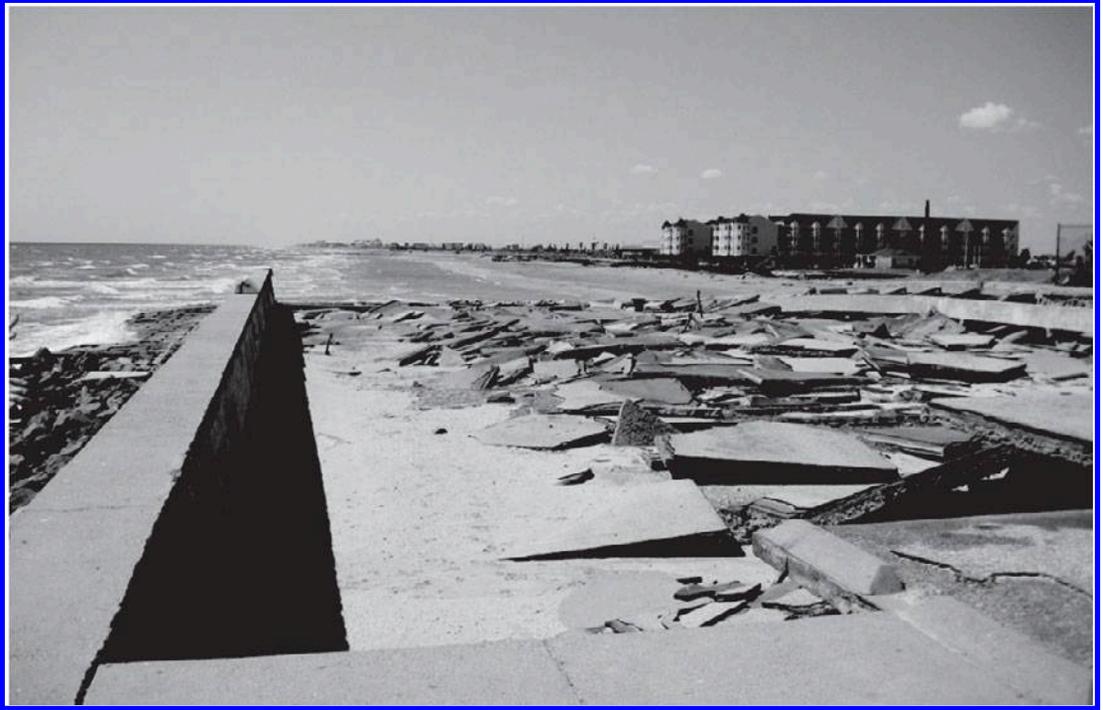
damage, this report concentrates on small buildings. Figure 5-9 documents damage to the west end on the Galveston Seawall.

*Figure 5-9. Damage at southwest end of seawall*

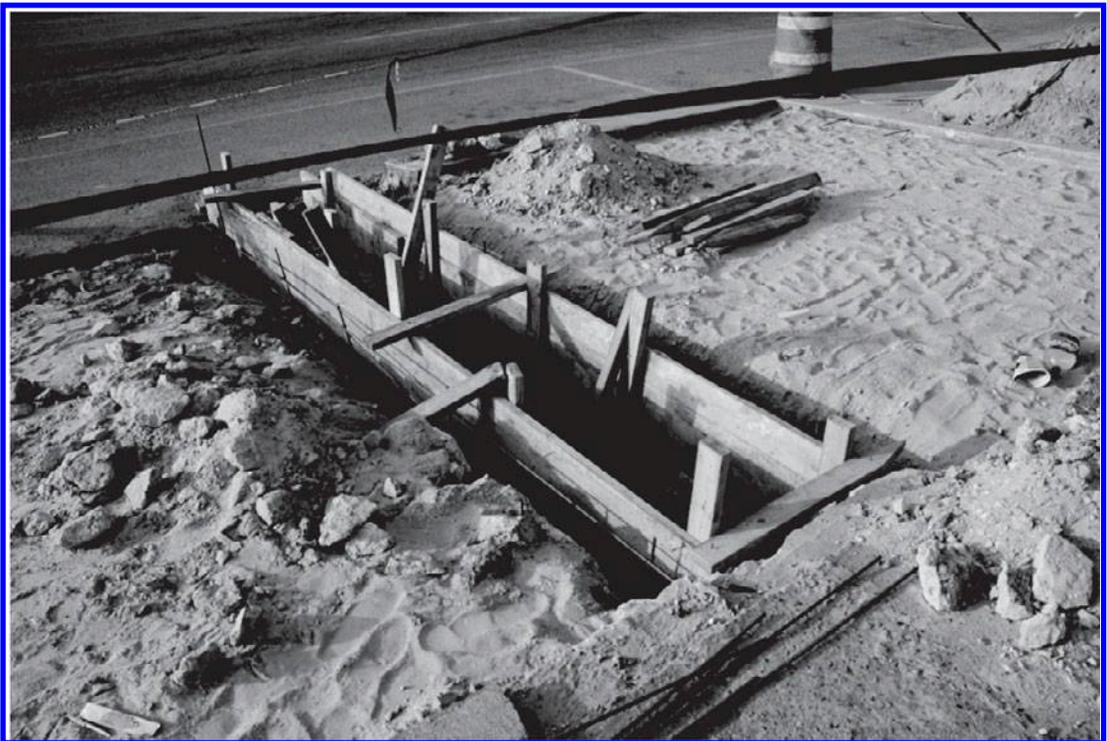
Other damage at the seawall occurred from the loss of backfill in some locations causing a failure of the sidewalk (Figure 5-5). The repair of these sections proceeded without appropriate filter materials at cold joints (Figure 5-10). Workers first formed and poured a concrete trough between the highway paving and the cast drainage holes in the top of the seawall. They filled the trough with sand and poured the sidewalk as the top of the drain. Presumably the sand in the trough is washed out after the sidewalk has cured. Many of the problems in the sidewalk were caused by sediment washed out through the various joints between components.

*Figure 5-10. Repair of street drains that connect through the seawall*

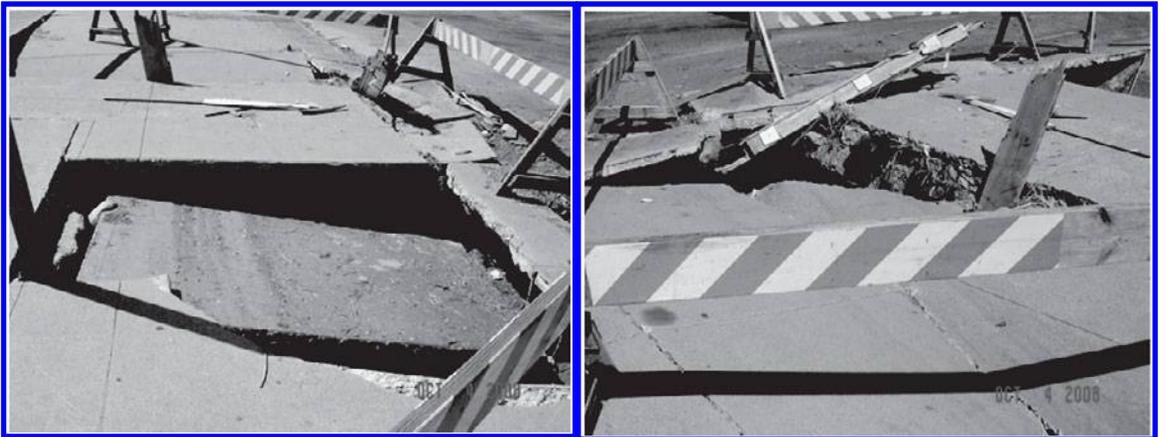
*Figure 5-12. Settlement of slabs behind the seawall, potentially caused by piping failures*

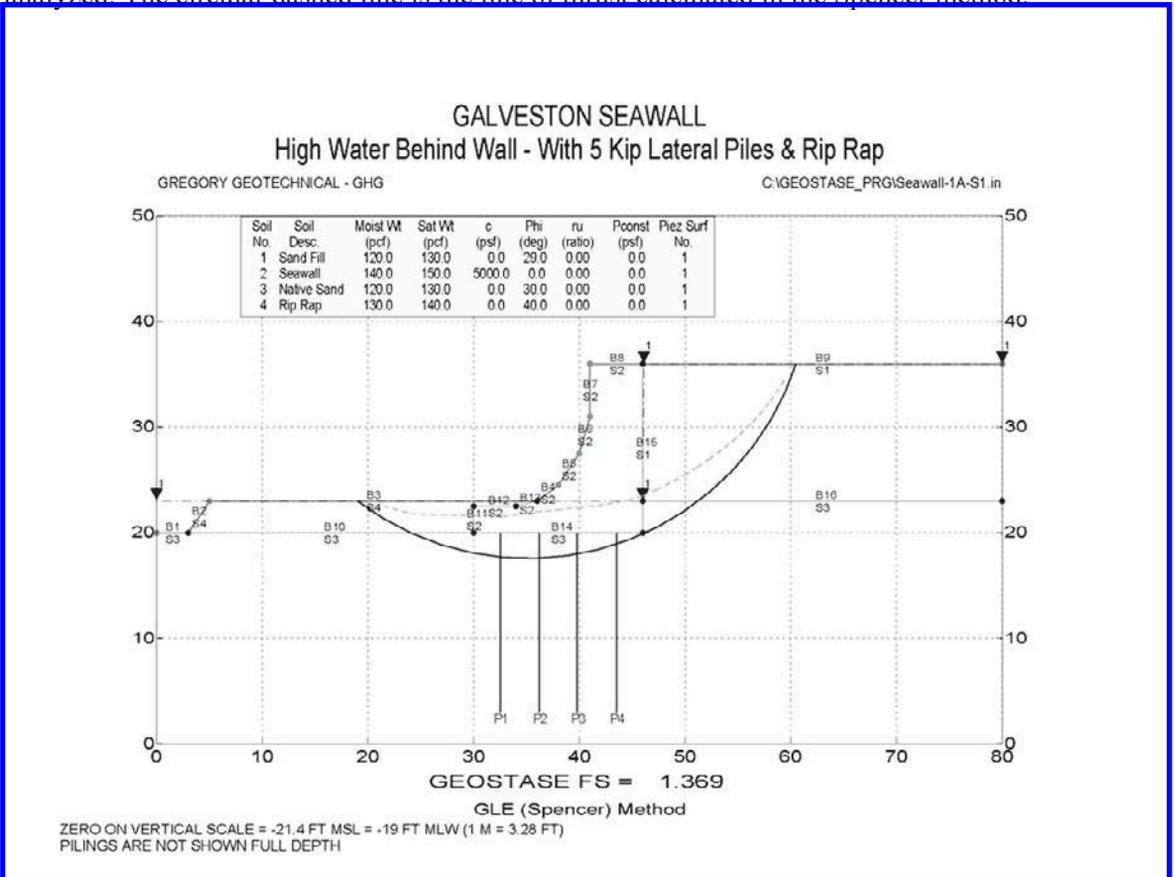
Preliminary global stability analyses were performed with the two-dimensional limit equilibrium computer program *GEOSTASE* (Gregory 2005) using the Spencer option. Three conditions were analyzed. A total of 500 potential failure surfaces were analyzed for each condition using a random search technique for generating circular surfaces. The water level in the backfill behind the wall was modeled at the ground surface with a lower water level in front of the wall in all three analyses. The first analysis assumes that the pilings have not deteriorated and each pile is capable of providing an allowable lateral capacity of 5 kips and that the rip rap is in place at the toe of the wall. The calculated factor of safety (FS) for this condition is 1.369, or approximately 1.4 (FS values are expressed to three decimal places for relative comparison only. Realistically achievable accuracy should be considered to one decimal place only). This FS value may be marginally acceptable but would be considered low for current standards. The second analysis assumes that the piles are available to provide lateral capacity as described for the first analysis, but the rip rap has been displaced by the storm. The calculated FS value for this condition is 1.116, or approximately 1.1. This FS value would not be considered acceptable and within the margin of error, and it indicates potential failure. The third analysis assumes that the piles have deteriorated at the connection to the base of the seawall or that the sand in front of the piles has been eroded away or severely loosened by the storm, and the piles no longer provide any significant lateral capacity. The third analysis also assumes that the rip rap has been displaced. The calculated FS value for this condition is 0.987, or approximately 1.0, indicating global sliding failure of the wall. The profile plots from the three analyses are presented in Figures 5-14 to 5-16. The circular, solid line in the figures is the most critical surface (lowest FS value) of the 500 analyzed. The circular dashed line is the line of thrust calculated in the Spencer method.

Figure 5-14. Stability analysis for Galveston Seawall with high water behind wall, 5 kip lateral piles, and rip rap toe protection

The stability analyses are very preliminary in nature and are based on estimated values and assumed conditions. Accordingly, the calculated FS values can only be considered as general indicators of the potential stability concerns for the seawall. More detailed information could produce significantly different results. However, the preliminary analyses indicate that the seawall may not have adequate FS values for global stability if the assumed values are reasonably accurate and the assumed conditions are produced in a future storm event. Consequently, the integrity of the rip rap and pilings is of major importance. Steps should be taken to prevent displacement of the rip rap in a major hurricane, and the integrity and lateral capacity of the piles should be verified.

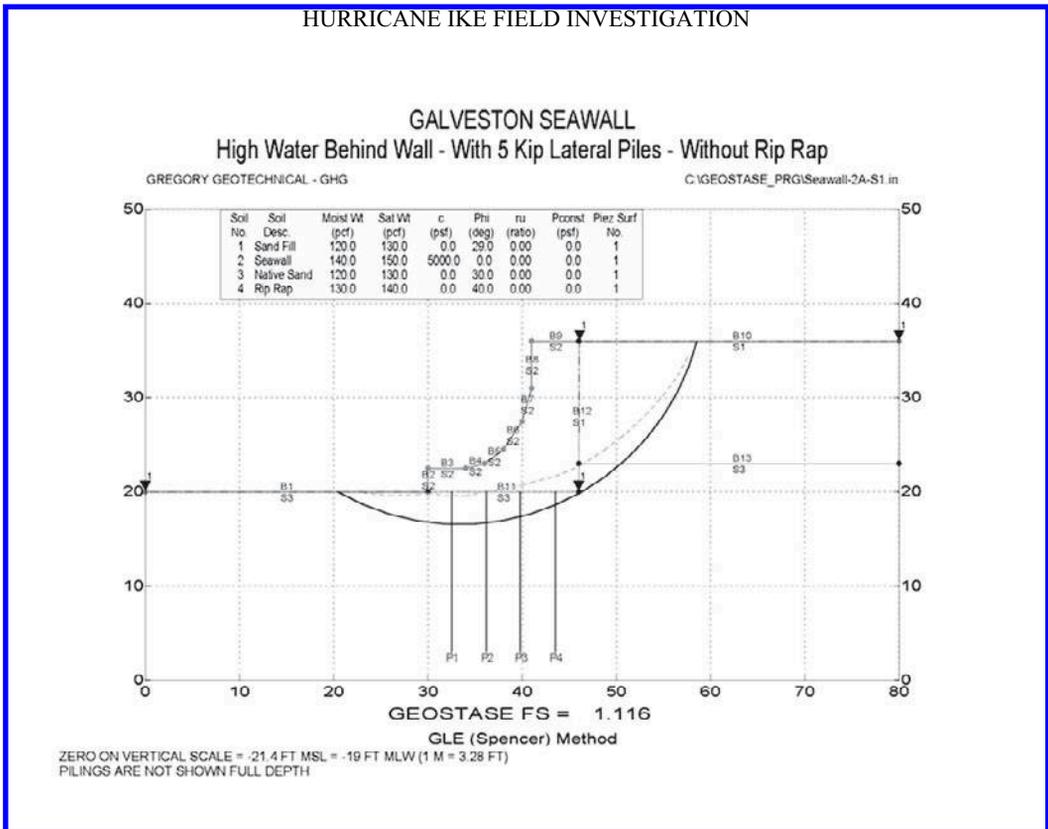
Figure 5-15. Stability analysis for Galveston Seawall with high water behind wall, 5 kip lateral piles, and without rip rap toe protection

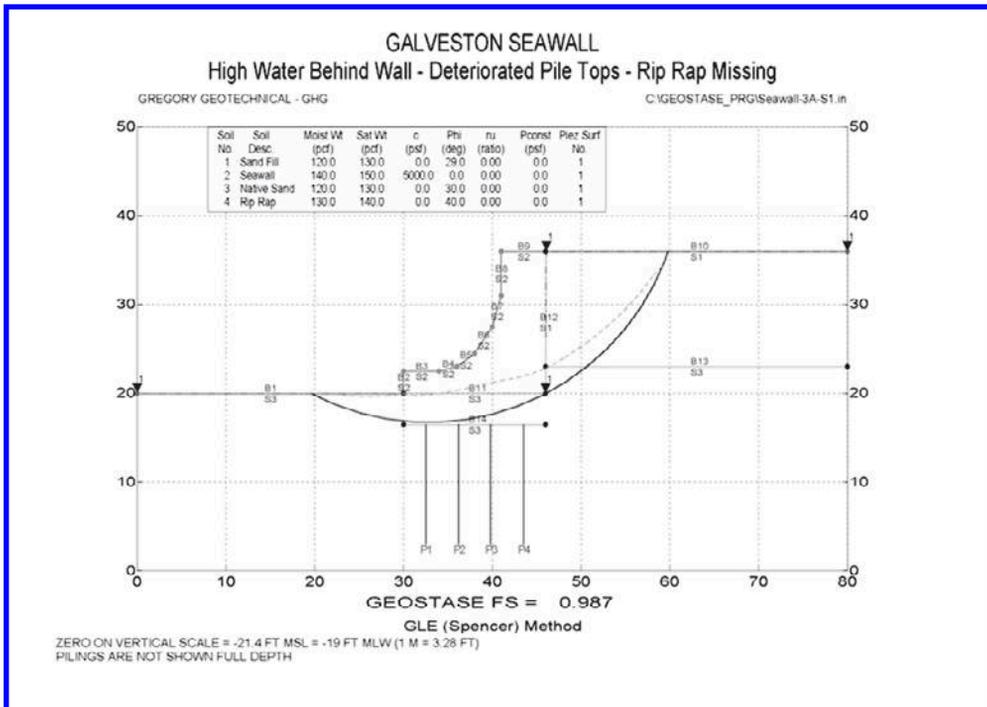
Figure 5-16. Stability analysis for Galveston Seawall with high water behind wall, deteriorated pile tops, and without rip rap toe protection

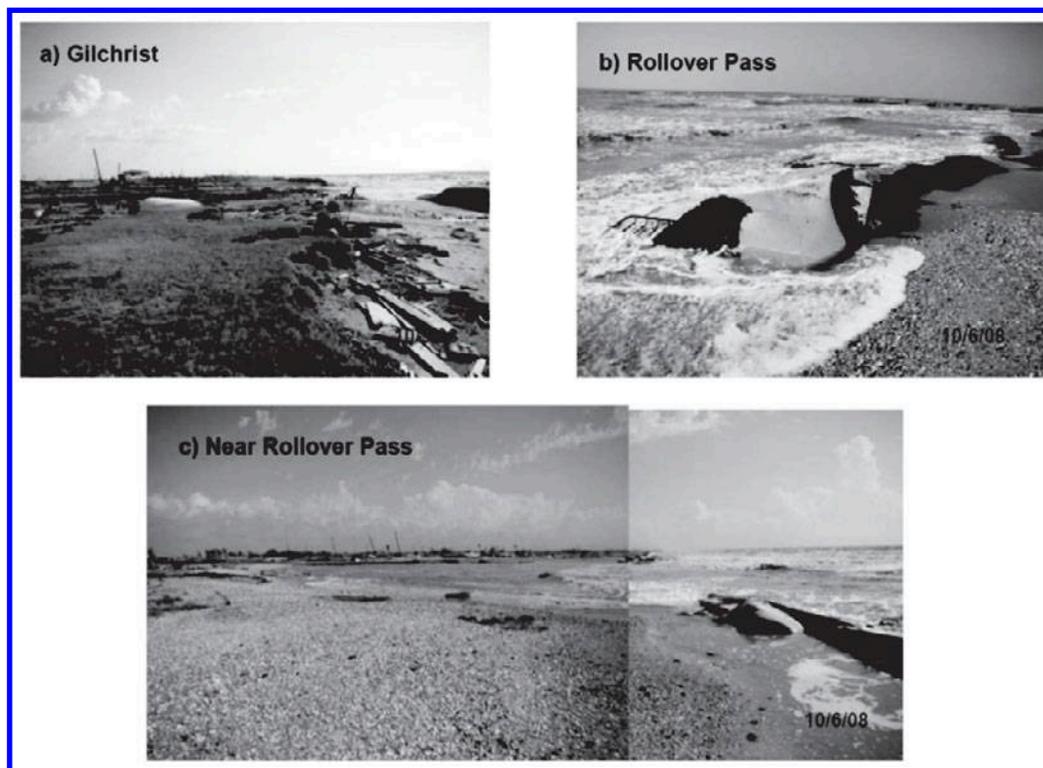
Figure 5-17 shows a ground view of the gap and scour channel on the east end of this installation. Most of the tubes were completely exposed as the sand was eroded away by the storm surge. In some cases only the apron was left after the top tube broke open and was washed away. In other cases scour on the gulf side caused the top tube to roll toward the gulf and be partially submerged on the gulf side of the base layer. Similar response occurred on the west side of Rollover Pass in Caplen where that installation was some 4,300 m long.

Figure 5-17. Geotextile tube performance on Bolivar Peninsula, (a) at Gilchrist, and (b) and (c) near Rollover Pass, showing shoreline erosion between gaps in structure

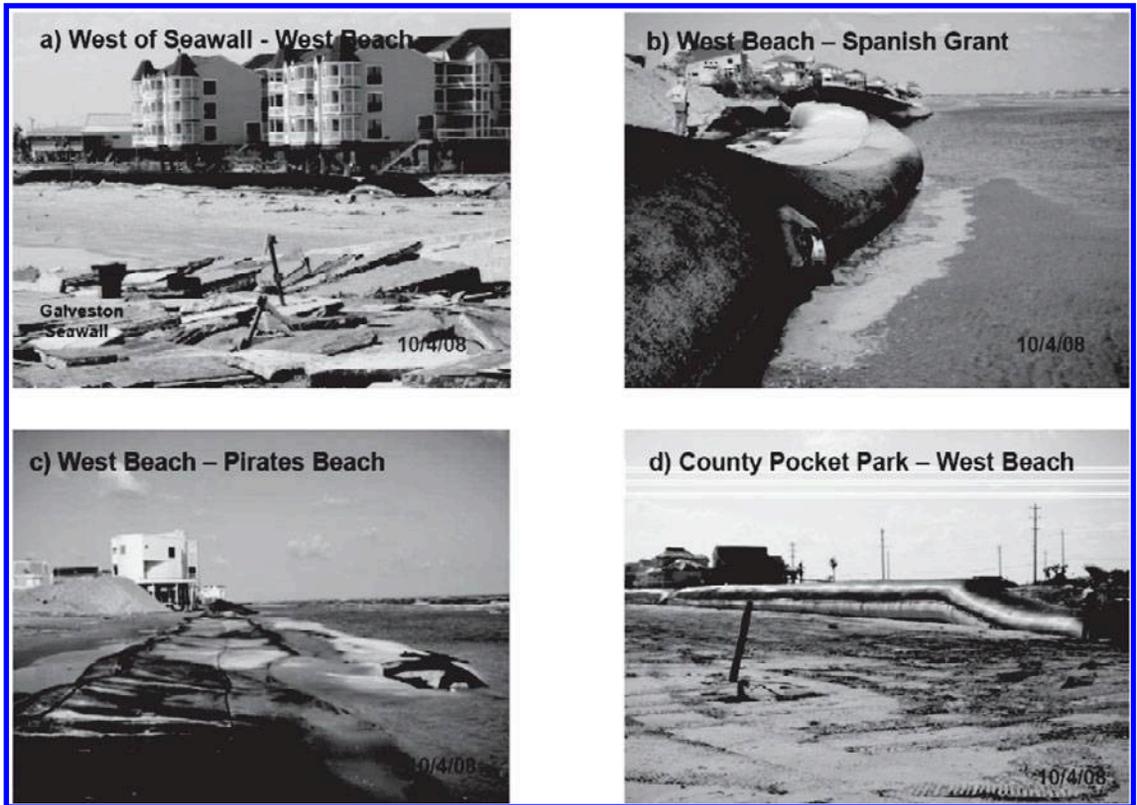
All of the geotextile tube installations in Galveston County were on West Beach. The first placement was in front of condos at Boddecker Channel, just to the west of the seawall. The tubes were intact after the storm but were completely exposed with the dune sand eroded away. A few short gaps were formed and some of the tubes rolled off their apron (Figure 5-18a). A 1,673-m-long linear installation at Spanish Beach was completely exposed and experienced several tubes rolling off their base apron due to gulf-side scour (Figure 5-18b). Several gaps were formed where tubes failed and were deflated. At Pirates Beach, the 2,480-m-long geotextile tube structure suffered much the same fate with cutting and deflation of the top tube, which resulted in a gap and loss of protection (Figure 5-18c). The short installation at a county pocket park near Kahala Beach fared well with little damage to the geotextile tube structure, but all the dune sand placed over the structure was eroded, completely exposing the geotextile structure (Figure 5-18d).

Figure 5-18. Performance of geotextile installations along Galveston Island, (a) just west of Galveston Seawall with gaps and exposed from erosion of dune, (b) at Spanish Grant showing collapse of top tube Gulfward, (c) cut and deflation of top tube leaving only base layer, and (d) intact but uncovered tube at Galveston County pocket park near Kahala Beach

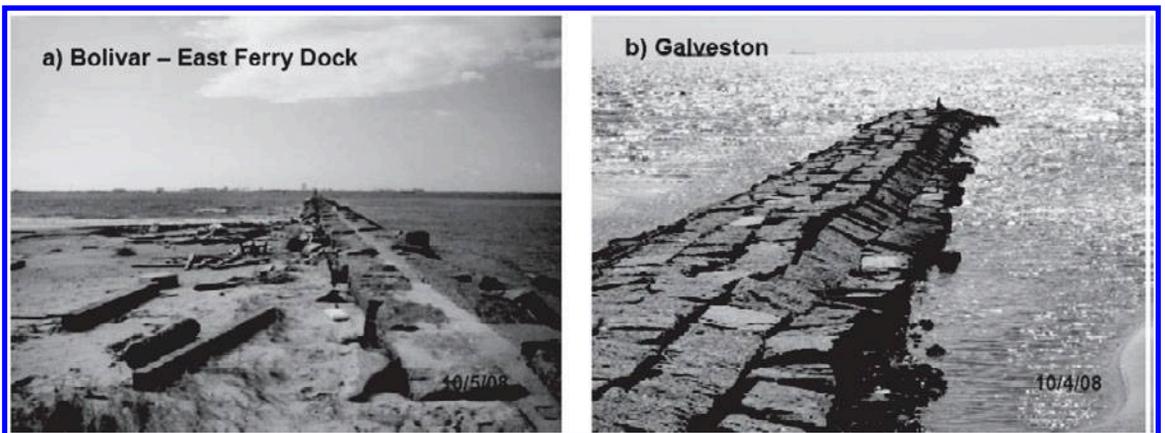
Two stone groins are located at the Bolivar Peninsula Ferry Dock. These groins define the edges of the ferry terminal. The southern groin is constructed of cut red granite, and the northern groin is sheet pile. Both experienced only minimal damage (Figure 5-19a).

Figure 5-19. Groins at (a) Bolivar Peninsula and (b) along the Galveston Seawall showing little damage

The only other use of groins was on East Beach in Galveston where 15 groins were constructed perpendicular to the Galveston Seawall. All of these groins were cut stone (Figure 5-19b). Four of them had a concrete cap to allow walking access on the groin. Table 5-4 summarizes the damage visible in the aerial photographs. Most of the groins had minimal damage. The concrete caps on groins, consisting of smaller stone, did not fare as well. All of the groins caps were damaged, and some of the rocks were displaced at the gulfward end or along the water line.

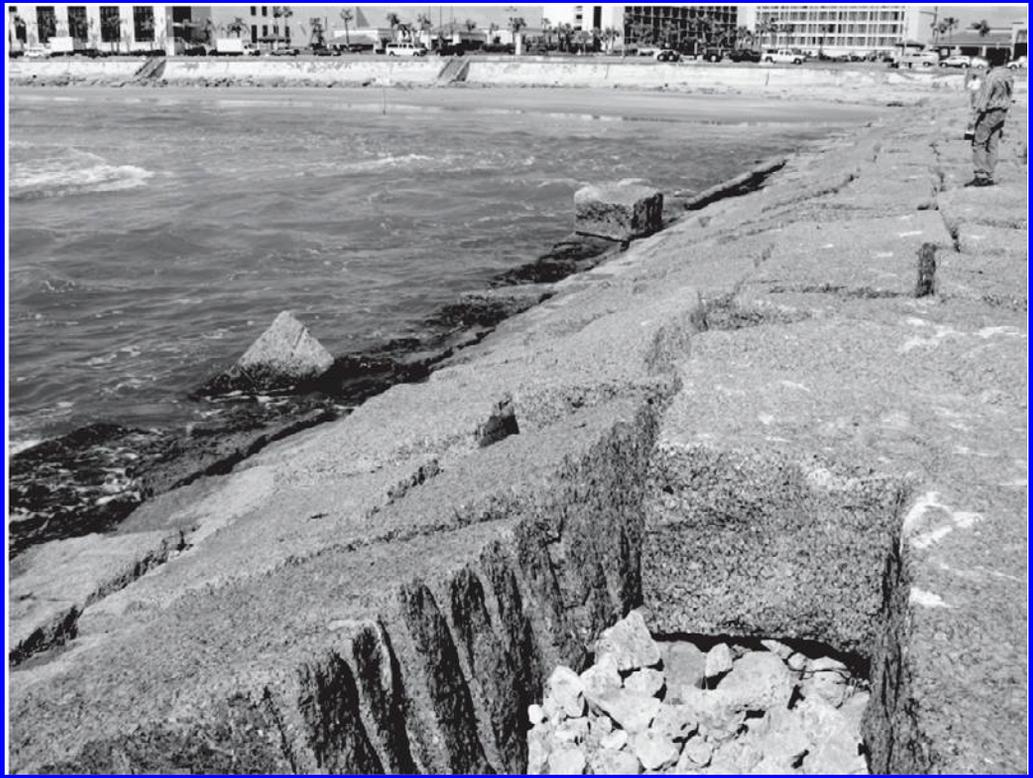
Some of the stones were also dislodged as shown in Figure 5-20. These stones were picked up by the waves and were displaced to lower levels, leaving a void in the crest of the groin. The stone appeared to be 3 to 5 ton granite.

Figure 5-20. Loss of armor stone from 53rd Street groin fronting the Galveston Seawall
