## REHABILITATION TECHNOLOGY SELECTION

## Narragansett Bay Commission Rehabilitation of Large Diameter Brick Sewer with Geopolymer Mortar

### 1. ABSTRACT

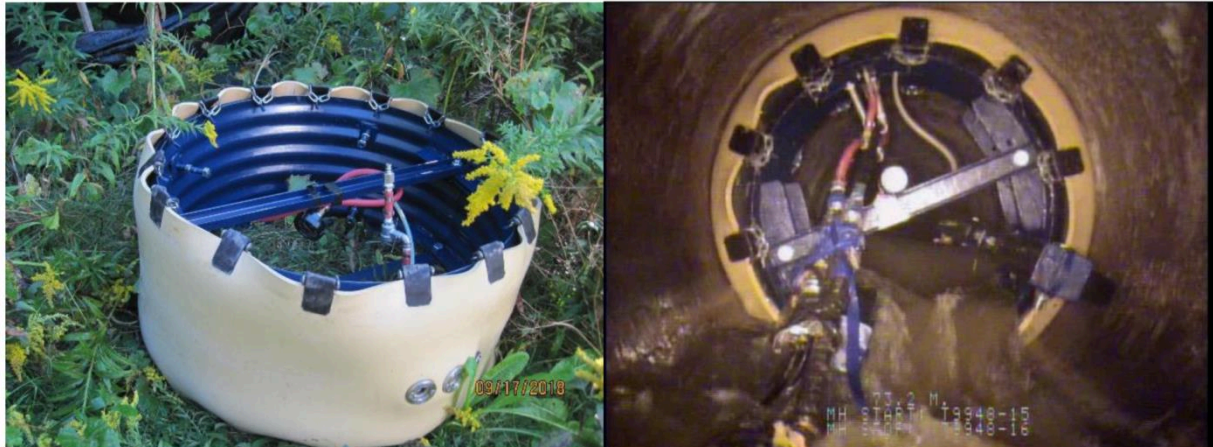
**Figure 2: Inflatable grout packer before (left) and in service (right)**

Several sewer rehabilitation options were considered for the YDSS project that included chemical grouting, full length Cured-In-Place Pipe (CIPP) and CIPP spot repair. Chemical grouting was selected as most cost effective for York Region. Chemical grouting is a non-structural solution involving the injection of grout into pipe defects such as leaking joints and minor cracks. The grout is typically a two-part grout that when mixed forms a gel-like structure. Some grouts have similar viscosity to water which allows them to penetrate the defect and any voids behind the pipe wall. This rehabilitation method can be used to significantly reduce, or even eliminate infiltration and exfiltration in sewers. When properly used, chemical grouting can stabilize and seal the defect in the pipe, as well as stabilize the adjacent soil or fill voids outside the pipe. Grout volume and back pressure is monitored to determine when a sufficient amount of grout has been injected. For this project chemical grouting utilized inflatable packers (Figure 2) for all sewer diameters 20 to 54 inches (525 to 1,350 mm), to isolate the section of pipe to be grouted and prevent grout from entering the rest of the sewer, while the sewer is in service. Generally, the grout will cure within minutes while the packer remains in place over the defect. Required pressures used to install chemical grout are typically 0.5 psi per vertical foot of pipe depth below grade plus 2 psi; however, installation pressure shall not exceed 10 psi. In small diameter applications the packer can be easily lowered through the manhole or assembled at its base for deployment. The entire sewer section is recommended to be cleaned prior to grout installation for the packer to form a seal with the sewer wall. The flow becomes the largest factor when installing chemical grout and is generally accomplished during low flow periods, typically at night.

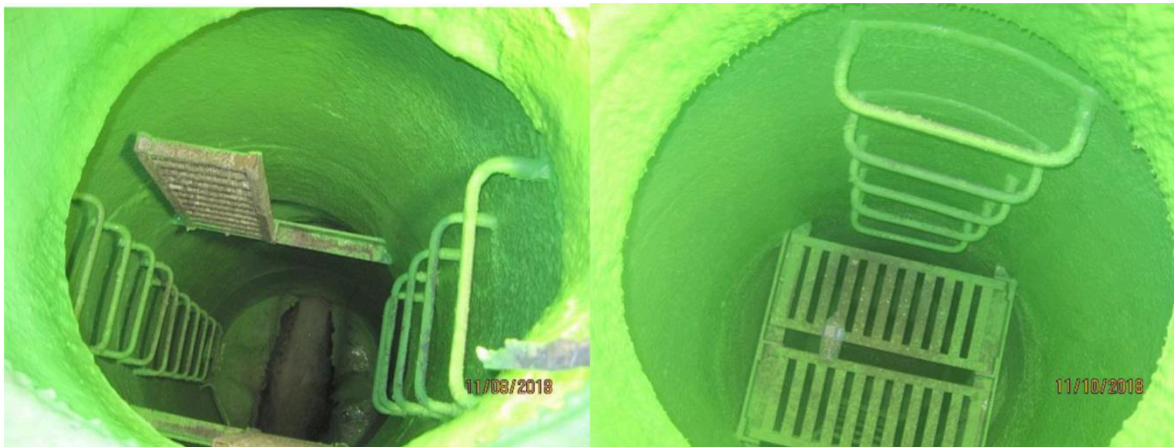
**Figure 6: Maintenance holes after rehabilitation: 22A (left) and 31A(right)**

rehabilitation and adhesion testing during the maintenance hole rehabilitation (Figure 6).

- Reduction of the cycles from 60 hz to 40 hz to lower the pumping rate. This was able to be accomplished without vibration issues at the lower speed. This would entail the manual operation of variable speed pumps for the entire duration of the maintenance hole rehabilitation.
- Installation of a temporary weir wall in MH 22A to further increase the time for the workers within the maintenance hole.

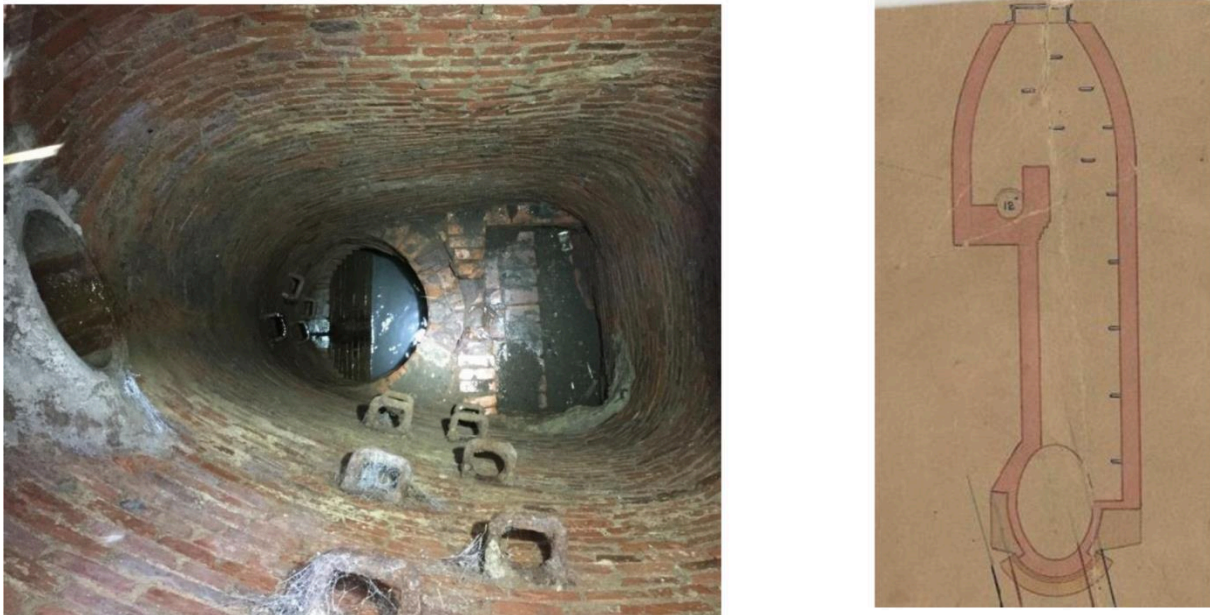
2. The 10 to 20' deep access manholes were irregular in shape (See **Figure 2**) and shared a second 12" pipe at a higher elevation. Use of CIPP would have required excavation down to the pipe and replacing the manhole structure.

**Figure 2 Irregular brick manhole with parallel 12" collector at a higher elevation**
