## Anatomy of Glass Damage in Urban Areas during Hurricanes

K. Butler<sup>1</sup>, A. Kareem<sup>2</sup>

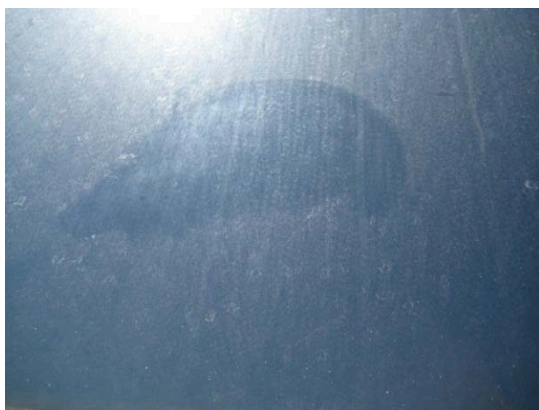
*Figure 8. Tenacious deposits on glass surface due to rainwater run-off from concrete panels. (RCI 2010, with permission from RCI, Inc.).*

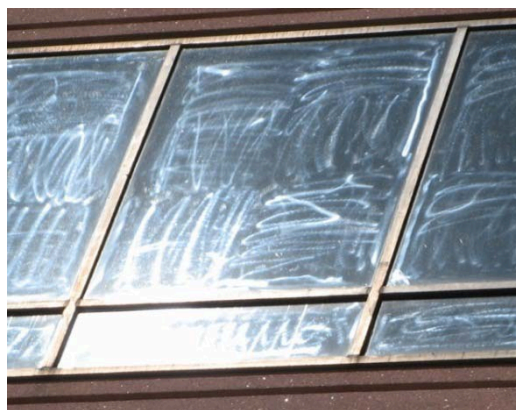
*Figure 9. Unacceptable cleaning pattern remains after improper polishing operation. (RCI 2010, with permission from RCI, Inc.).*

Given the cause of the swirling pattern, attempts were made to mitigate the pattern using an optical-grade polish. While recommended surface restoration techniques vary among the major glass manufacturers and fabricators, many of them include polishing with cerium oxide. As a laboratory trial, a proprietary blend of cerium oxide polish was applied with a hard felt pad mounted on a variable speed drill. Localized results on the spandrel panel sample indicated that the fine scratches of the swirling pattern were essentially removed.

Based on these promising laboratory trials, field mock-ups were performed utilizing commercial-grade, closed-wheel automated equipment that recirculates a thin slurry of a blended cerium oxide polishing compound in potable water. Ten polishing trials were performed to evaluate the number and pattern of polishing passes necessary to achieve conditions acceptable to building management. After the first several trials with multiple polishing passes in each direction, the exterior glass surfaces were significantly improved compared to their original conditions when viewed in sunlight. However, when viewed in critical light (i.e., viewed at very small angles relative to reflected sunlight), the remaining faint crisscross pattern and residual scratches were judged to be unacceptable by building management. Only a combination of multiple linear and circular polishing passes resulted in a nearly blemish-free surface under critical sunlight conditions (Figure 10). A separate edge polishing unit was used to address the outer one inch of affected surface area that could not be reached with the shrouded closed-wheel unit.

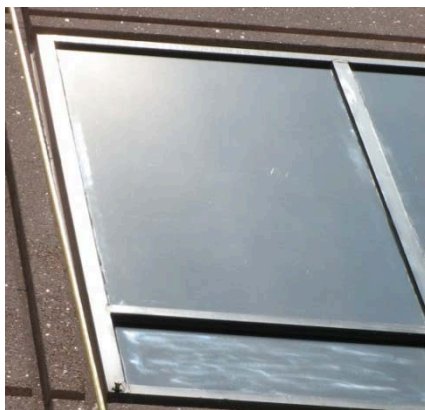
*Figure 10. Upper window unit after remedial polishing, resulting in a nearly blemish-free surface. (RCI 2010, with permission from RCI, Inc.).*

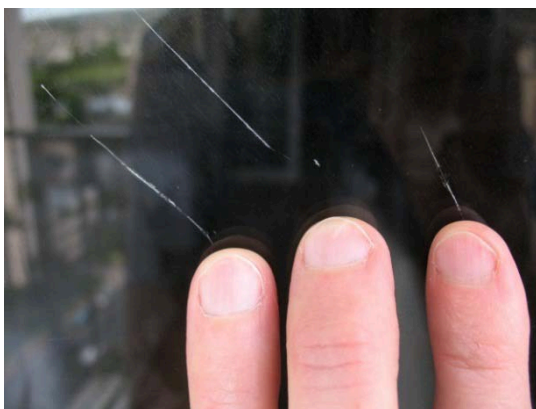
The glass frequently exhibited many closely spaced parallel linear scratches as shown in Figure 11. Some scratches were longer than 3 inches. While the scratch pattern was typically random, near obstructions (e.g., balcony railings) the scratches were generally oriented in the same direction. By experimenting with the type of scraper (Figure 12) reportedly used to remove concrete patching debris from the glass, the authors were able to replicate the documented scratches.

All noted scratches were similar in appearance; therefore, it could be concluded that they were generally the result of inappropriate cleaning operations rather than previous storm damage. Some particles were noted to be adhered to the exterior heat-treated glass surfaces (as noted in the “Industry Debate” section above). By experimenting with trial cleaning of these surfaces, it was determined that adhered particles did not play a significant role in the development of the subject scratches.

*Figure 11. Multiple linear scratches documented on sliding glass doors. (RCI 2010, with permission from RCI, Inc.).*

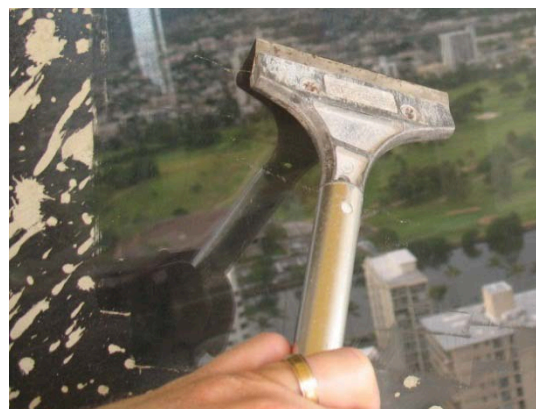
*Figure 12. Tile scraper reportedly used to remove concrete patching debris from glass. (RCI 2010, with permission from RCI, Inc.).*

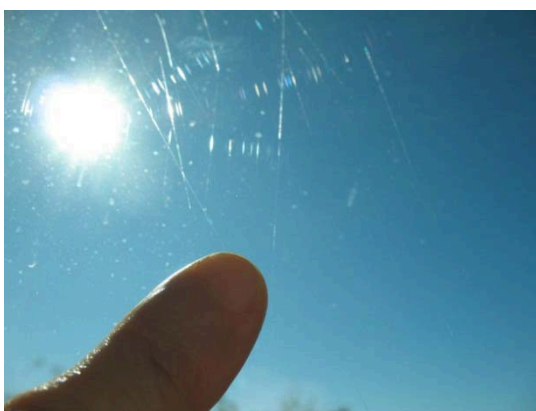
Two recently completed residential towers containing sliding glass doors and punched window assemblies had documented glass surface damage in the form of scratches and point blemishes. As shown in Figure 13, both deeper scratches as well as fine angel hair scratches were noted on the interior (No. 4) and exterior (No. 1) IGU surfaces. Point blemishes (Figure 14) were also present on both surfaces. As noted above, the occurrence of relatively uniform angel hair scratches from storm debris are less likely than other blemishes with a relatively prominent point of impact. Based on laboratory analysis, the dark-colored point blemishes had a morphology consistent with molten iron. As a result, this damage was not likely caused by a storm event.

*Figure 13. Combination of linear scratches and angel hair scratches observed in direct sunlight. (RCI 2010, with permission from RCI, Inc.).*

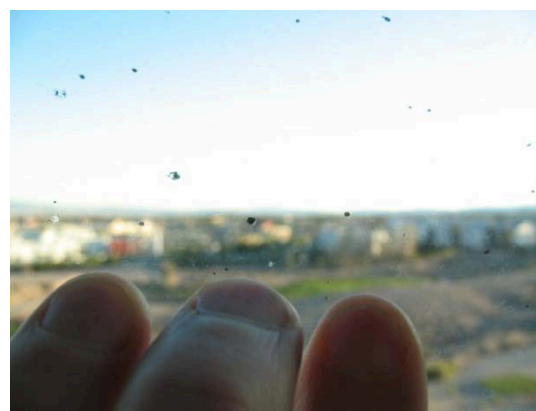
*Figure 14. Dark-colored point blemishes. (RCI 2010, with permission from RCI, Inc.).*

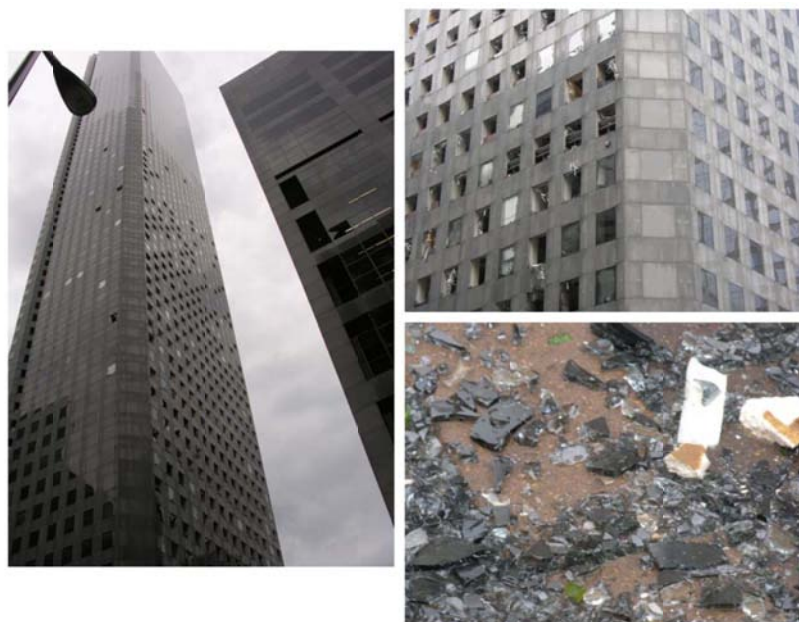
Chase Center. As Figure 3 shows, the damage to the JPMCT was greatest amongst the floors up to approximately the same elevation as the Chase Center, with most of this area losing all of its windows and coverings. Most, if not all, of the glass and glazing on the Travis Street face of the Chase Center was similarly damaged in the storm.

Figure 3. Damage to the JPMCT from Hurricane Ike (2008).
