Reconciling Conflicting Utility Location Data: A Case Study of Submarine Gas Lines in the Providence River

John A. DeRuggeris, P.E., Susan E. Nilson, P.E.

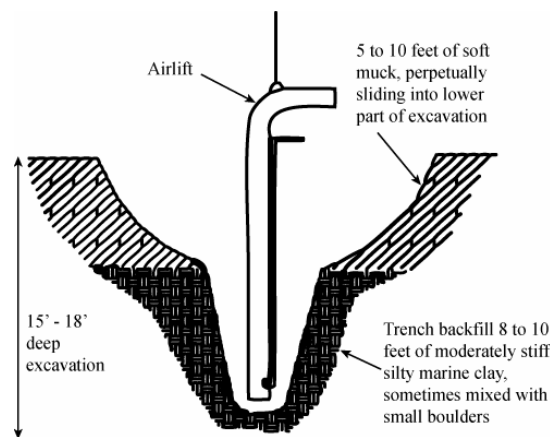
Fig. 4 Typical Air lifted exploration hole

In General most of the exploratory holes developed the funnel shape shown in the above figure. Soils on the Western limit of the channel were found to be considerably softer, and were unstable to deeper depths than the Eastern two thirds of the channel. The only way to overcome the instability was time-consuming, and involved the process of greatly enlarging the upper portion of the excavation. In other locations the stratification of the marine soils overlying the pipes caused a number of problems, including a persistent sloughing of the soft muck in the upper surface layers into the smaller lower excavation. At times a second soft layer was found near the pipeline depth, which tended to create a “bell hole” at the bottom of the excavation. This condition could only be stabilized by “punching” numerous holes through the intermediate stiff layer until it collapsed on itself, thereby opening the excavation to a width where it was safe for a diver to enter the excavation.

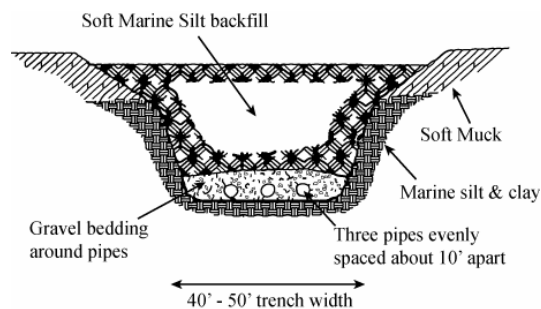
➤ While traces of gravel were found from time to time in the pipeline excavation, in no instance was the presence of measurable quantities of gravel backfill in the pipeline trench. (Gravel bedding and cover had been indicated on various plans and documents of record that were reviewed prior to the pipeline excavation.)

➤ There was no evidence of typical marine coating on any of the pipes, such as heavy taping or concrete jacketing, nor was there any evidence of the cast iron jackets referred to in permit documents. Oak staves or strapping of unknown length, measuring roughly 2" by 2" were found along the long axis of a few of the pipelines in a few of the Eastern locations. The original intended purpose of this wood is not known.

Fig. 5 Expected pipe placement and burial conditions based on documentation.

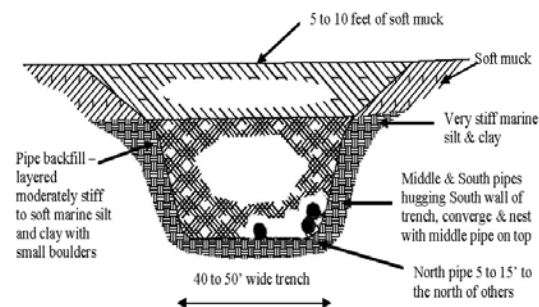
➤ The backfill material over the pipelines in the east side of the Federal Channel was found to be a moderately stiff marine silt and clay that held almost vertical side slopes. Conversely, the backfill material over the pipelines on the extreme West side of the Federal Channel was much softer (almost soupy), as such it would not hold reliable side slopes; this required that excavations be much larger. Concentrations of 12" boulders were found in a number of locations on the Western exploration area, which also made excavation more difficult. Not only did the boulders tend to lodge in and clog the air lift, but their presence made hand probing by the divers much more difficult.

➤ The pipes were found to be out of compliance with respect to the 10-foot separation shown on permit drawings. The middle pipe was found to encroach on the

southern pipe, and in fact was laying directly on top of the southern pipe for a significant percentage of the route. It is possible that the middle pipe actually crosses over the South pipe somewhere on the eastern third of the channel, then re-crosses back over the South pipe about 500 feet east of the Federal channel limit.

Fig. 6 Typical pipe trench conditions found during investigation.
