Effects of Hurricanes Katrina and Rita Flooding on Louisiana Pavement Performance

Xingwei Chen¹ and Zhongjie Zhang²

ABSTRACT: In August and September of 2005, Louisiana was devastated by Hurricanes Katrina and Rita. There were approximately 2,000 miles of roadway in the Greater New Orleans area which were submerged in floodwaters for up to 5 weeks. After the hurricanes, there was great concern in the Louisiana Department of Transportation and Development (LADOTD) about the pavement structures in the flooded area due to the sustained flooding, as well as the pavement damage from the heavy debris trucking traffic. In this study, the pavement performance system (PMS) data for District 02 (most seriously influenced by Hurricanes) collected before and after the Hurricanes were analyzed to assess the pavement performance damage due to the sustained flooding or/and the heavy debris trucking traffic. The PMS data illustrated increased damage to highways as a result of heavy trucking or vehicle loading required to transport the vast amounts of debris following the Hurricanes. In addition, the data established an escalation in deterioration occurring as subgrade components were not initial

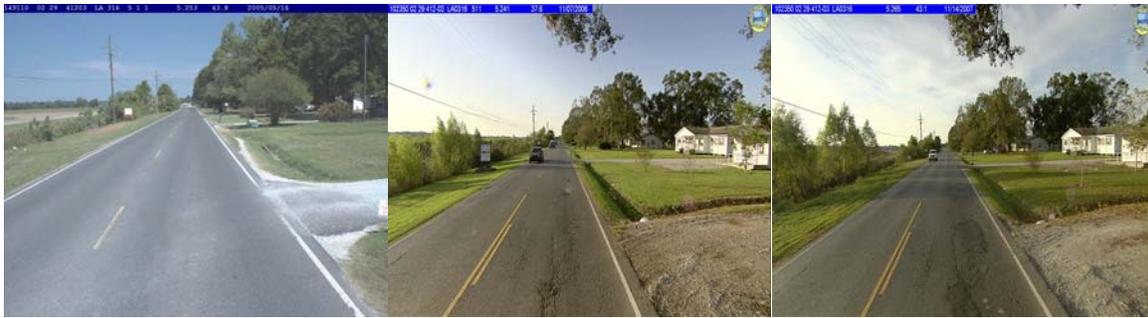
FIG. 3. PMS Pictures of Asphalt Pavement on LA 316 in Lafourche Parish.

Figures 3 to 5 were examples of PMS photos for asphalt, composite, and concrete pavements before and after Hurricanes at the same location, respectively. Figure 3 presents the PMS photos for an asphalt pavement section on LA 316 in Lafourche Parish. This section was not in the flooded zone but there was a debris dump site nearby. As show in Figure 3a), the pavement was in a good shape before Hurricanes. After Hurricanes, alligator cracking and patches were found in this section as show in Figures 3b) and 3c).

a) Picture on 05/16/2005 b) Picture on 11/07/2006 c) Pictures on 11/14/2007

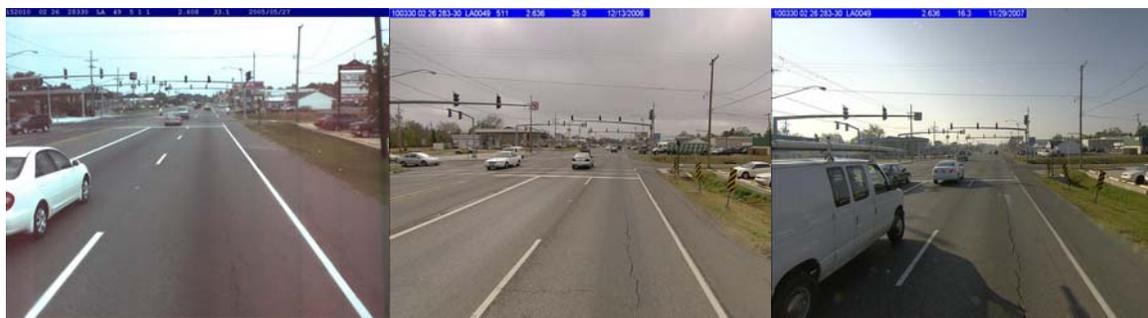
FIG. 4. PMS Pictures of Composite Pavement on LA 49 in Jefferson Parish.

Figure 4 presents the PMS photos for a composite pavement section on LA 49 in Jefferson Parish. This section was also not in the flooded zone but it was a heavy debris hauling route. As show in Figure 4a), the pavement had low severity level longitudinal cracking before Hurricanes. After Hurricanes, medium and high longitudinal crackings were found in this section in 2006 and 2007, respectively, as show in Figures 4b) and 4c).

a) Picture on 05/27/2005 b) Picture on 12/13/2006 c) Picture on 11/29/2007

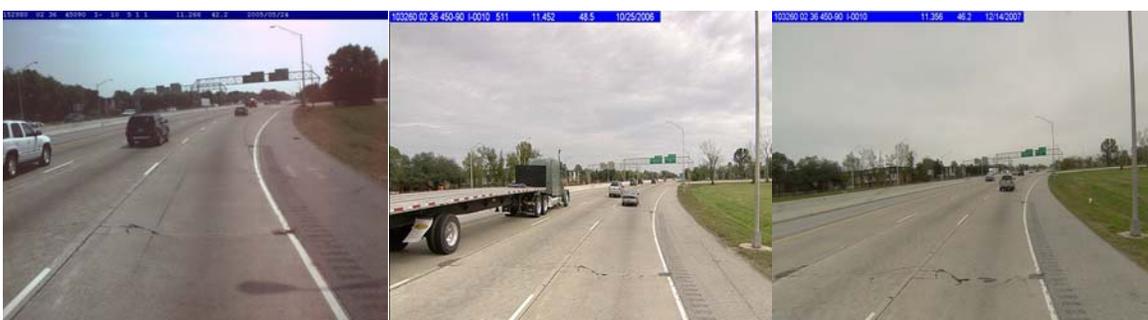
FIG. 5. PMS Pictures of Concrete Pavement on I-10 in New Orleans Parish.

Figure 5 presents the PMS photos for a concrete pavement section on I-10 in New Orleans Parish. This section was in the flooded zone and was underwater for a prolonged period. The distress at the transverse joint of concrete pavement was worse after Hurricanes than before.

a) Picture on 05/24/2005 b) Picture on 10/25/2006 c) Picture on 12/14/2007

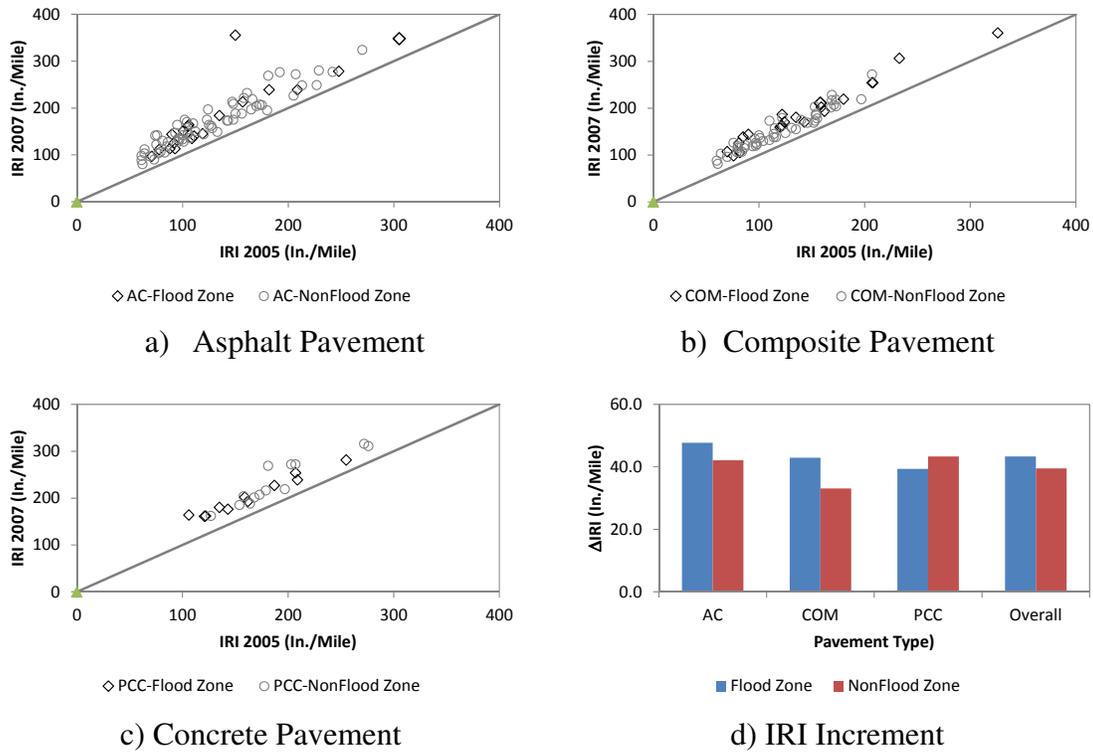
FIG. 6. Comparison of IRI in 2005 and 2007 for Highly Deteriorated Pavement.

Table 1 presents the queried highly deteriorated pavements in district 02 based on IRI. A total 172 control sections in District 02 were queried with highly deteriorated pavement subsections based on IRI, including 51 sections in flooded zone and 121 sections in non-flooded zone. Among these total 1025.8 miles pavements, there were 100.6 miles length (about 9.8%) highly deteriorated pavements based on IRI, including 29.2 miles in flooded zone and 71.5 miles in non-flooded zone. It was interesting that the highly deteriorated pavement length rate in flooded zone (7.9%) was slightly lower than that in non-flooded zone (10.9%). The average IRI values in 2005 and 2007 were shown in Table 1 and Figure 6. For asphalt and composite pavements, the average IRI values and IRI increments in flooded zone were slightly higher than those in non-flooded zone. For concrete pavements, the average IRI values and IRI increments in flooded zone were slightly lower than those in non-flooded zone. Over all, the average IRI values and IRI increments in flooded zone were slightly higher than those in non-flooded zone.

For asphalt and composite pavements, the average IRI values and IRI increments in flooded zone were slightly higher than those in non-flooded zone. For concrete pavements, the average IRI values and IRI increments in flooded zone were slightly lower than those in non-flooded zone. Overall all, the average IRI values and IRI increments in flooded zone were slightly higher than those in non-flooded zone.

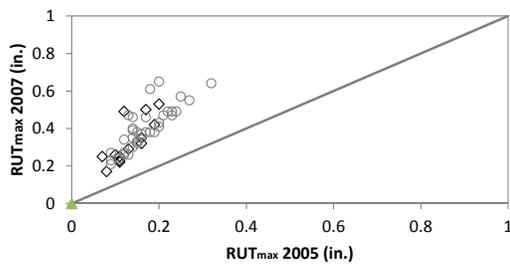
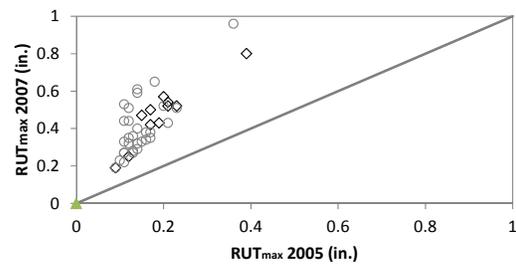
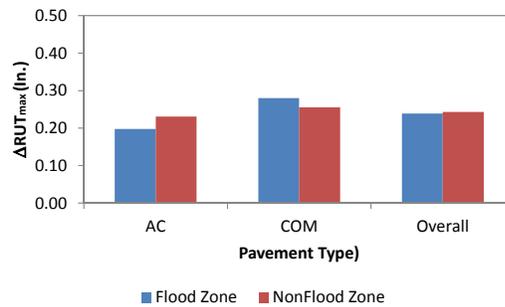
Figure 7. Comparison of Rut Depth in 2005 and 2007 for Highly Deteriorated Pavement.

Table 2 presents the queried highly deteriorated pavements in District 02 based on rutting. A total 90 control sections in District 02 were queried with highly deteriorated pavement sub-sections based on rutting, including 24 sections in flooded zone and 66 sections in non-flooded zone. Among these total 582.8 miles pavements, there were 34.5 miles (about 5.9 %) highly deteriorated pavements based on rutting, including 7.3 miles in flooded zone and 27.3 miles in non-flooded zone. It was interesting that the highly deteriorated pavement length rate in flooded zone (4.1%) was slightly lower than that in non-flooded zone (6.7%). The maximum rut depths within tenth of a mile subsection in 2005 and 2007 were shown in Table 2 and Figure 7. For asphalt pavements, the average maximum rutting depth for tenth of a mile subsection and increments in flooded zone were slightly lower than those in non-flooded zone; while, for composite pavements, the average maximum rutting depth for tenth of a mile subsection values and increments in flooded zone were slightly higher than those in non-flooded zone.

For asphalt pavements, the average maximum rutting depth for tenth of a mile subsection and increments in flooded zone were slightly lower than those in non-flooded zone; while, for composite pavements, the average maximum rutting depth for tenth of a mile subsection values and increments in flooded zone were slightly higher than those in non-flooded zone.
