**Claro, Pisco, Cell Site (S13.7103, W76.2045)**

**Telefónica, Ica City, Central Office and Cell Site (S14.0666, W75.7289)**

**Cell Sites Near Paracas (S13.8214, W76.2443)**

### **Telefónica Cell Site Outside of Ica City**

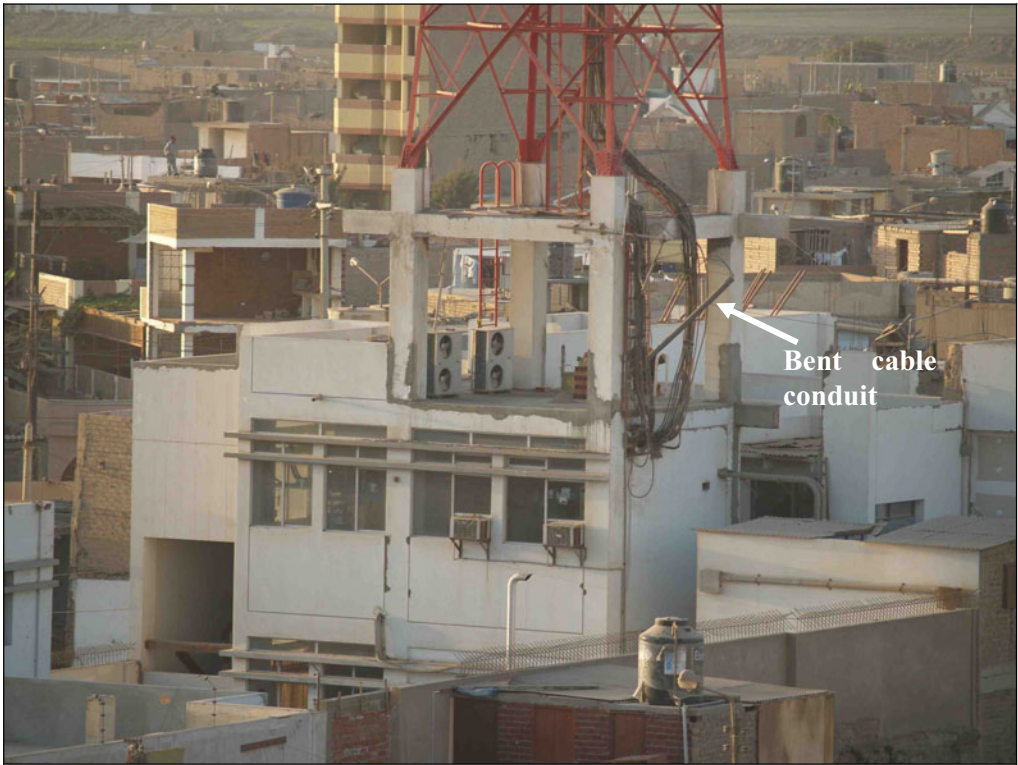
*Fig. 7.18. Damage at the base of the tower support structure was repaired.  
Note the massive waveguide that drooped down below the tower support structure*

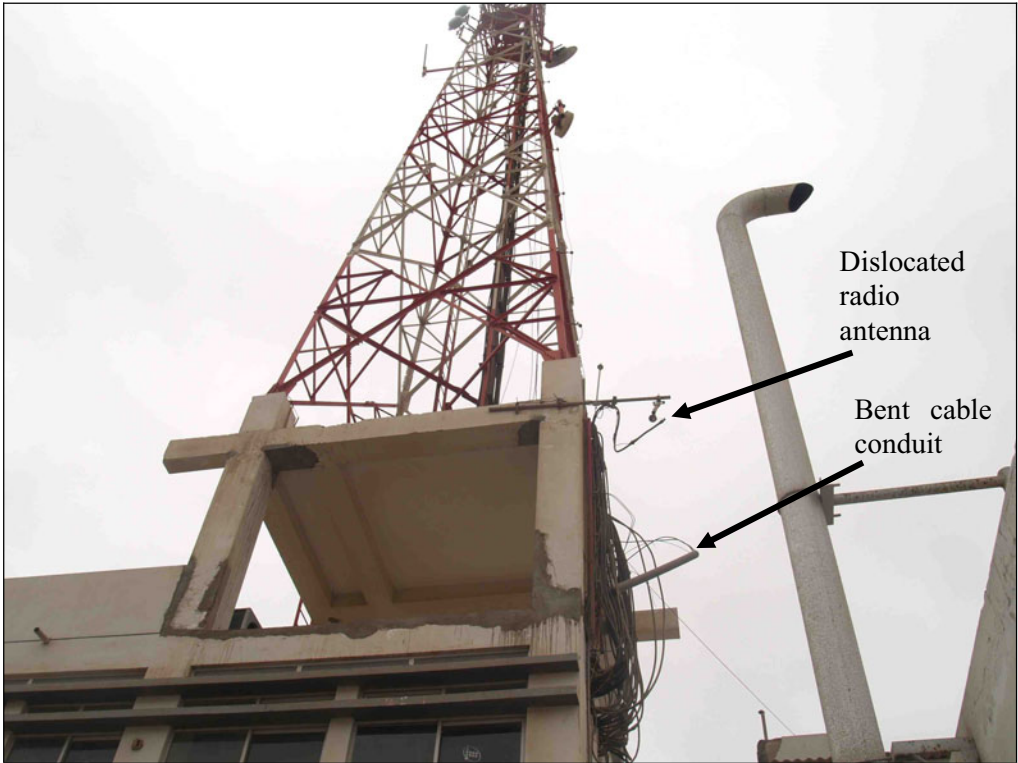
*Fig. 7.19. Damage viewed from the bottom of the structure in the yard of the CO facility*

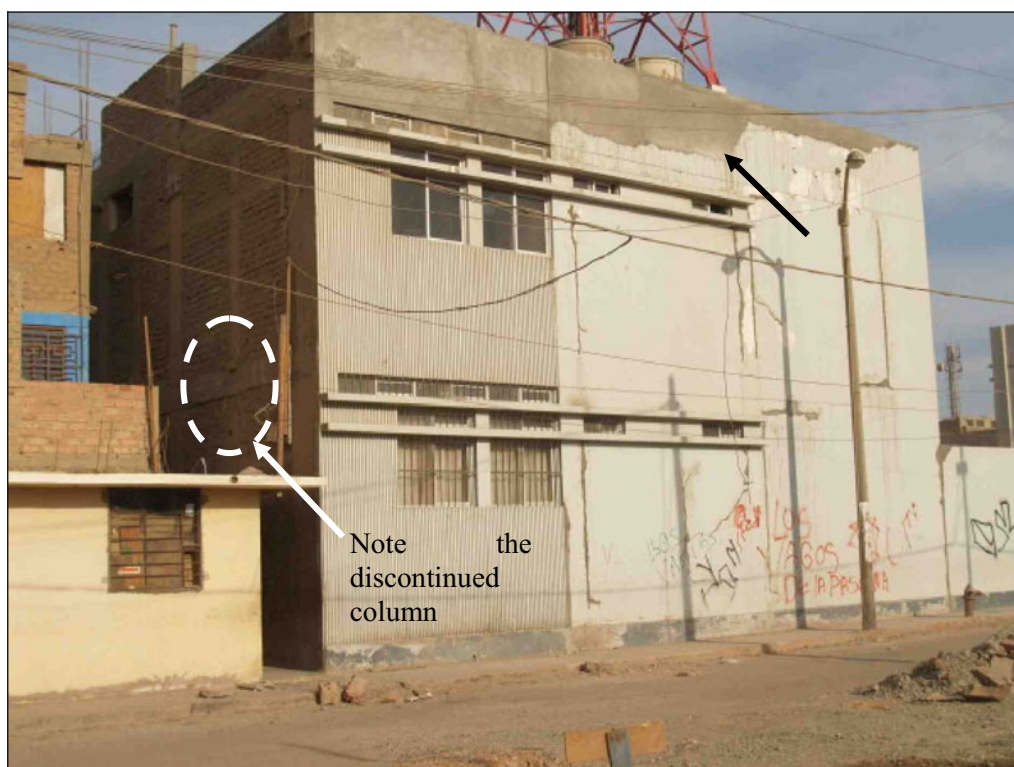
*Fig. 7.20. Repaired top of the building at the back of the Telefónica CO*

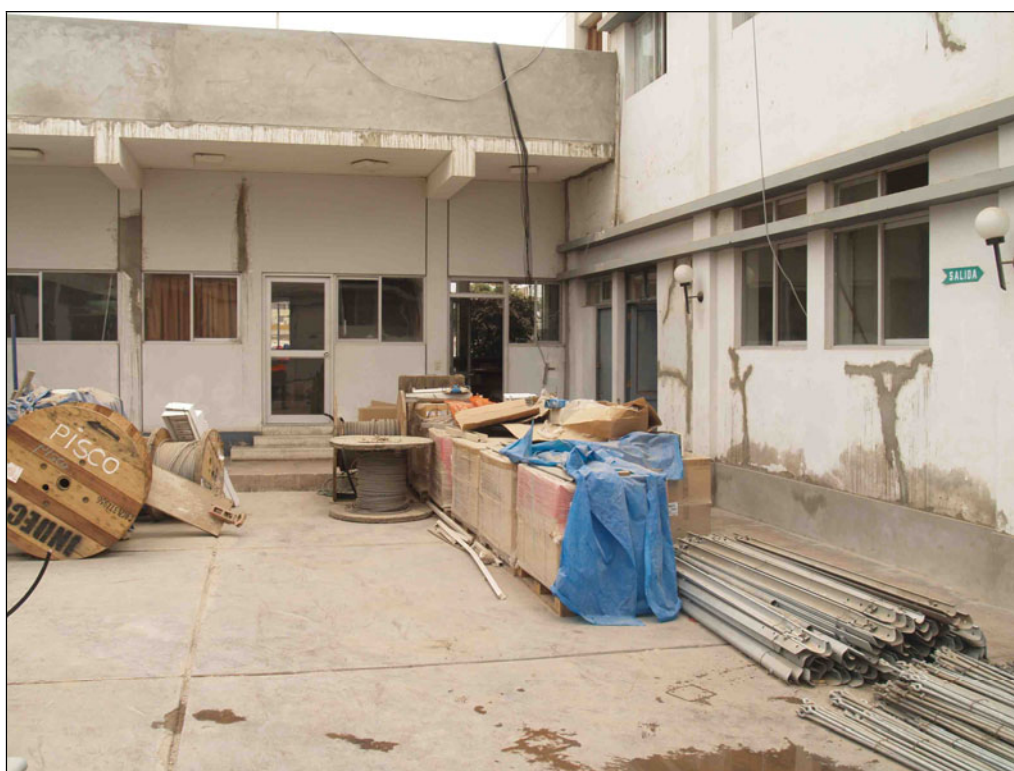
*Fig. 7.21. Material for repairing damage in the yard of this CO. Note the repaired cracks on the walls.*

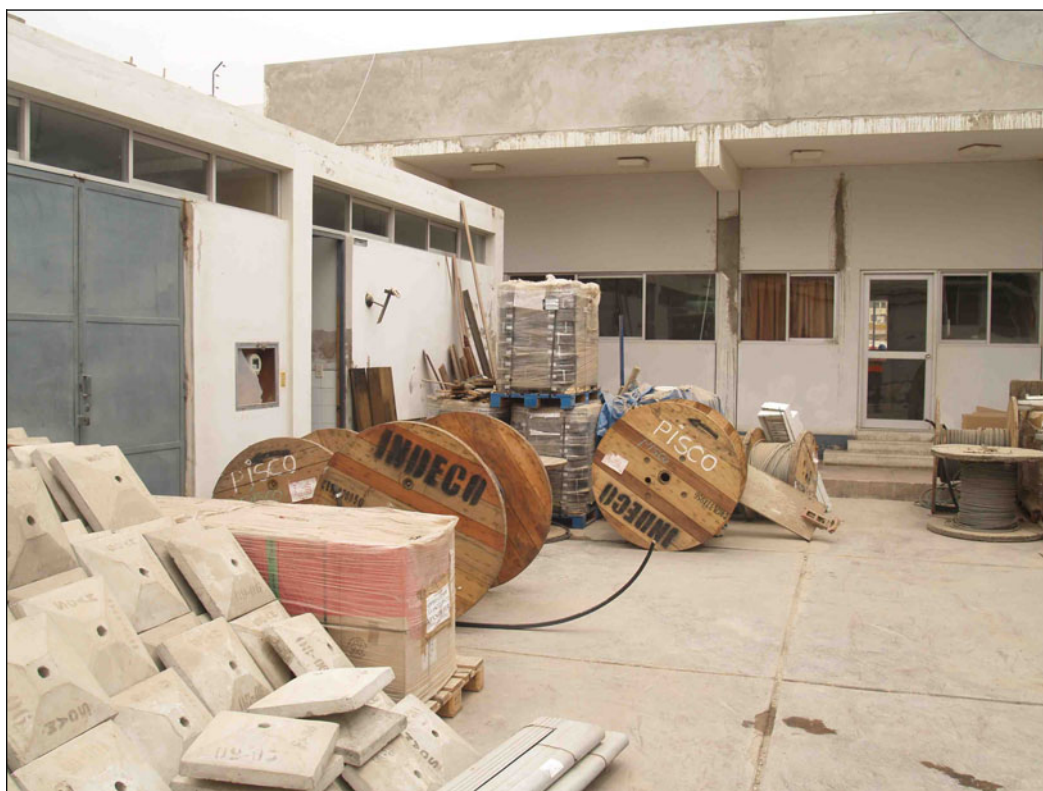
*Fig. 7.22. More repair material in the CO yard, note repair on the column*

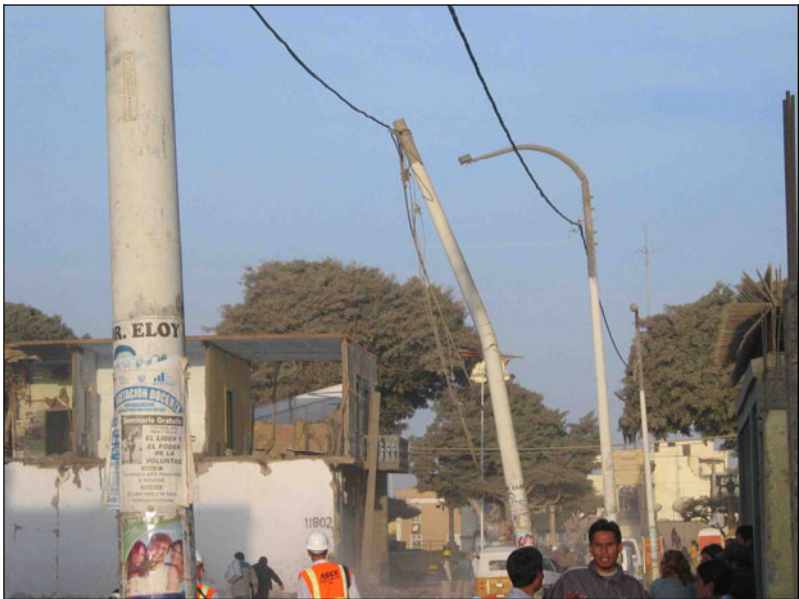
Claro personnel indicated the power outage exceeded five days at this site. Power generators were brought in to restore service to the cell site, which did not have power until two weeks after the earthquake. This delay was most likely due to extensive damage to the utility poles and the power distribution system in this area (Fig. 7.25).

*Fig. 7.25. Utility pole damaged in the street next to Hotel Candelobra, Pisco.*

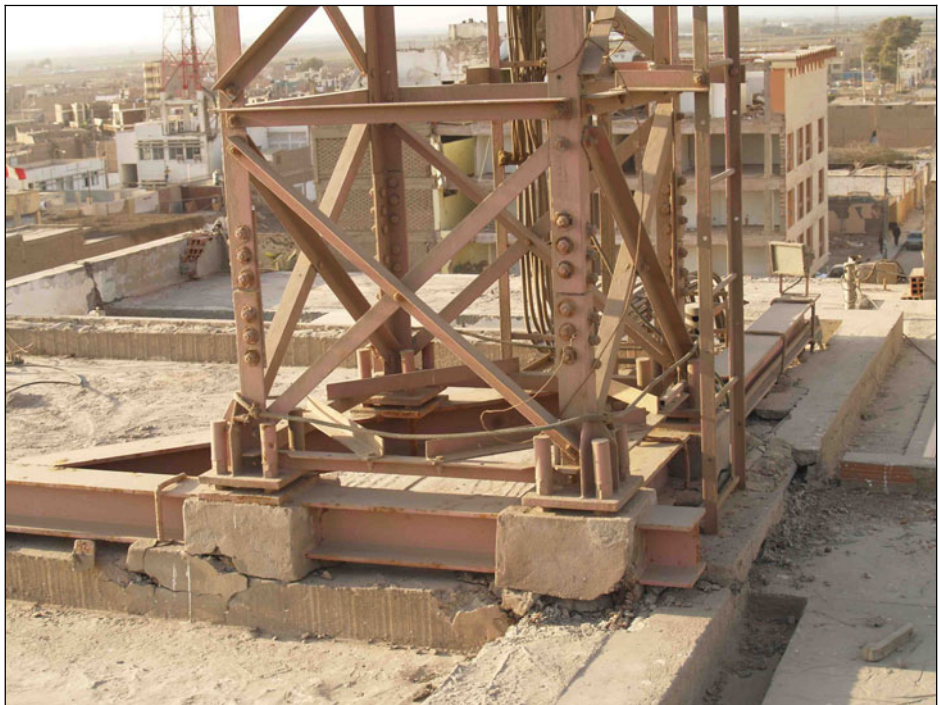
This cell site is equipped with 20 channels to support its customer base. The observed damage was to the base, where the tower is anchored to the roof (Fig. 7.26). The beams were secured to the roof structure by steel reinforcement rods welded to the reinforcement of the building (Fig. 7.27). At the time of ASCE/TCLEE visit, the damage was not repaired.

*Fig. 7.26. The damage at the base of the tower*

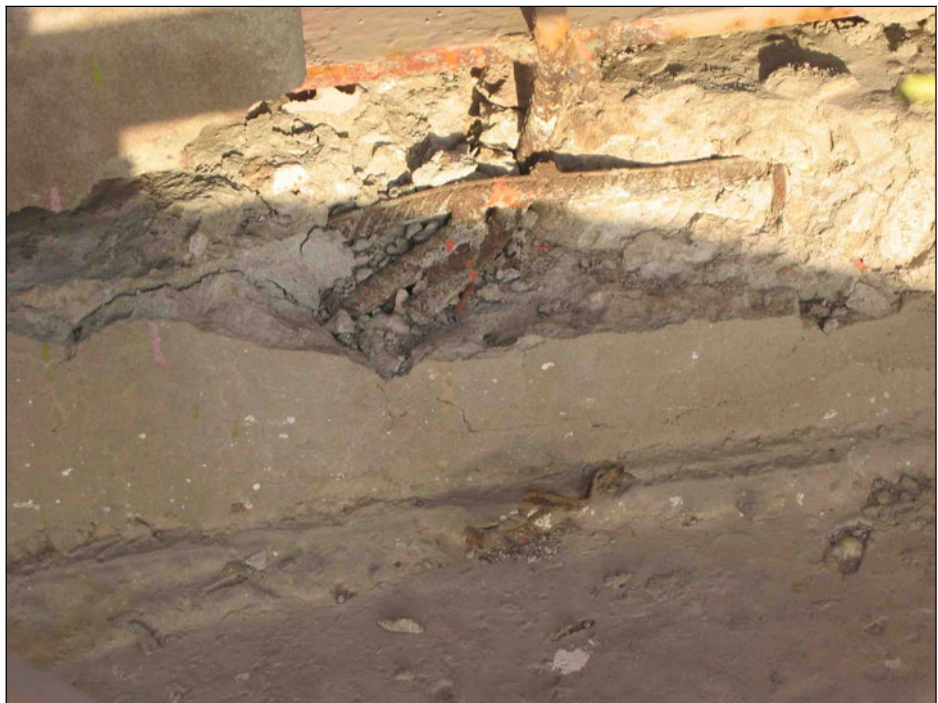
*Fig. 7.27. Details of securing the steel beam to the roof structure*

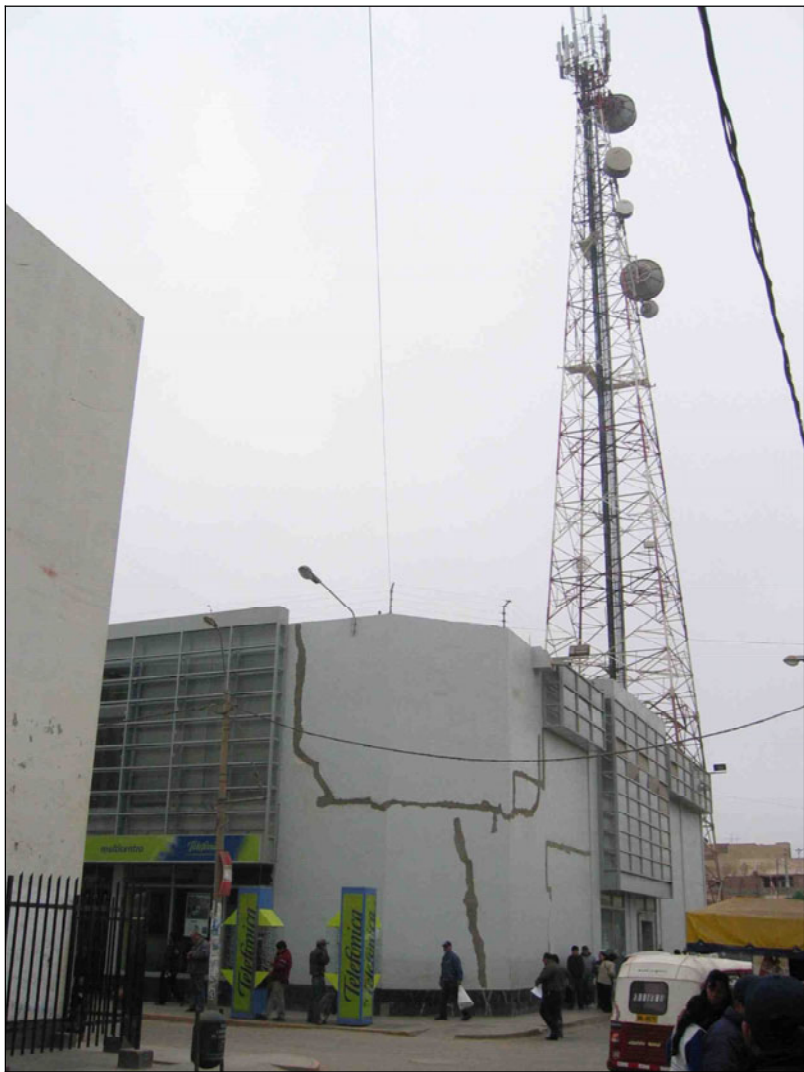
*Fig. 7.28. Telefónica central office in Ica City. Surface cracks on the outside wall were fixed.*

The only damage observe at this location was the crack on the building’s outside wall (Fig. 7.28). There were no signs of damage on the inside where we met the office manager.

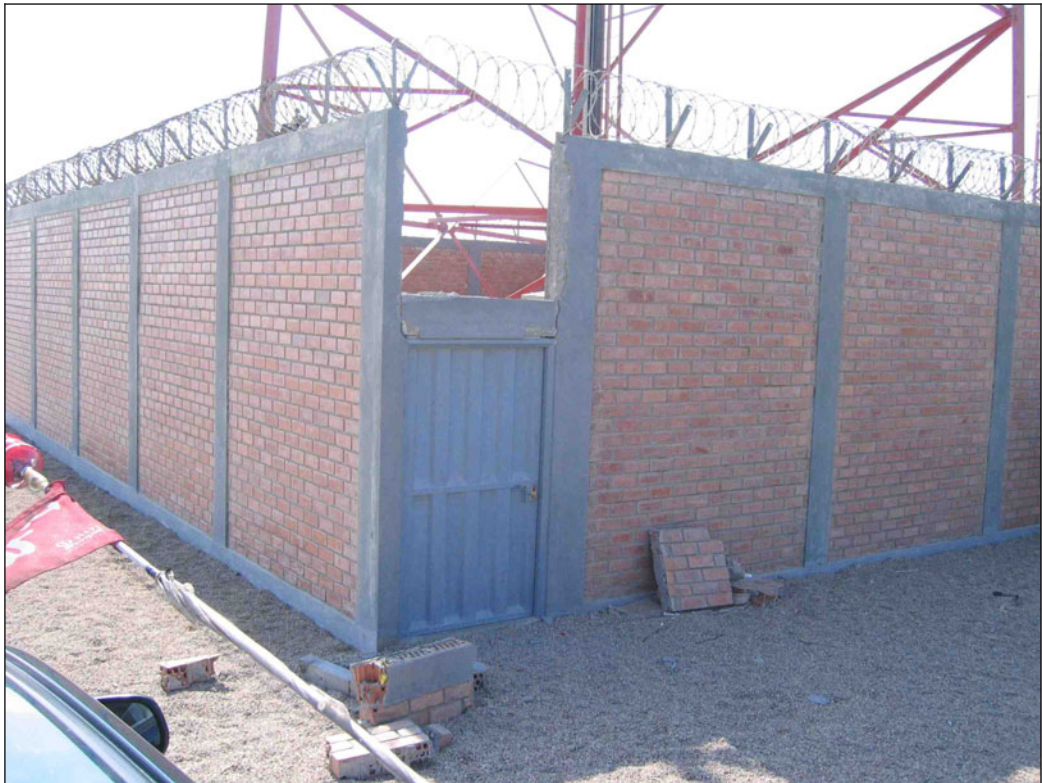
The cell sites of Telefónica, Nextel, and Claro are located very close to each other on the west side of the highway leading to the Port of San Martín (Fig. 7.29). This location is less than 1 km from the coast. These cell sites were built on sandy ground. We did not observe any signs of ground deformation or liquefaction. The only damage observed was the wall above the doorway of the Telefónica cell site (Fig. 7.30).

*Fig. 7.30. Damaged wall above the door, no other signs of damage observed*

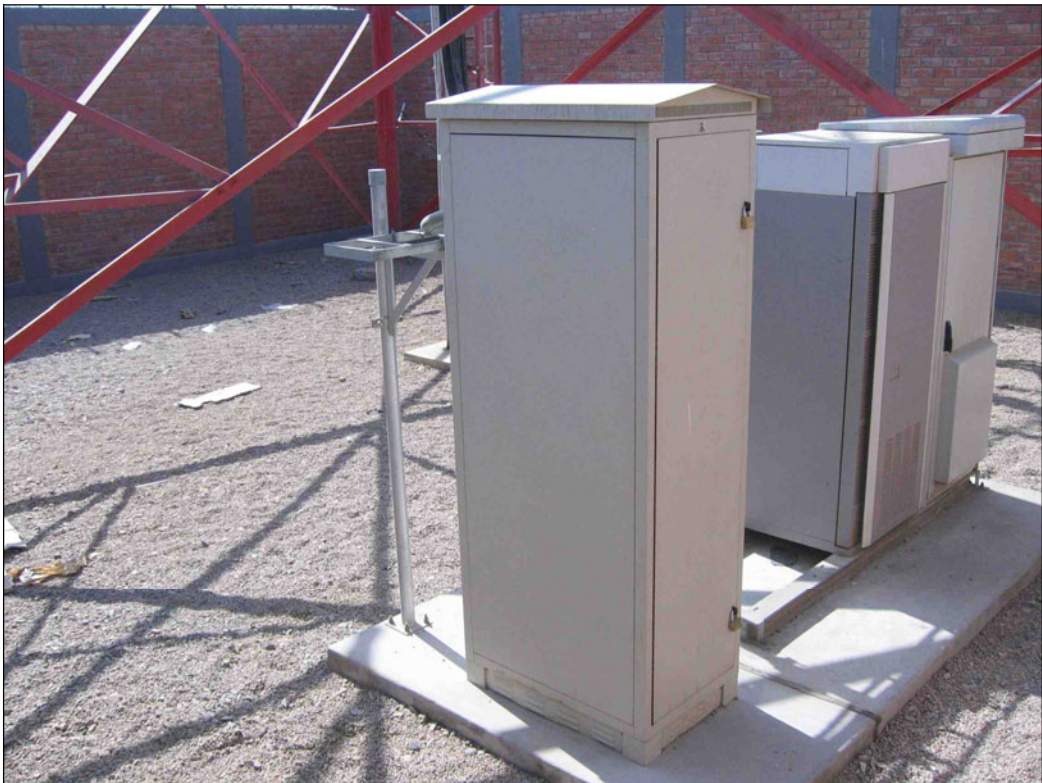
The equipment was anchored to a concrete pad. The power equipment was anchored to two steel beams that were secured to the concrete pad by four U-shape brackets (Fig. 7.31). This installation method is typical of the other cellular service providers. The only difference is the design of the antenna towers (Fig. 7.29).

*Fig. 7.31. Cell site equipment anchored on concrete pads*

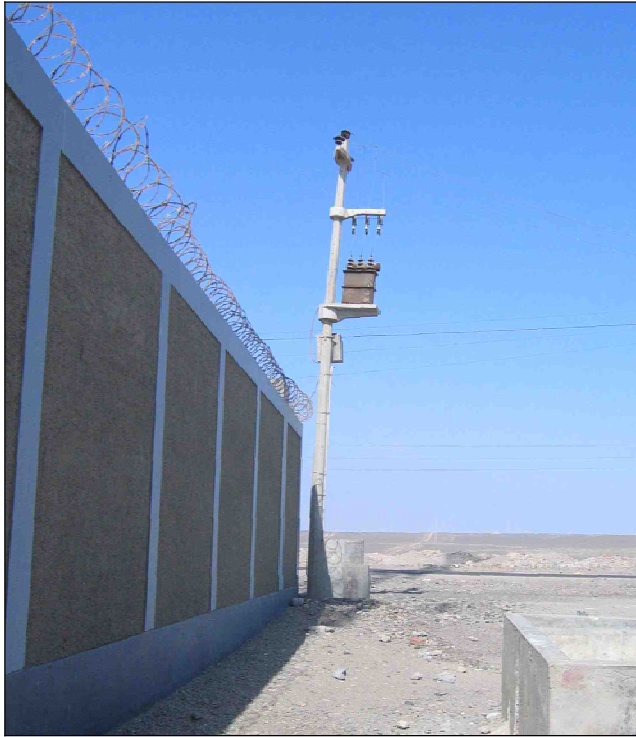
The electric power supply to these cell sites came from a single source (Fig. 7.32). The feed cable comes down from the pole-mounted transformer along the pole and then feeds the sites via underground conduits. Although there are three cell sites, there is no redundancy to prevent a power failure.

*Fig. 7.32. Electric power supply to all three cell sites comes from this pole. This is an underground feed to the sites.*

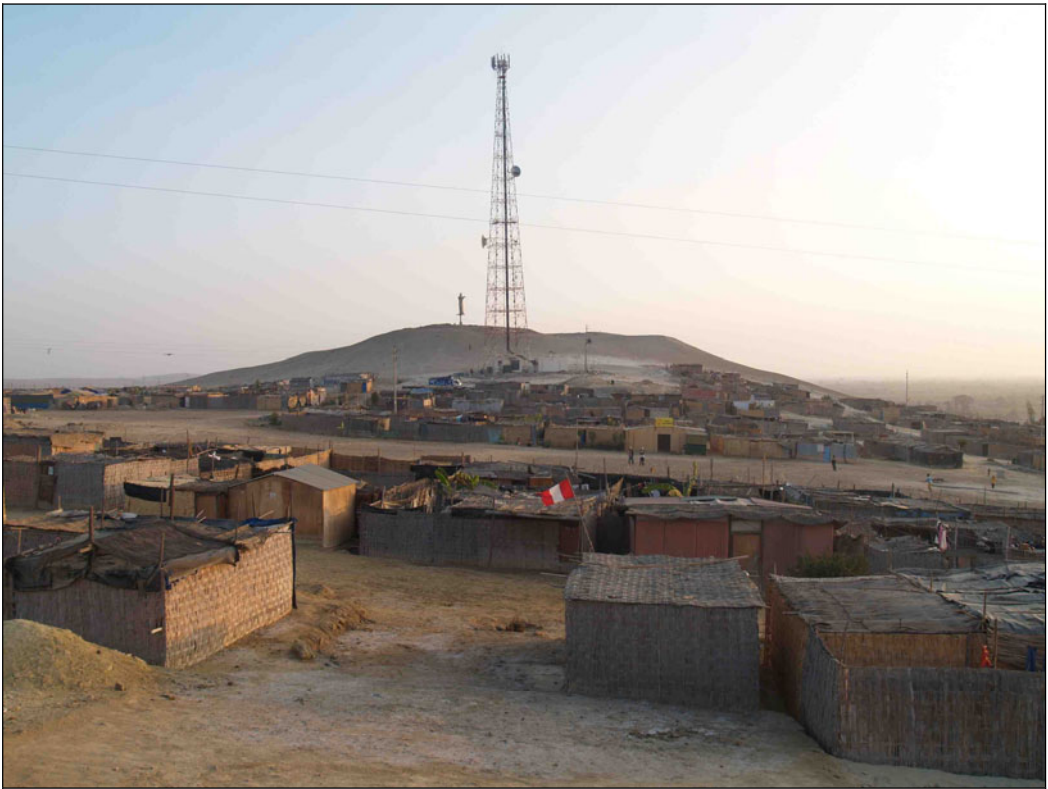
At the time when the ASCE/TCLEE investigation team visited this site, the collapsed wall around the cell-site equipment building has not been rebuilt (Figs. 7.33 and 7.34).

*Fig. 7.33. Telefónica cell site outside of Ica City*

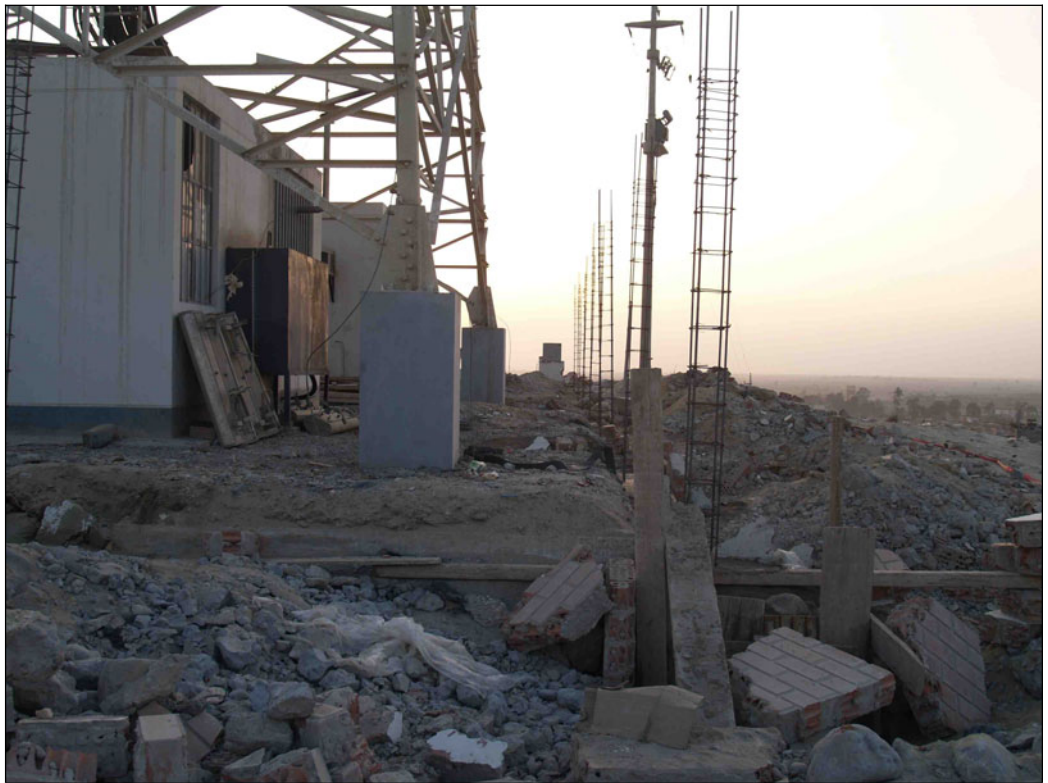
The damaged electric power transformer (Fig. 7.37) was chained to the halon cylinder for fire suppression at this cell site. The transformer was a pole-mounted transformer just outside the perimeter of the collapsed wall (Fig. 7.34).

*Fig. 7.34. Preparation for rebuilding the enclosure wall. Note the utility pole with a pole mount transformer serving this site.*
