### 3.1 Tsunami Overtopping without Structural Failure

### **3.2 Tsunami Overtopping with Structural Damage or Failure**

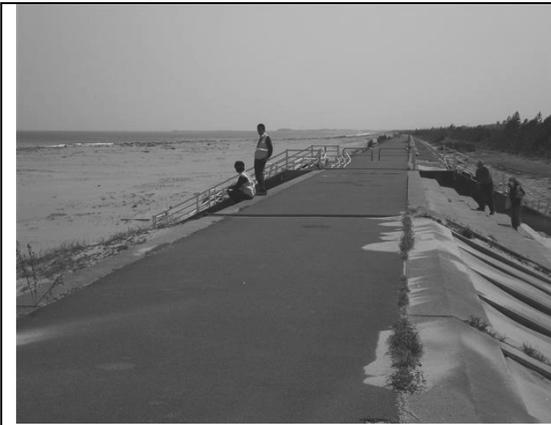
*Figure 19. Arahama Beach shoreline dike — Minor damage to top pavement/backside concrete slope; scour on landward side of dike*

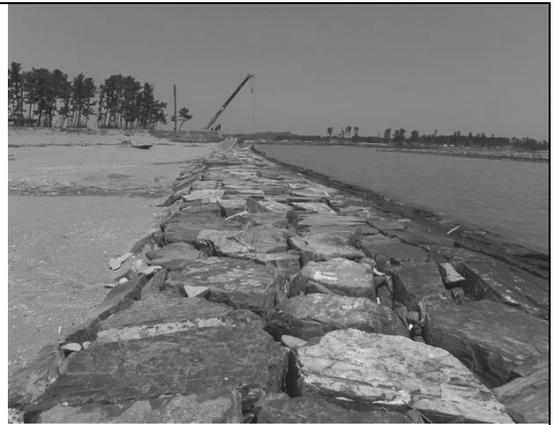
*Figure 20. Naruse River north entrance jetty — Damage to a small section of the river revetment, as indicated by the work crane; no damage to the jetty itself*

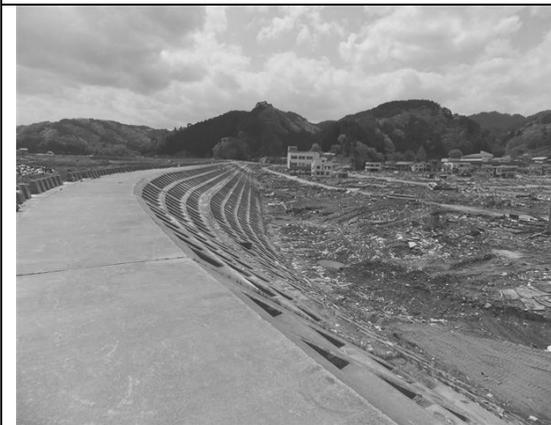
*Figure 21. Taro tsunami wall — No substantial damage to section shown*

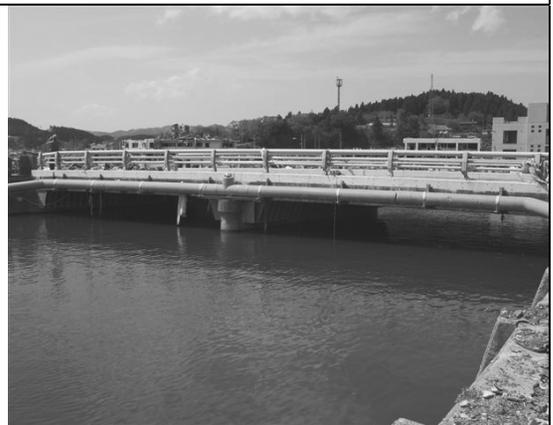
*Figure 22. Shizugawa, fishing port bridge — No damage observed*

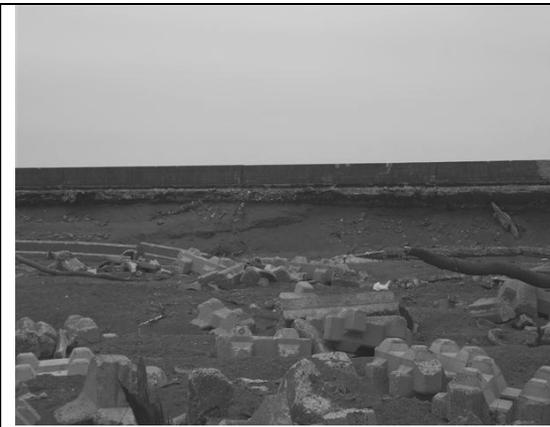
*Figure 23. Noda Tsunami Seawall (old wall) — Backside erosion/concrete armor units tossed over wall; wall sections broken off*

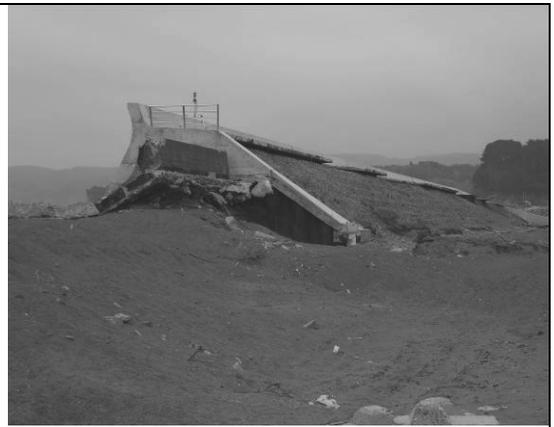
*Figure 24. Noda Tsunami Seawall (new wall) — Backside erosion with loss of precast concrete panels; one upper section of wall sheared off*

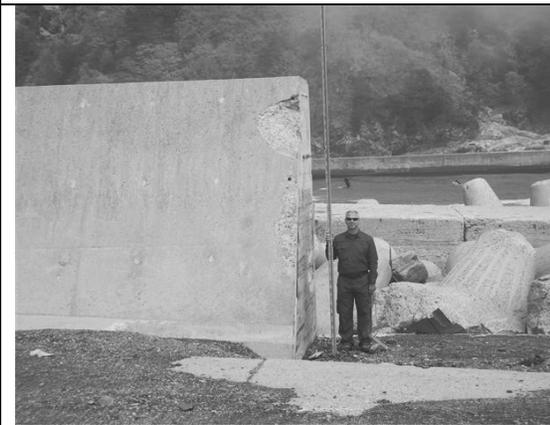
*Figure 25. Omoto Port breakwater — 3.5m high x 56m long section of wall sheared off*

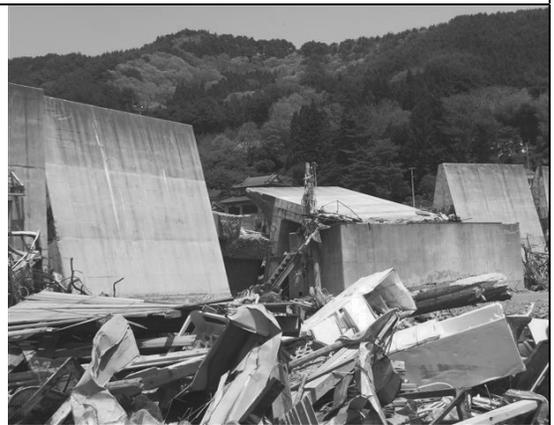
The examples shown in Figures 23 – 26 all exhibit various combinations of these loads. In Figure 26, for example, the wall sections at Kojirahama experienced overturning due to lateral loading. However, the landside scour that occurred during overtopping and the added buoyancy in the units from the airspace of a built-in tunnel on their landside face exacerbated damages caused by overturning.

*Figure 26. Kojirahama tsunami wall — Five wall sections overturned due to landside scouring resulting in 74m-breach*

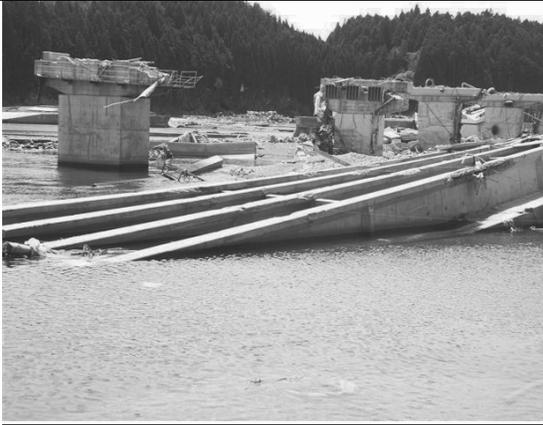
*Figure 29. Utatsu Port Bridge — Bridge deck uplifted off its foundation piers and overturned*

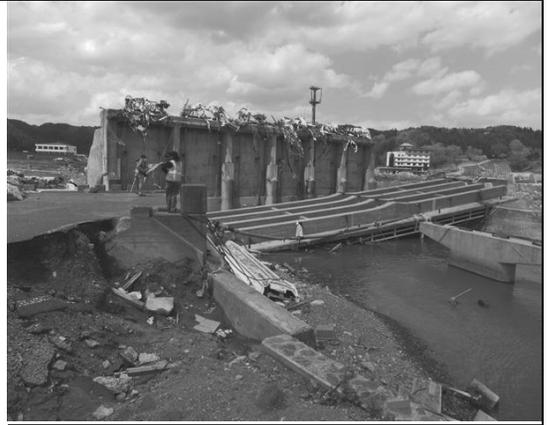
*Figure 30. Taro Miyato Bridge — Bridge deck uplifted off its foundation piers and overturned*

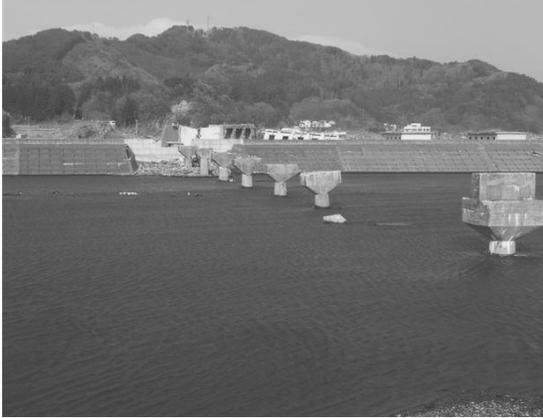
*Figure 31. Otsuchi Bridge — Bridge deck (not visible) uplifted off its foundation piers*

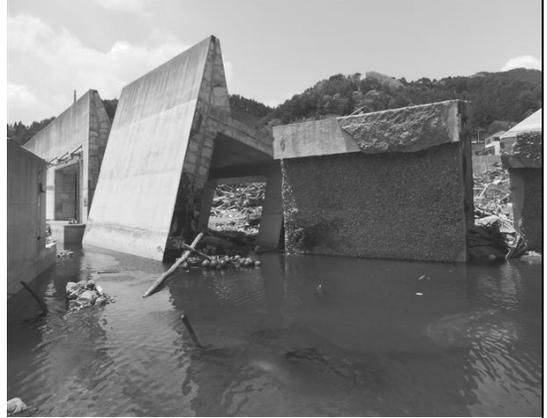
*Figure 32. Kojirahama tsunami wall — Five wall sections ( 12.5m x 8.5m x 10 – 12m long, 74m in total length) scoured on landward side, uplifted, and rotated/overturned*

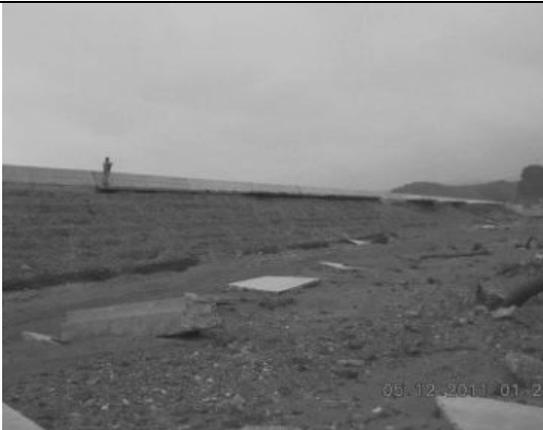
*Figure 33. Noda barrier wall — Panels of inland side of wall detached and washed inland*

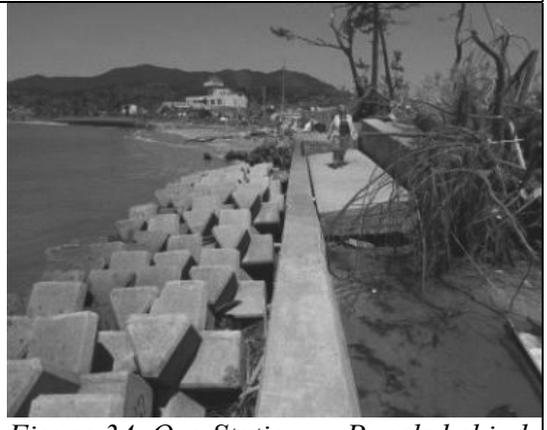
*Figure 34. Oya Station — Panels behind seawall uplifted; scour inland of seawall*

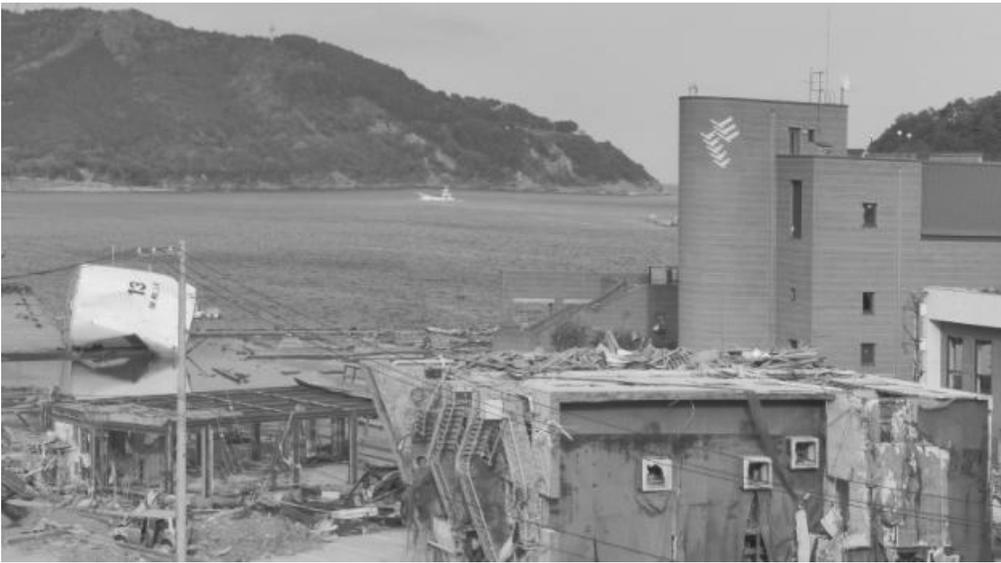
*Figure 35. Onagawa — Tank and building overturned; significant subsidence experienced throughout the area during the earthquake*

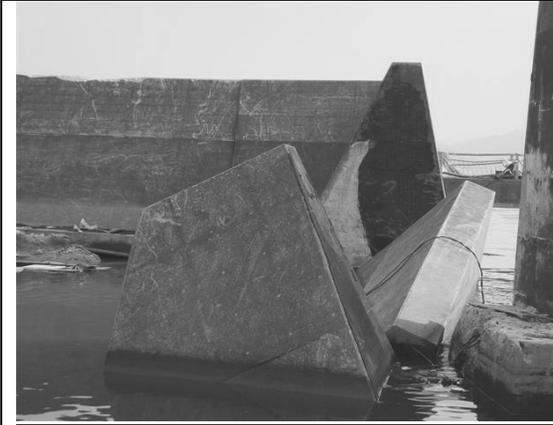
*Figure 36. Otsuchi tsunami wall — Wall sections (54m in total length) scoured on landward side, slid off foundation, and rotated/overturned*

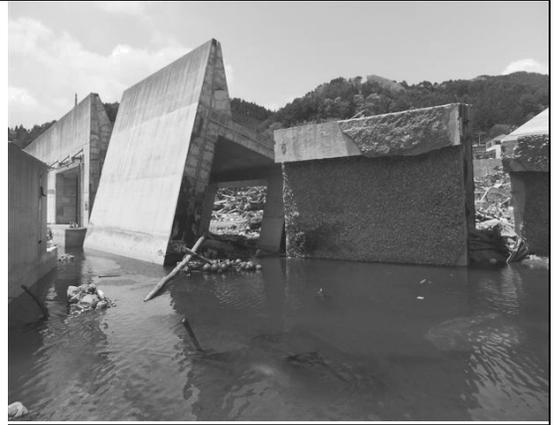
*Figure 37. Kojirahama tsunami wall -- The shallow foundation keyway is visible in underside of the overturned unit on the right side of the photo*

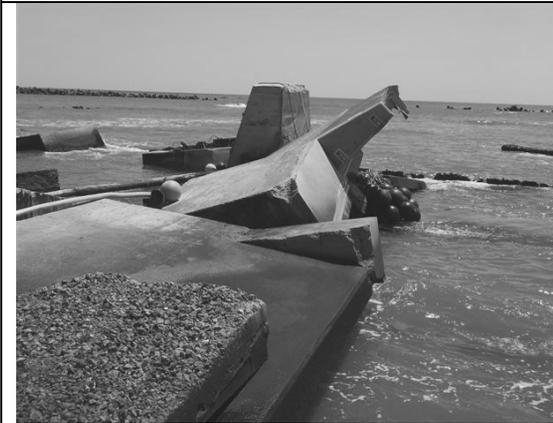
*Figure 38. Koizumihama Beach tsunami seawall — Seawall completely destroyed from hydrodynamic/impact loading and beach scour; seawall sections slid off foundation, rotated, and overturned*

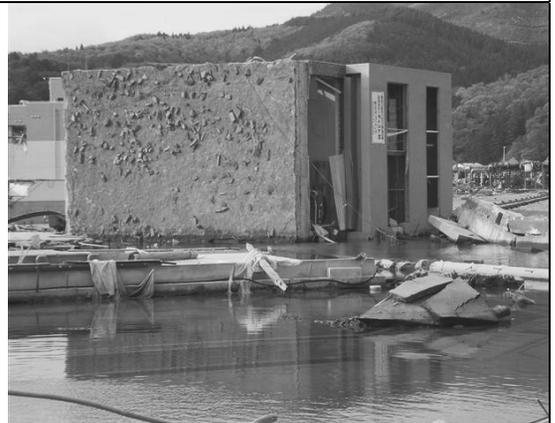
*Figure 39. Onagawa building — Three-story concrete building overturned off its foundation; underside visible slab on grade without piling or footings*

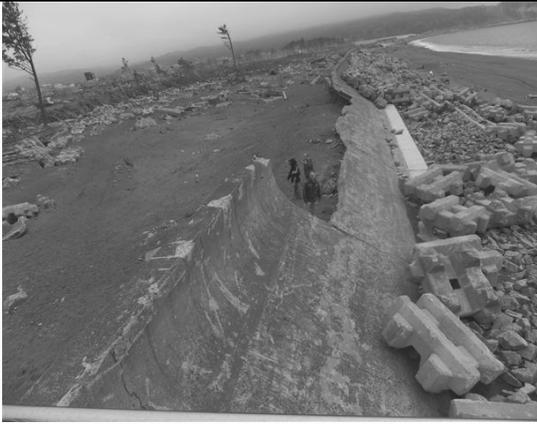
*Figure 40: Noda tsunami seawall (old wall) — Broken off concrete portions of seawall; 2m x 2m x 0.8m concrete armor units tossed 75m inland over the wall*

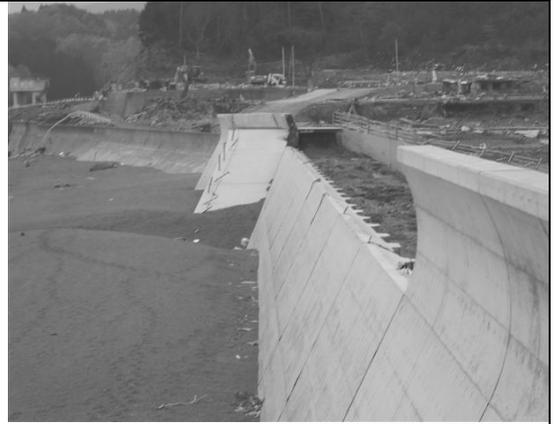
*Figure 41: Noda tsunami seawall (new wall) — Sheared off top precast concrete section of seawall with insufficient steel rebar vertical/horizontal connections*

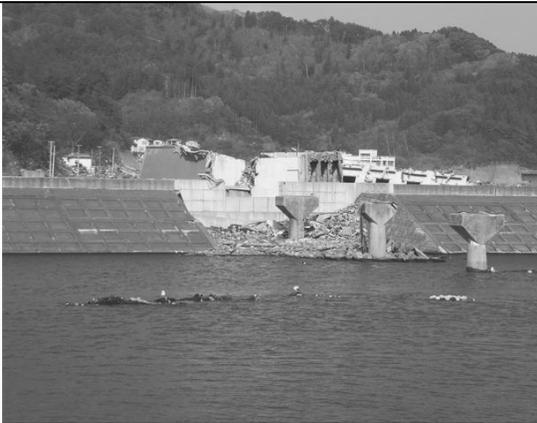
*Figure 42: Otsuchi tsunami seawall — Ripped out section of tsunami wall where the supported bridge deck intersected and is now missing from uplift/impact)*

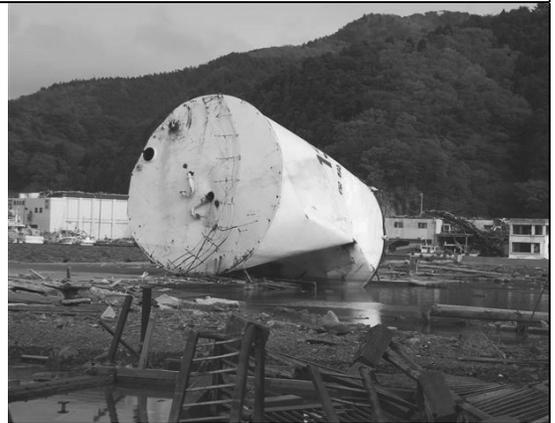
*Figure 43: Onagawa tank structure — Collapsed tank ripped off its foundation (Note: Storage tanks, often partially full, commonly float because their fluid contents are usually less dense than water.)*

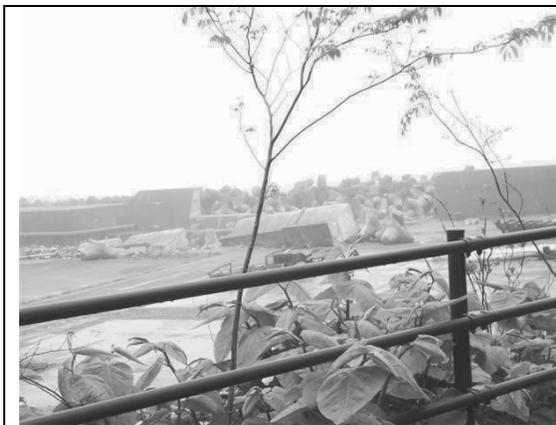
Figure 45. Otanabe (Fudai) breakwater — Caisson breakwater sections and concrete armor units moved inland off their rubble mound foundation due to combination of hydrostatic and hydrodynamic loads on seaward side

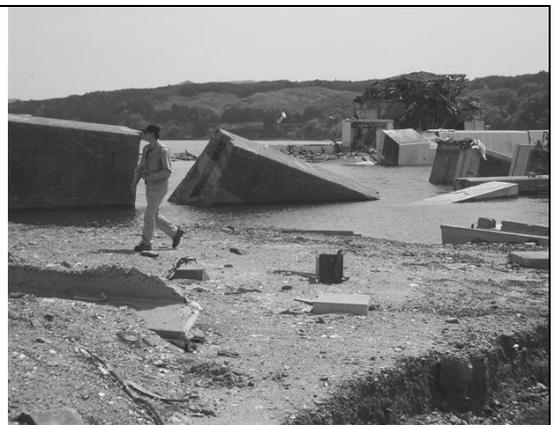
Figure 45. Otanabe (Fudai) breakwater — Caisson breakwater sections and concrete armor units moved inland off their rubble mound foundation due to combination of hydrostatic and hydrodynamic loads on seaward side

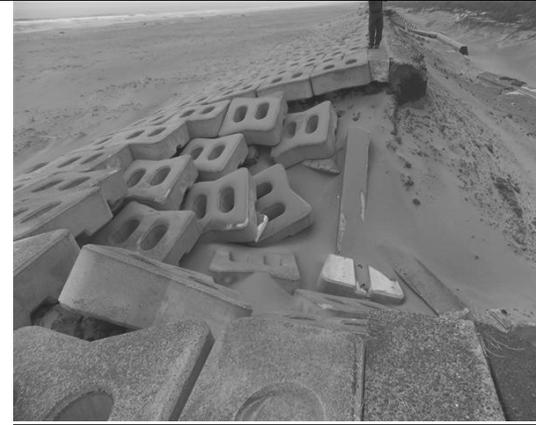
*Figure 47. Natori Beach shoreline dike — Collapsed sections of seaward facing concrete paver units due to combination of hydrostatic and hydrodynamic loads on seaward side and overtopping scour of landward side*

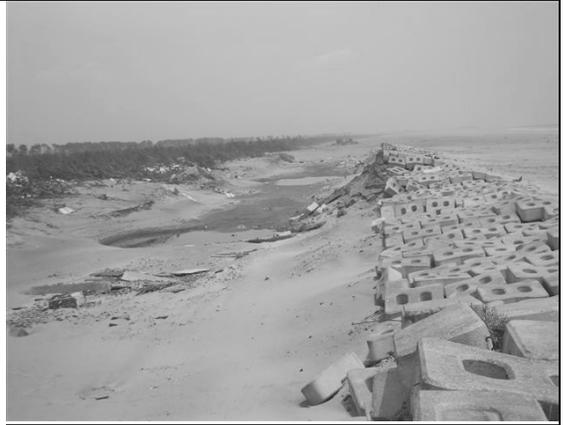
*Figure 48. Natori Beach shoreline dike — Complete collapse of landward facing concrete paver units due to combination of hydrostatic and hydrodynamic loads on seaward side and overtopping scour of landward side*

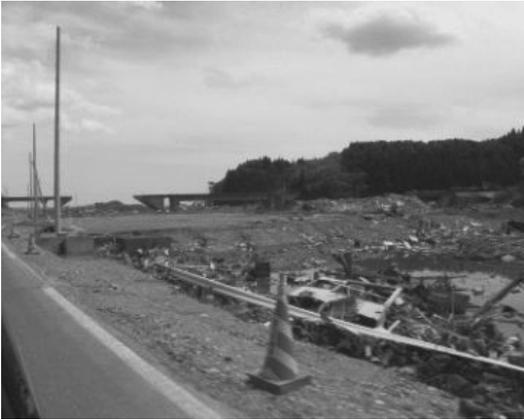
*Figure 49. Utatsu — Effects of flow obstruction (Greater area facing flow is subject to higher hydrostatic and hydrodynamic forces.)*

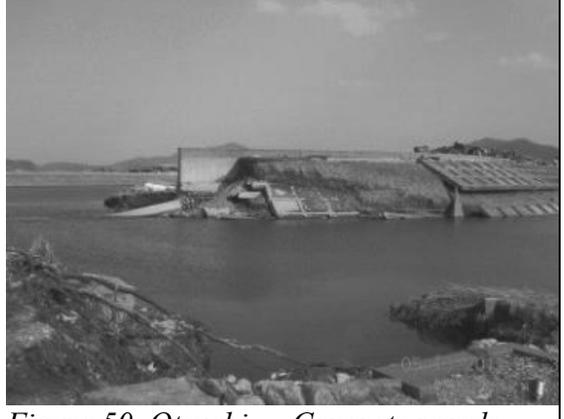
*Figure 50. Otsuchi — Concrete panels removed due to flow behind wall; caused scour of earthen fill and structural failure of the wall*
