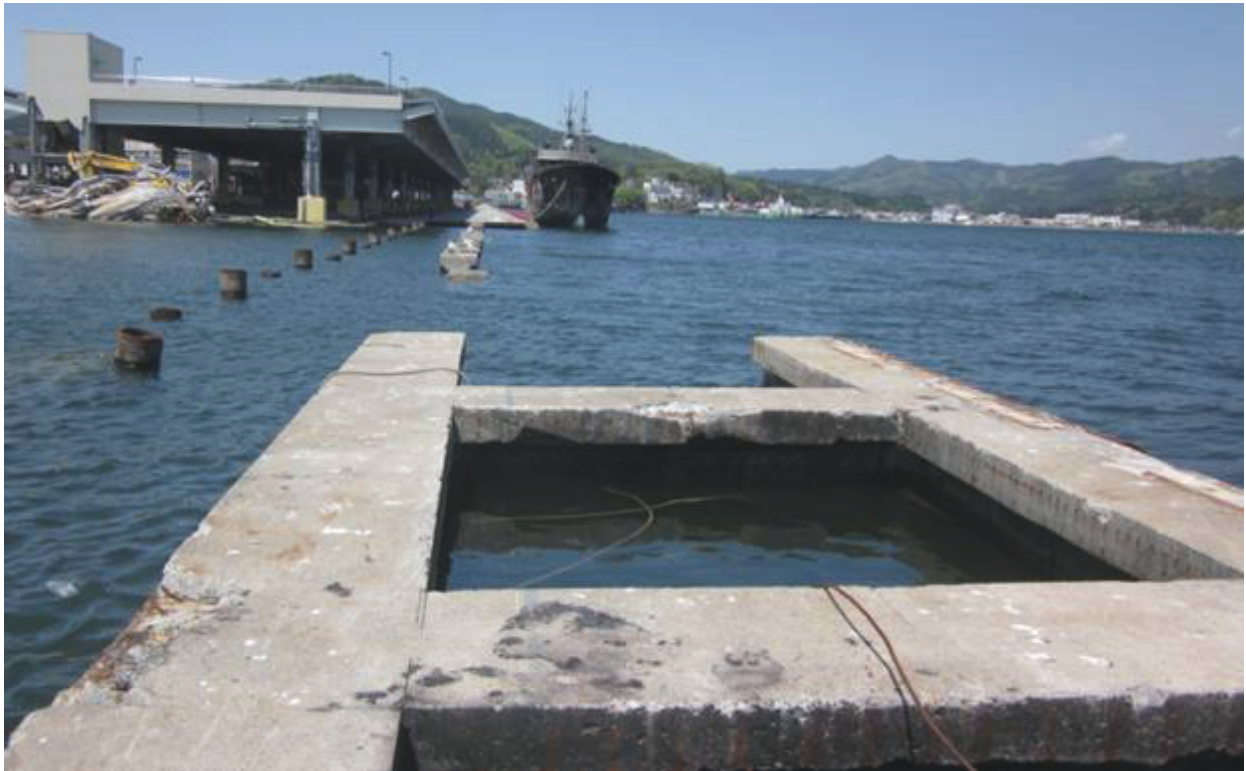
Figure 8-37 – Demolition likely prior to earthquake

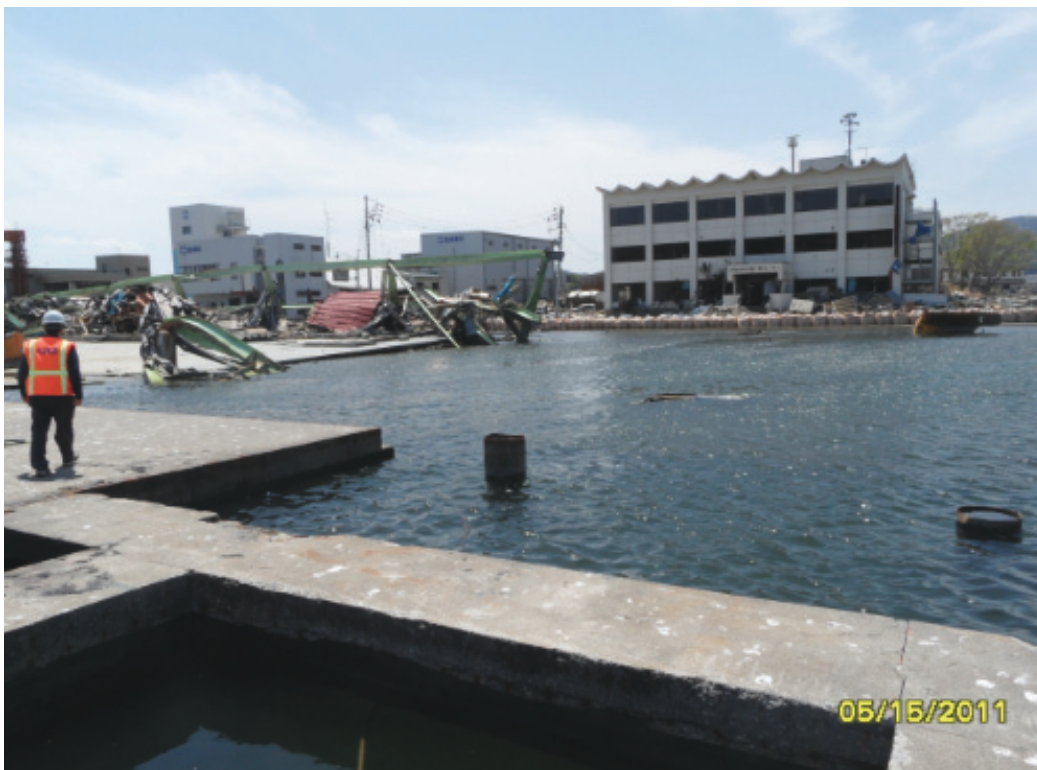
Figure 8-38 - Failed landside behind demolished wharf area

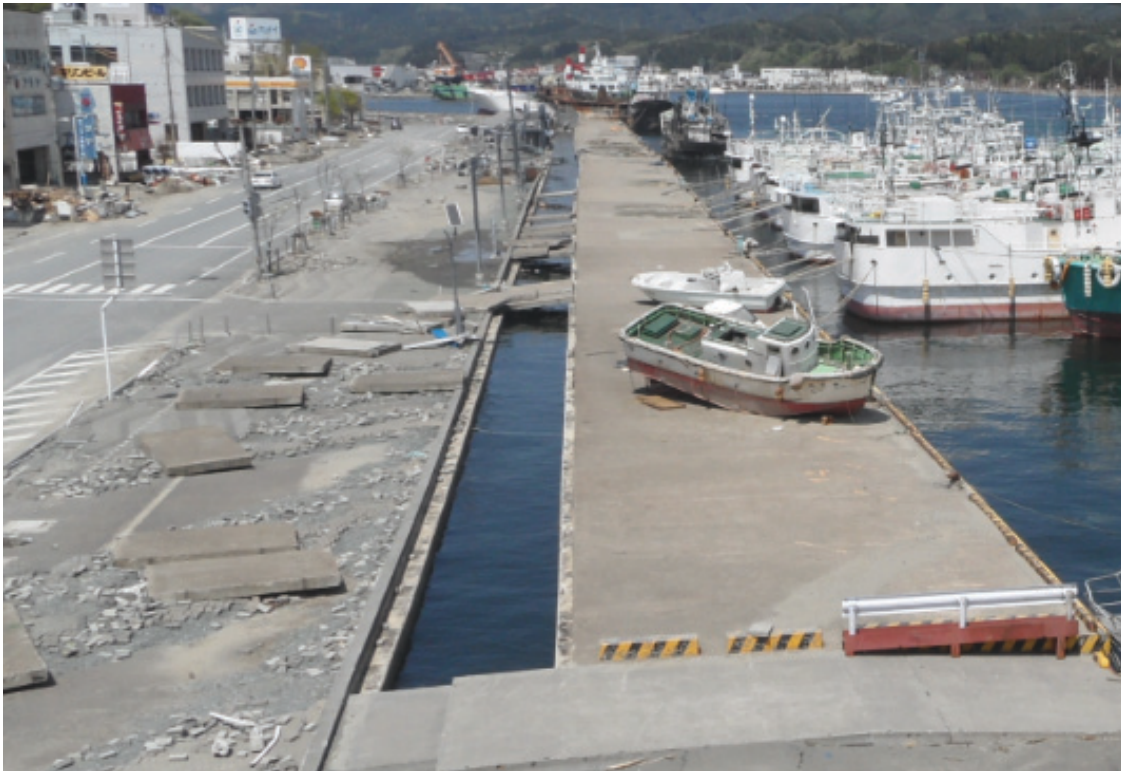
Figure 8-39 – Ramps popped out of place due to tsunami uplift loads

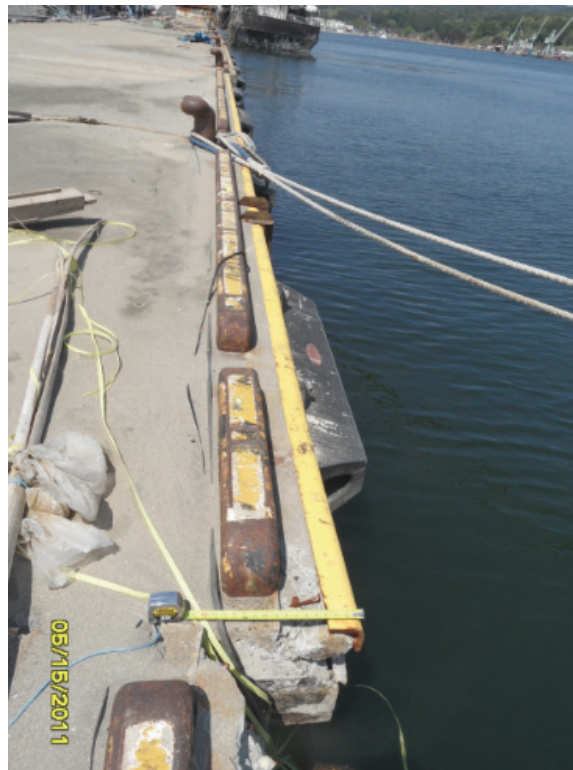
Figure 8-40 – Differential transverse movement of Location 5 wharf at construction joints

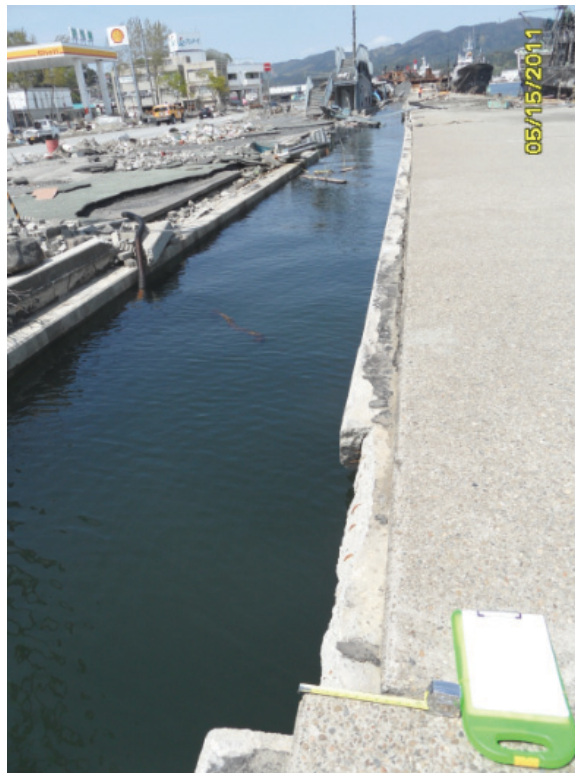
Figure 8-41 - Landside settlement along the wharf at Location 5 wharf

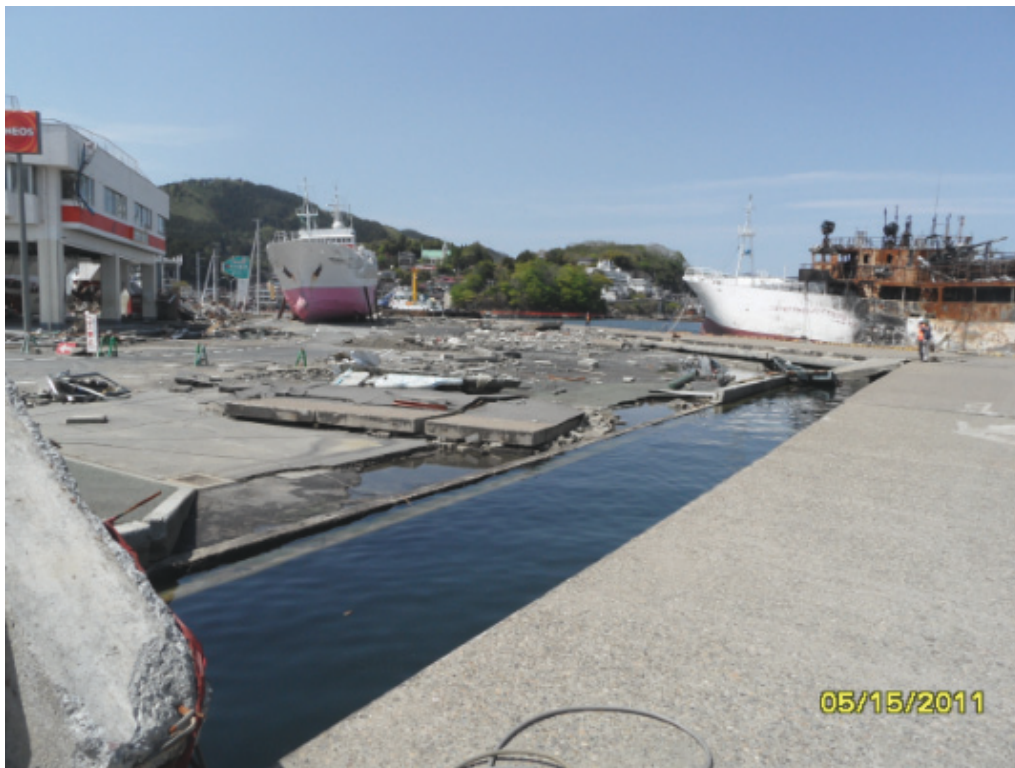
Figure 8-42 - Landside settlement at corner of Location 5 wharf

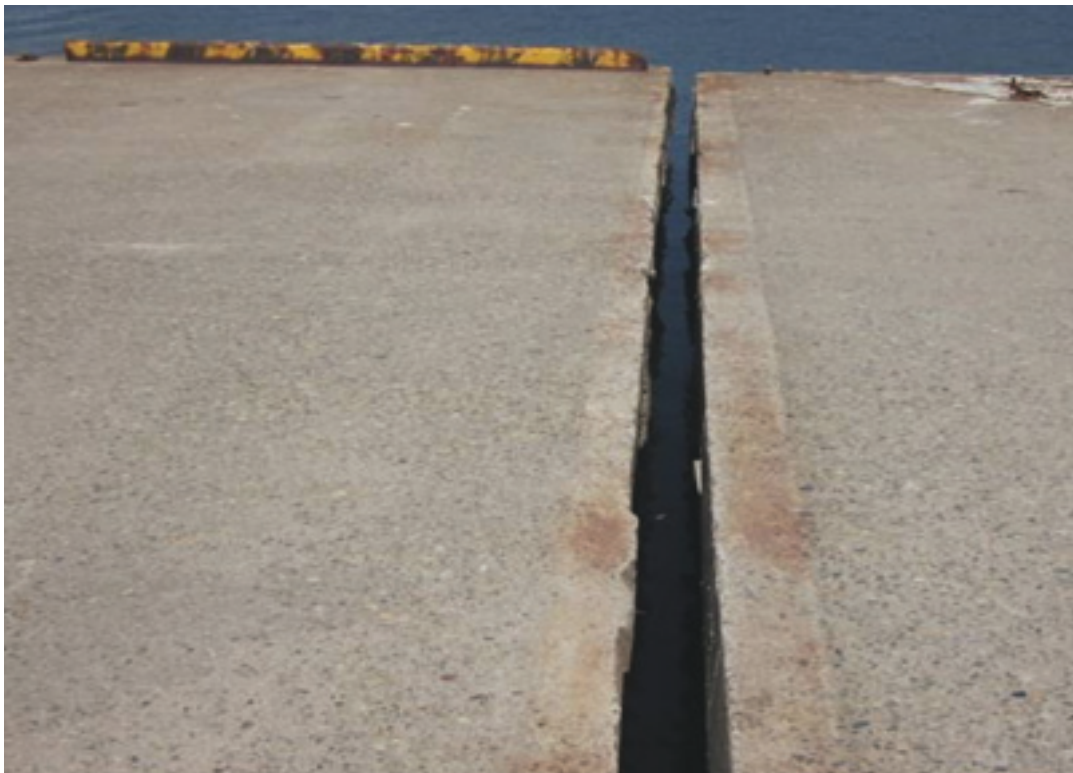
Figure 8-43 – Expansion joint separated 50 mm to 100 mm

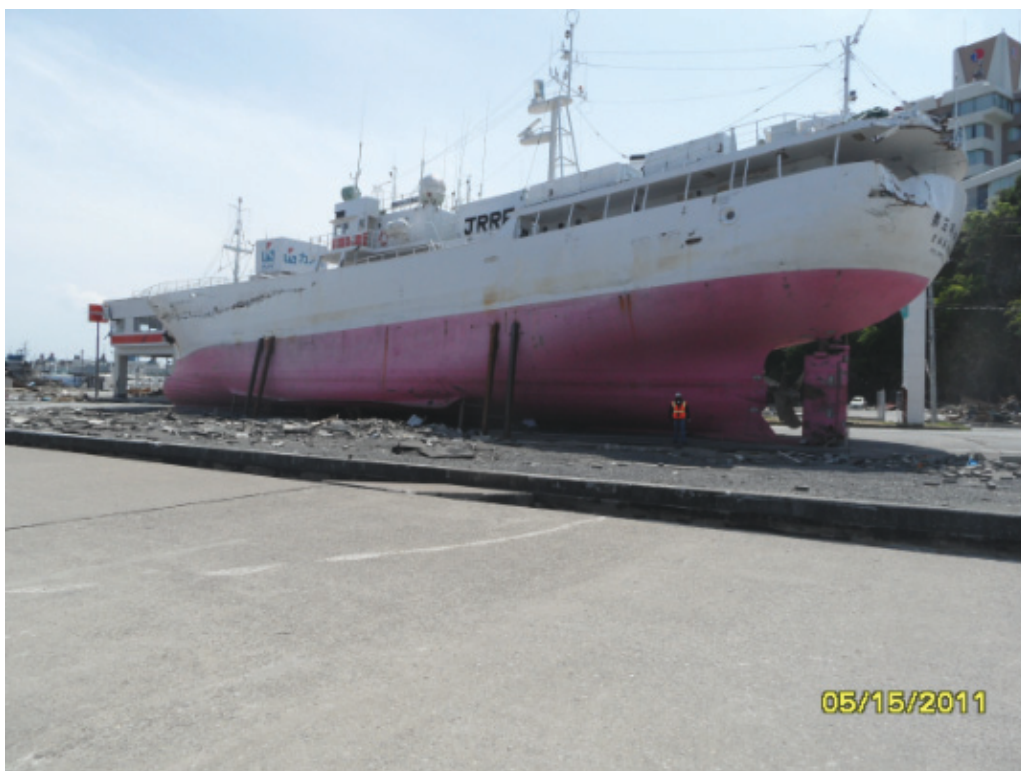
Figure 8-44 - Large vessel washed onto landside at northern end of Location 5 wharf

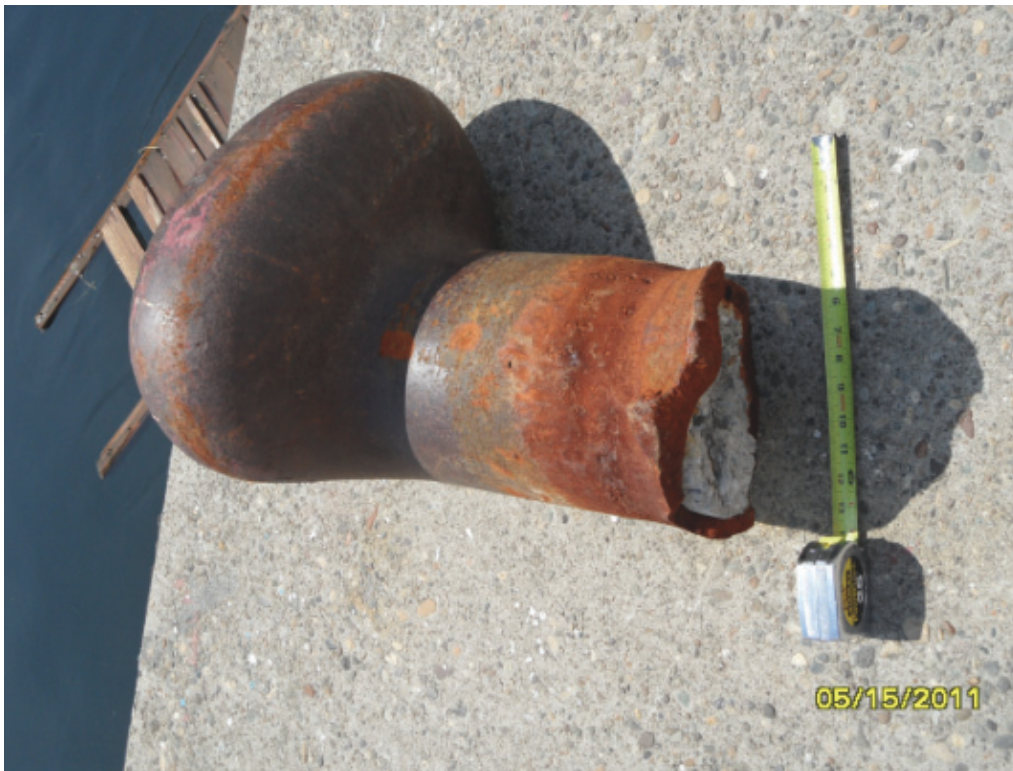
Figure 8-45 – Part of a ruptured bollard at northern end of Location 5 wharf

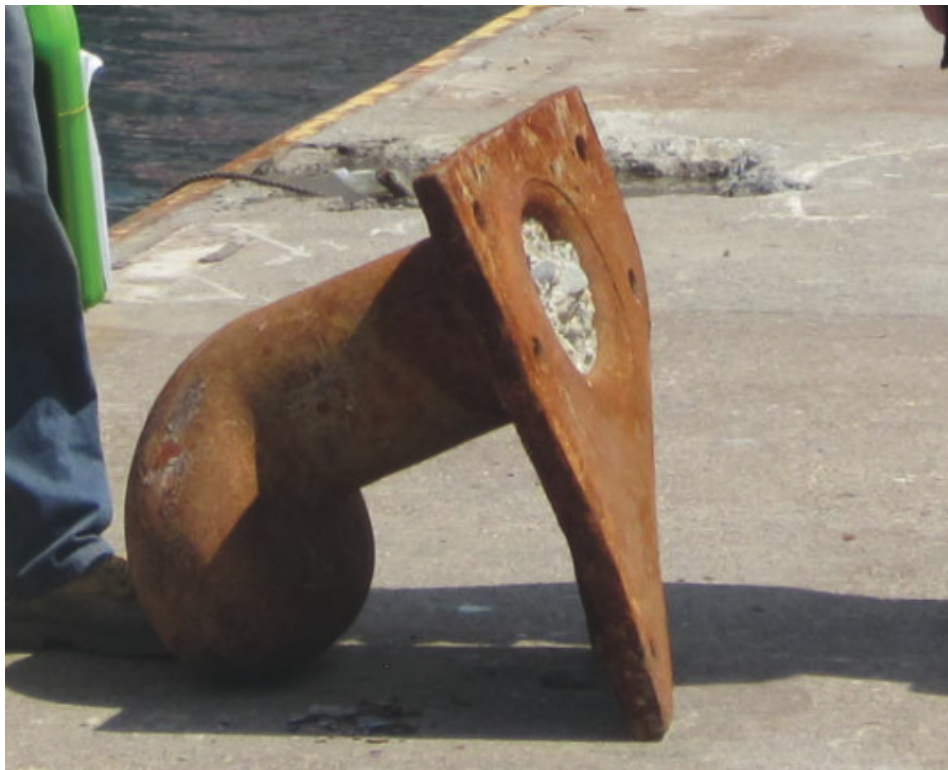
Figure 8-46 - Bollard with bent base plate at northern end of Location 5 wharf

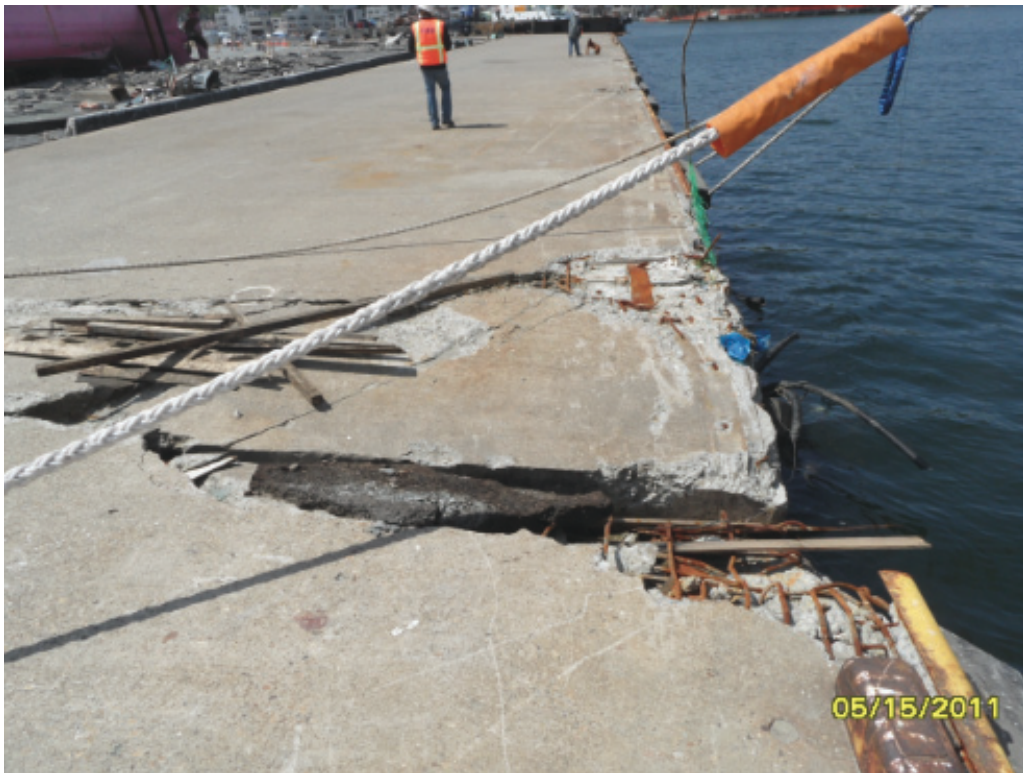
Figure 8-47 – Ruptured concrete anchorage for bollard at northern end of Location 5 wharf

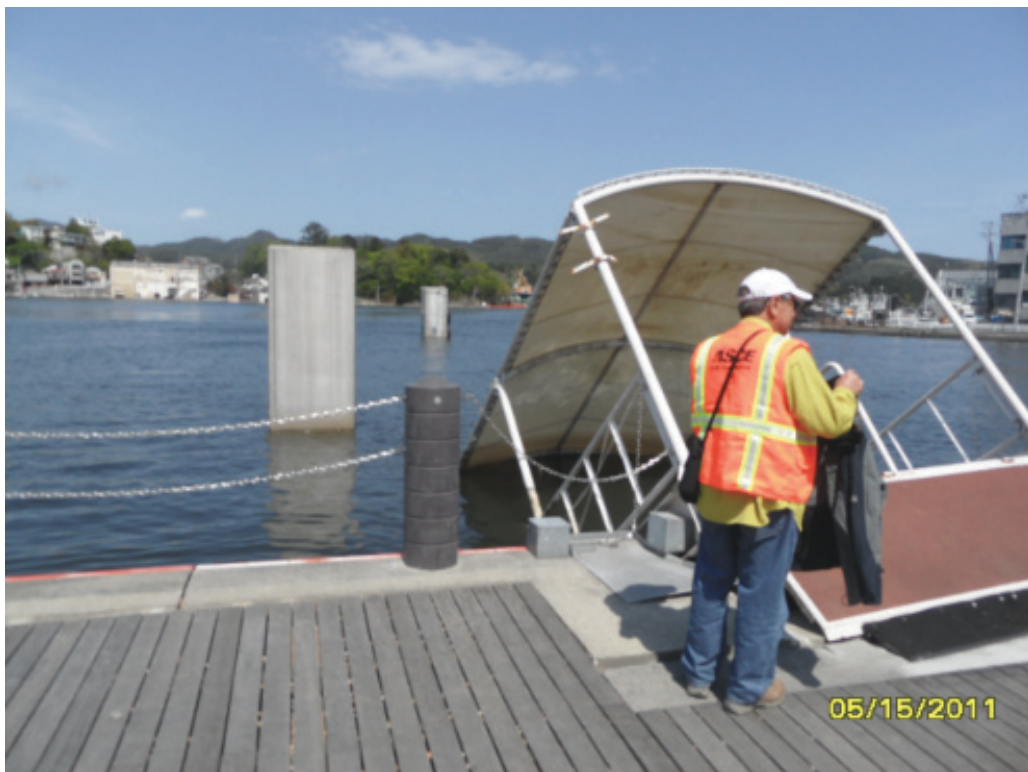
Figure 8-48 - Failed gangway and undamaged piles at Location 6 floating dock

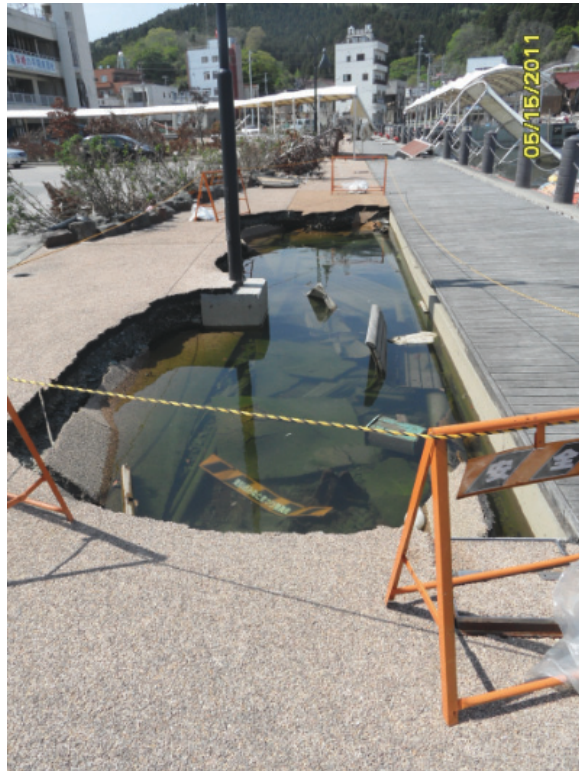
Figure 8-49 - Small area of Location 6 pedestrian wharf likely scoured away

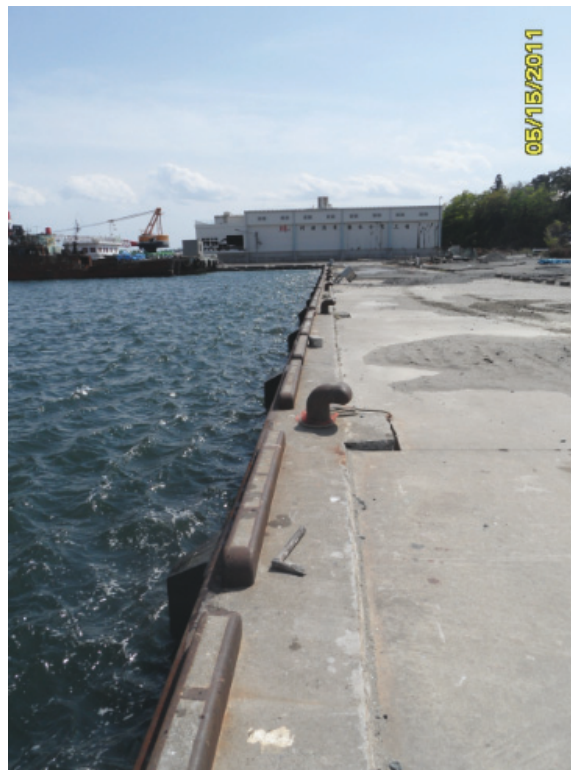
Figure 8-50 – Sheetpile wall wharf at Location 7 with limited settlement and no obvious movement

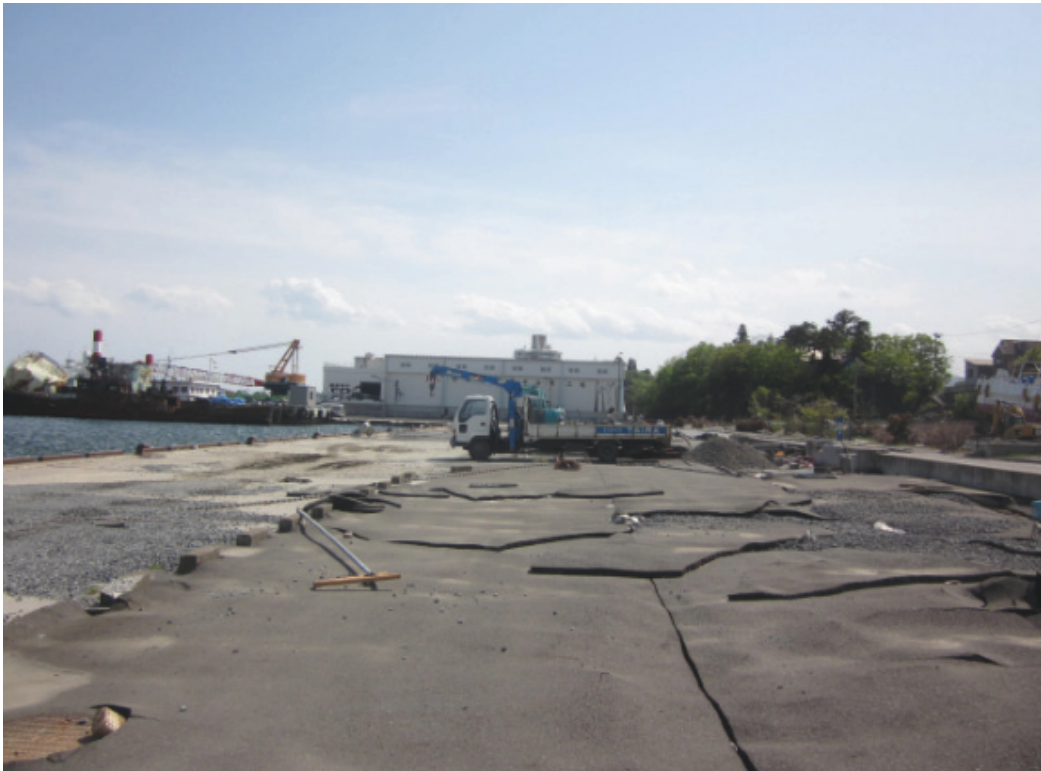
Figure 8-51 - Sheets of asphalt scoured from the deck surface at the Location 7 wharf

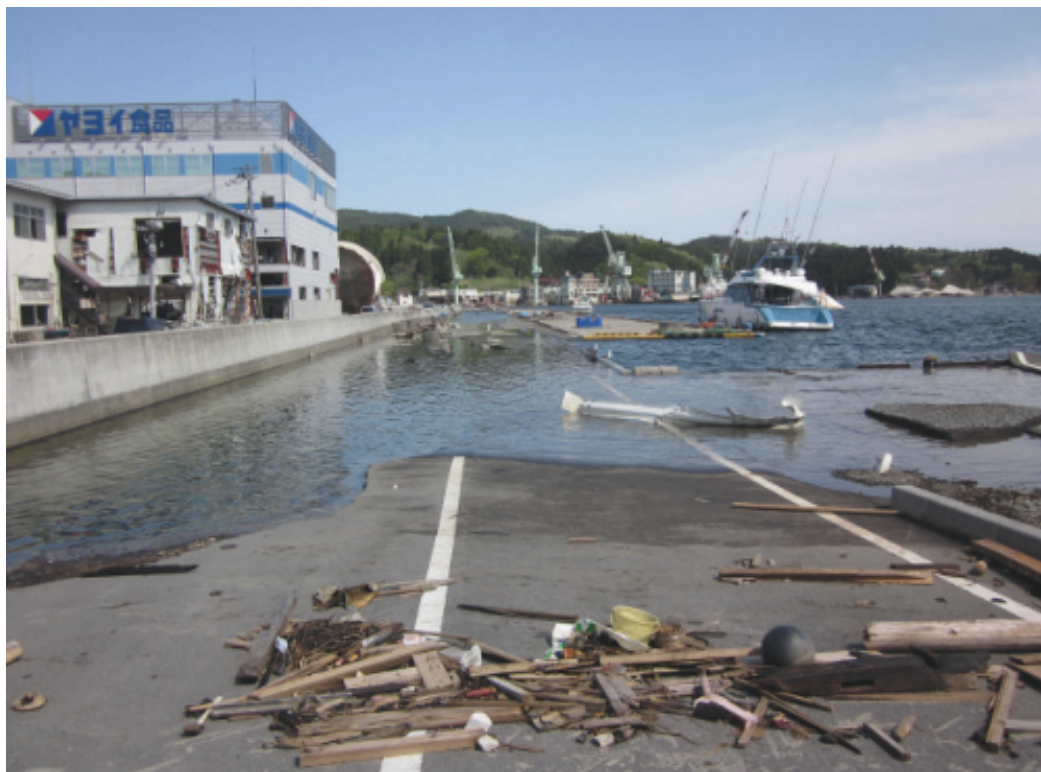
Figure 8-52 - Significant settlement behind gravity caisson wharf at Location 7

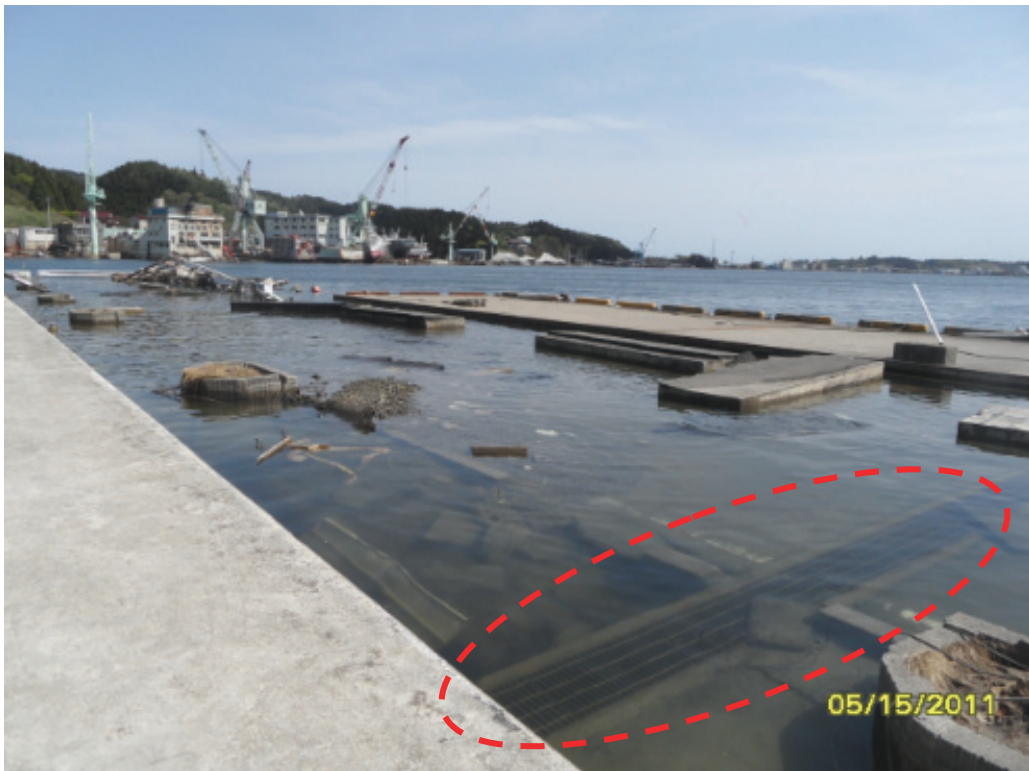
Figure 8-53 - Undamaged drainage grating and planters at backland settlement behind gravity caisson at Location 7

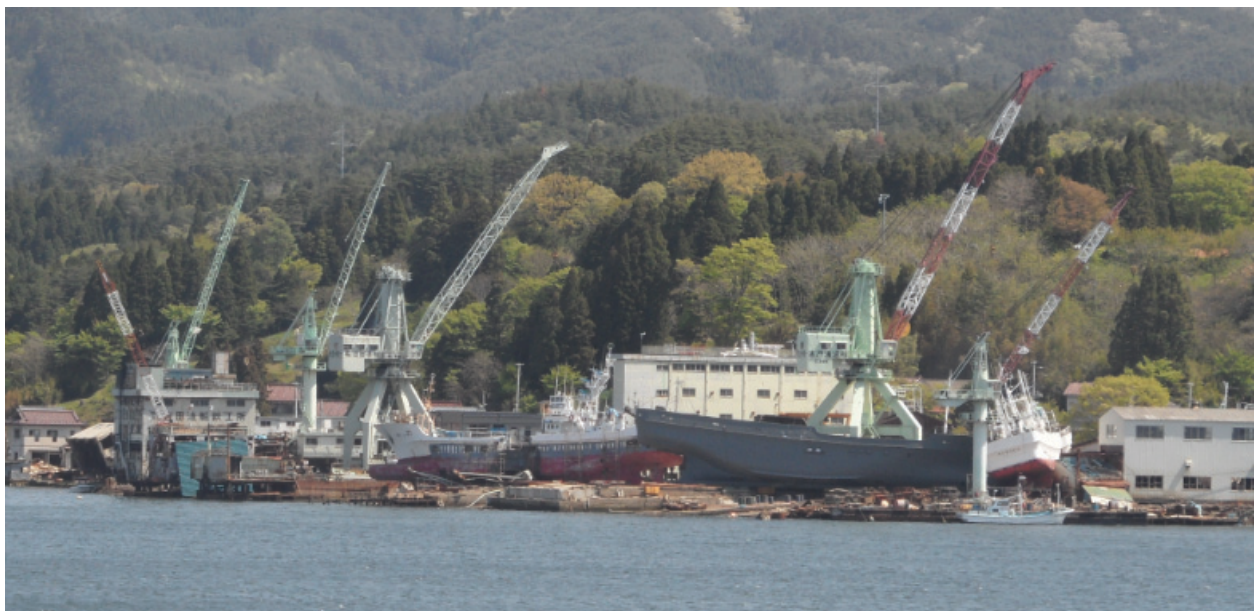
Figure 8-54 – Small shipyard with several cranes at Location 8

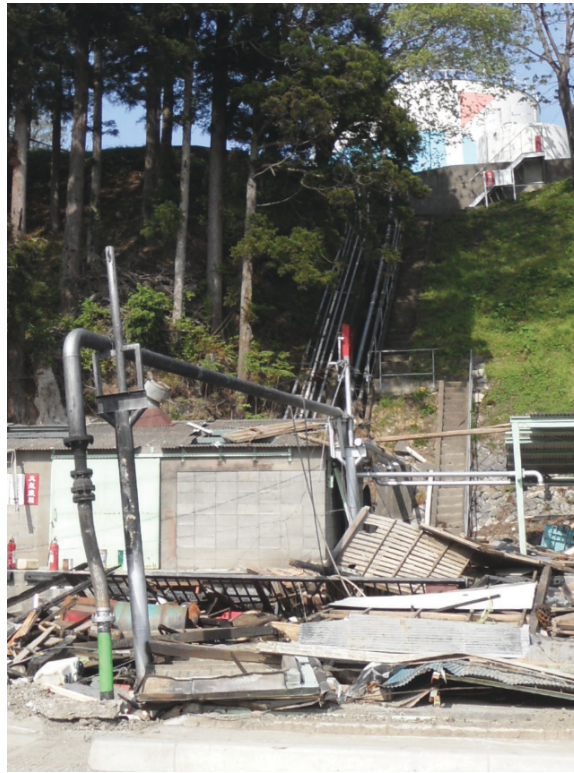
Figure 8-55 - Small bunkering facility South of Location 8
