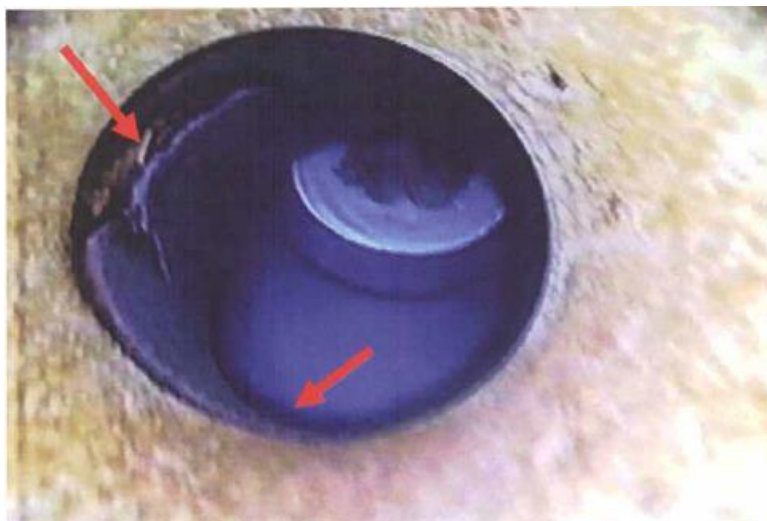
PHOTOGRAPH 1. Rupture in the Drain Pipe in Underdrain No. 2 at the Second Bend. (Hawkins, 2009)

Discussion of the 2008 camera inspection resulted in performing a follow-up camera inspection at the outlet works drains in 2009. Only outfall Nos. 1, 2, and 3 were able to be inspected at the outlet works for this exam. Outfall No. 1 was still clear at this exam. Outfall No. 2, where the rupture was observed in 2008, was now found to be filled with sand and gravel. Outfall No. 3, which had gravel deposits in 2008, was found to be mostly open. However, a new rupture was observed at one of the pipe bend fittings, exposing gravel. The dive team also noted a lack of algae on the concrete immediately downstream of the drain outfalls. This lack of algae indicates flow from the drain outfalls.

Based on the results of both exams, the dive team installed temporary plugs in the drain outfalls for both structures to halt particle movement at the end of the 2009 exam. During installation of the plugs at the spillway, new sand boils were observed immediately to the left of the stilling basin just upstream of the end of the walls. Detailed inspection of the sand boils indicated they were mounding approximately 3 to 4 inches of material. The drain plugs were removed to lower the groundwater in the drain system. When the drain plugs were removed, sand and gravel material accumulated behind the plug was discharged into the stilling basin. These exams and evidence were used to justify repair construction at Twin Lakes Dam.

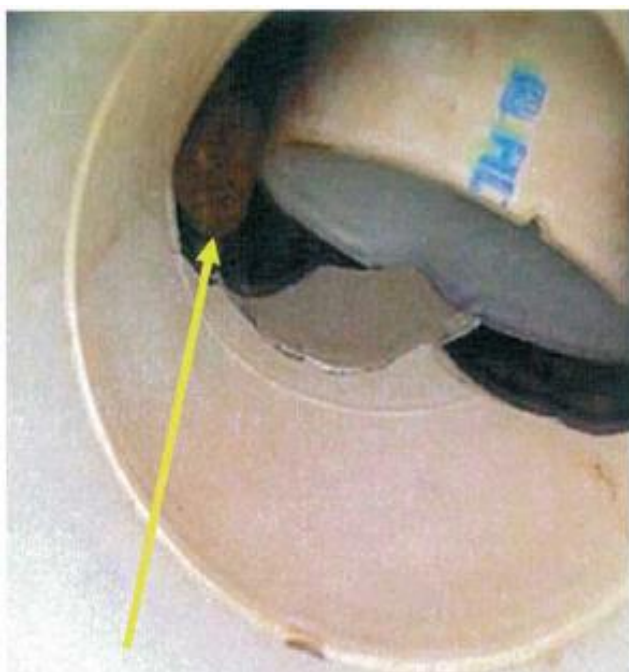
PHOTOGRAPH 2. Crushed Elbow at the Left End of the Spillway Stilling Basin Underdrain System. Arrow points to gravel observed outside the pipe. (Hawkins, 2010)

The spillway drains were also inspected during the 2009 exam. The spillway only has 4 drain outfalls, numbered 1 to 4 starting at the right wall (looking downstream). Outfall No. 1 was filled with fine sand soon after camera entry. A ½- to 1-inch-diameter hole in the pipe was observed just upstream of the filled pipe. This hole likely occurred during construction from equipment striking the pipe. Outfall Nos. 2, 3, and 4 were mostly clear with only localized sand and gravel observed in the pipe. In each of these pipes, the camera was able to enter the first cross-drain pipe. A vertical pipe at the end of this cross-drain pipe was found to have been forced through the elbow connection, shattering the pipe and exposing gravel outside the pipe as shown on Photograph 2.

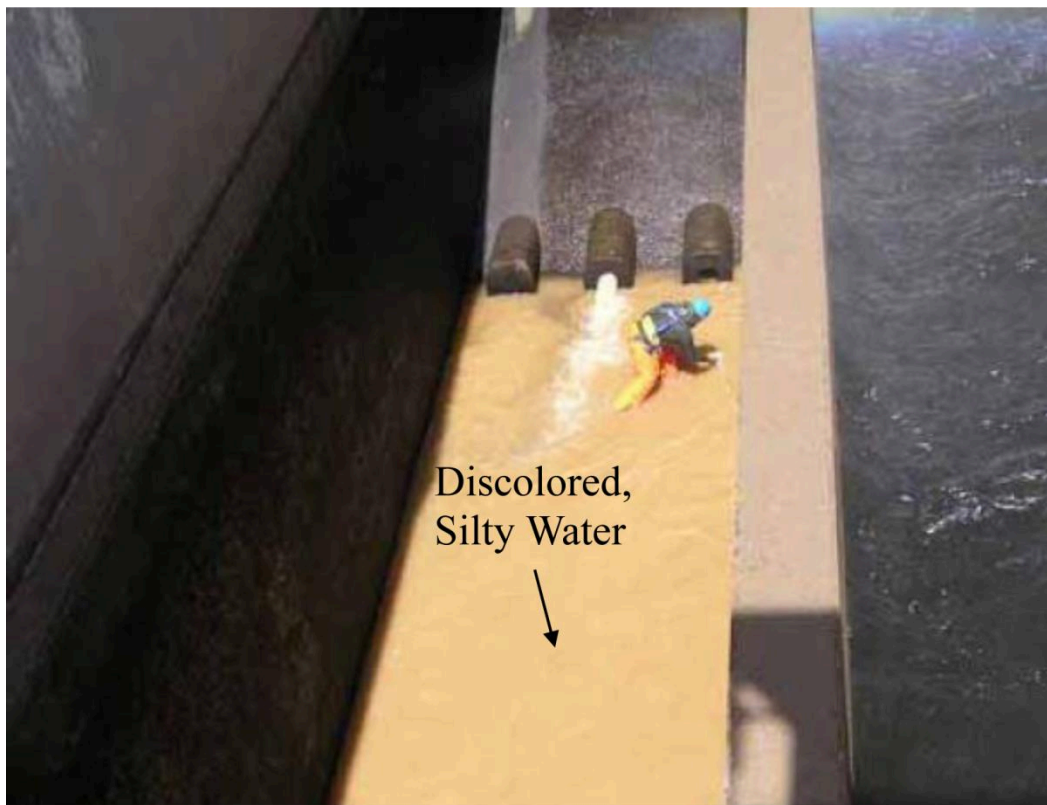
PHOTOGRAPH 3. Silty Water Entering the Right Side Outlet Works Basin at Sugar Loaf Dam Following the Removal of Temporary Drain Plugs. Also note the significant amount of flow from the drain under the chute. (Pytlik, 2005)

The first signs of distress at Sugar Loaf Dam were observed during an outlet works concrete examination in 2005. For this 2005 exam, the concrete in the chute and stilling basin was inspected following dewatering of the basin. Temporary plugs were installed in the structure drain outfalls to allow the basin dewatering. The concrete in the stilling basin was found to be eroded up to 2 inches deep, downstream from the chute blocks to approximately the midpoint of the stilling basin. A minor amount of undulation of the concrete erosion was observed. Following removal of the temporary plugs at the drains, silty water discharged from the drain system as shown on Photograph 3.

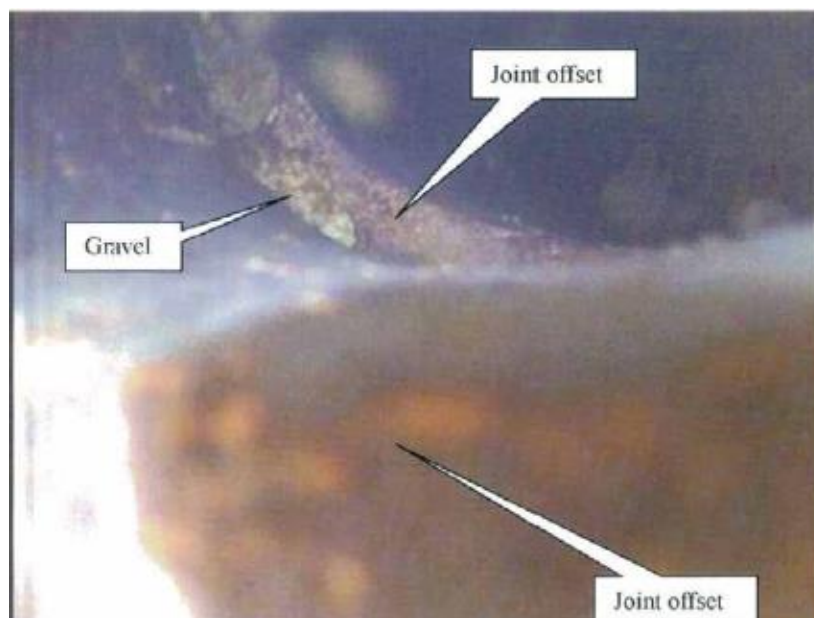
PHOTOGRAPH 4. View of Offset Joints in the Transverse Drain in the Sugar Loaf Outlet Works Drain System at Drain Outfall No. 4. (Hawkins, 2010)

The outlet works and spillway drain systems at Sugar Loaf Dam were inspected with the CCTV in 2010. At the outlet works, there are four drain outfalls in the chute blocks numbered 1 to 4 from the right stilling basin wall (looking downstream). Outfalls No. 1 and No. 4 are connected to the drain systems below the chute and outfalls No. 2 and No. 3 are connected to the drain systems beneath the stilling basin. At outfall No. 1, silty sand was observed in the pipe near the exit. This material became coarser, incorporating gravel, the further the camera traveled. After several feet of inspection, the camera encountered an offset joint in the pipe. The joint offset was significant enough to allow the entry of gravel-sized material into the pipe. The pipe at outfalls No. 2 and No. 3 were both completely filled with sand and gravel within a couple of feet of the exit. At outfall No. 4, the camera was advanced nearly the same distance as outfall No. 1 before encountering an offset joint. The offset joint appeared to allow gravel to enter the

pipe as shown on Photograph 4 and the camera could not be advanced past the joint. The source of the joint offsets is unknown but is likely related to settlement of the drain pipe and the outlet works conduit. Survey results from the outlet works conduit indicate conduit settlements up to 0.3 foot.

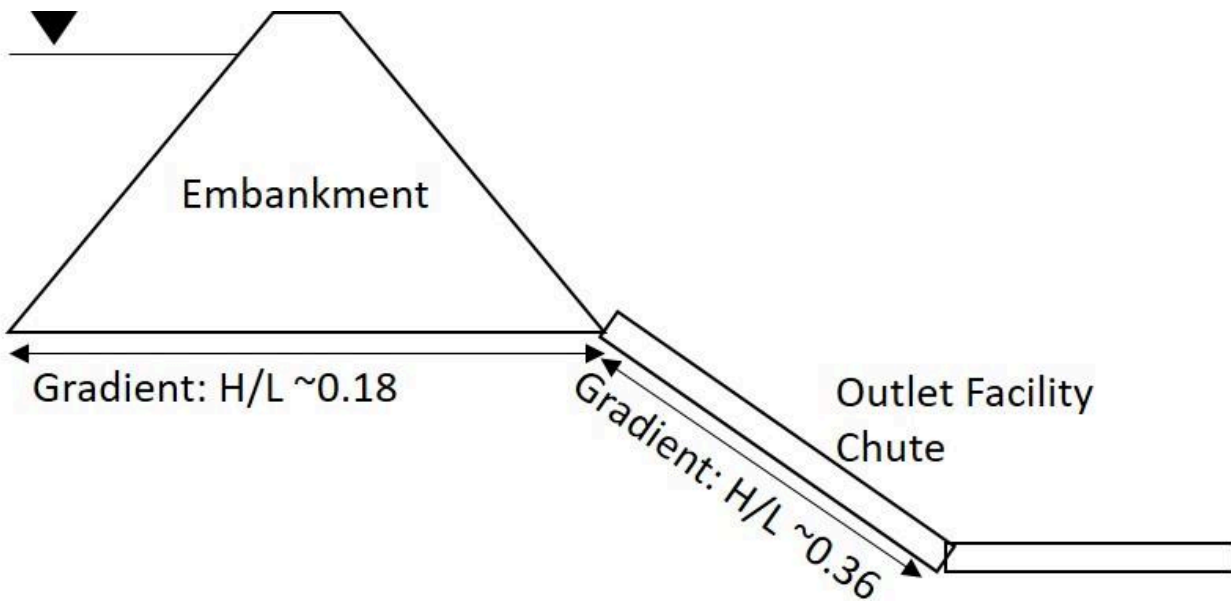
Alternately, the seepage at the structures can be subject to much higher gradients than seepage through the embankment. Seepage along conduits is a known concern, particularly at older structures (Federal Emergency Management Agency, 2005). For Twin Lakes and Sugar Loaf Dams, the seepage gradient through the embankments typically ranges from 0.18 to 0.19. It is probable that this seepage is forced under the chute structures of the outlet facilities. The chute structures at these dams range from 23 to 51 feet in height. The seepage gradient under the much shorter horizontal distance of the chute increases to 0.33 to 0.36 for Twin Lakes and Sugar Loaf Dams, nearly double the anticipated gradient through the embankments. This general relationship is shown on Figure 5.

FIGURE 5. General Relationship of Typical Gradient Values Through the Embankment Compared to Gradient Values at Outlet Facility Chutes With Elevation Drop.

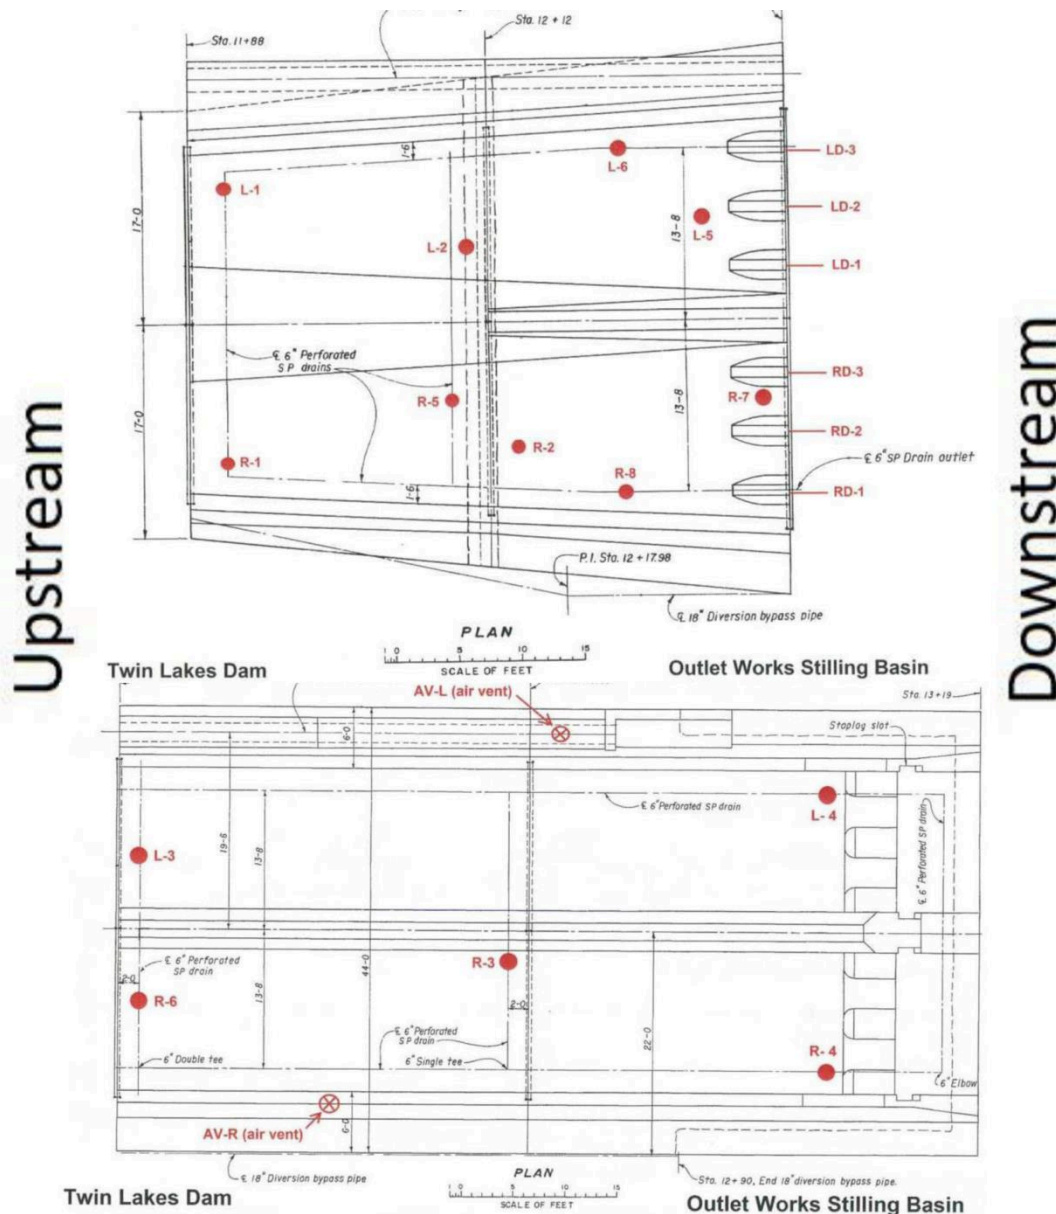
FIGURE 6. Boring Locations for Grouting Twin Lakes Dam Outlet Works.

and six borings were drilled through the left bay concrete as shown on Figure 6. Packers were installed in each boring following the drilling. At each boring, the crew used the presence of foam and PVC pipe in the drill bit to determine if they had intercepted the drain pipe. Out of the borings drilled, only R-5 missed the drain pipe while borings R-2, L-5, and R-7 were not located to intercept the drain pipes.

Water under pressure was encountered at all the borings in the bottom of the stilling basin and at the borings lower on the chute. This was a changed condition from the assumed conditions and increased the difficulty of installing the packers in each boring. Additionally, flows from borings L-2, R-2, and R-5 were cloudy and moved small amounts of sand and gravel, further evidence that material was exiting through the drain system. Voids of 0.55 foot and 1 foot were observed in borings R-7 and L-5, respectively.

The grout used had a water to cement ratio ranging from 0.6 to 0.7 by volume. Grouting was performed starting at the lowest boring, R-4, and proceeding upstream. At first, grout was pumped with all valves open. Typically, grey water was observed at the valves prior to observing grout. Open valves were closed once heavy grout was observed from any boring. This progression was used to grout from the downstream end of the stilling basin to the uppermost borings on the chute, R-1 and L-1. The grout takes at both of the uppermost borings were relatively low under higher grout pressures indicating that most, if not all, of the seepage paths beneath the structure from this point had been filled and grouting was completed at the outlet works structure.

For the outlet works, the total grout pumped through the system was 14 cy. The total estimated volume of the drain system pipes was 6 cy. Thus, approximately 8 cy of void volume was filled under the structure.

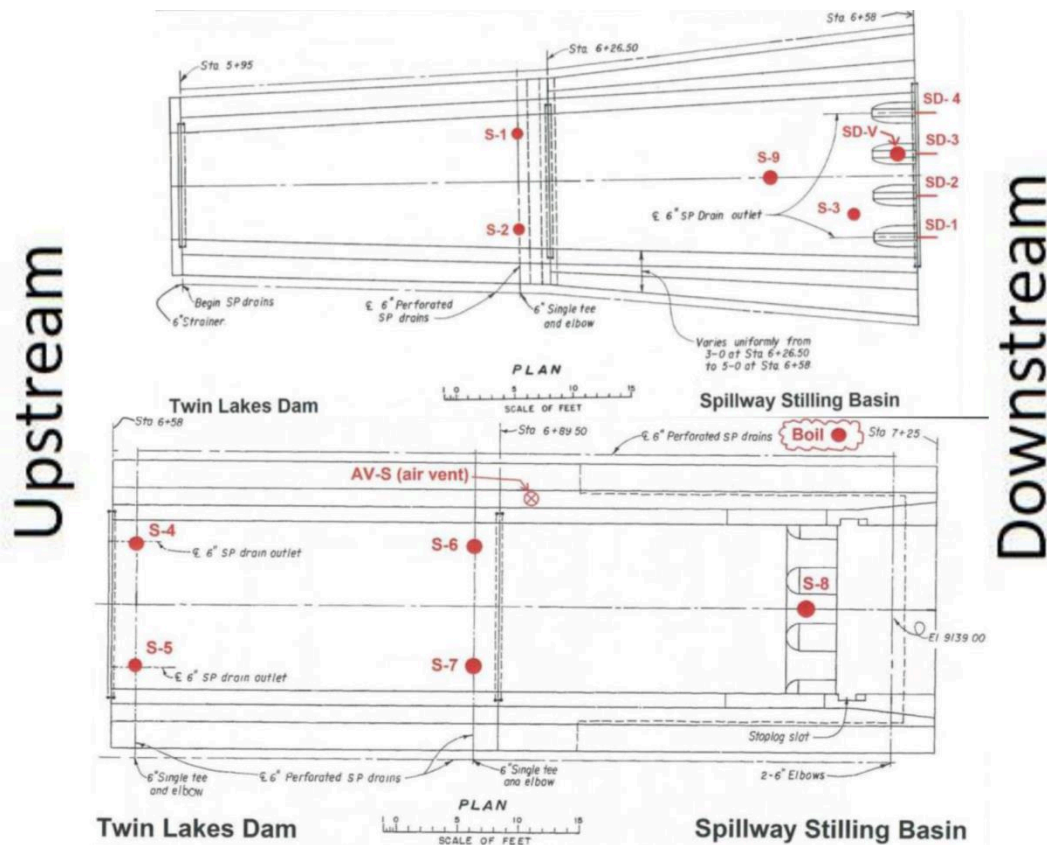
FIGURE 7. Boring Locations for Grouting Twin Lakes Dam Spillway.

Following the grouting at the outlet works, the construction shifted to the spillway structure. Ten borings were completed through the spillway chute and stilling basin concrete as shown on Figure 7. Packers were installed in each boring following the drilling. At each boring, the crew used the presence of foam and PVC pipe in the drill bit to determine if they had intercepted the drain pipe. Each of the borings planned to intercept the drain pipes was successful. Boring S-9 was completed to evaluate the presence of voids beneath the structure but no discernible void was found. Boring S-8 was located at the downstream end of the structure for initial grouting to slow any water flow through potential voids under the structure and to increase the probability that the remaining borings could be successfully grouted without washing out.

The dye testing was performed to evaluate the water flow directions under the structure. Blue dye was injected at boring S-1 (assumed to be the furthest upstream). Dye was observed at all the boring locations within 1 hour and 25 minutes. A small sand boil was located adjacent to the left spillway wall in the spillway stilling basin. Dye was observed at this sand boil 20 minutes after injection at boring S-1 as shown on Photograph 5. It was concluded that this is indication of a large void beneath the structure which was allowing water flow to pass directly from the upstream end of the chute to outside the stilling basin structure.

The grout used had a water to cement ratio ranging from 0.6 to 0.7 by volume. Grouting was performed starting at boring S-7 and proceeding upstream with the option to switch to S-8 if needed to slow water flow. At first, grout was pumped with all valves open except S-6 (due to proximity) and SD-3. Within 5 minutes of pumping grout, cloudy water was observed at the sand

boil adjacent to the left wall of the spillway stilling basin. Ten minutes later, grout was observed at the sand boil. From that point, grouting was moved to further upstream borings and followed the same protocol as grouting at the outlet works. The last boring grouted was boring S-8 at the downstream end of the stilling basin. Higher grout pressures and low take at this boring indicated grouting was complete.

For the spillway, the total grout pumped through the system was 13 cy. The total estimated volume of the drain system pipes was 6 cy. A dive inspection at the adjacent sand boil was performed and the estimated volume of grout ejected at the sand boil was 2 to 3 cy. Thus, approximately 4.5 cy of void volume was filled under the structure.

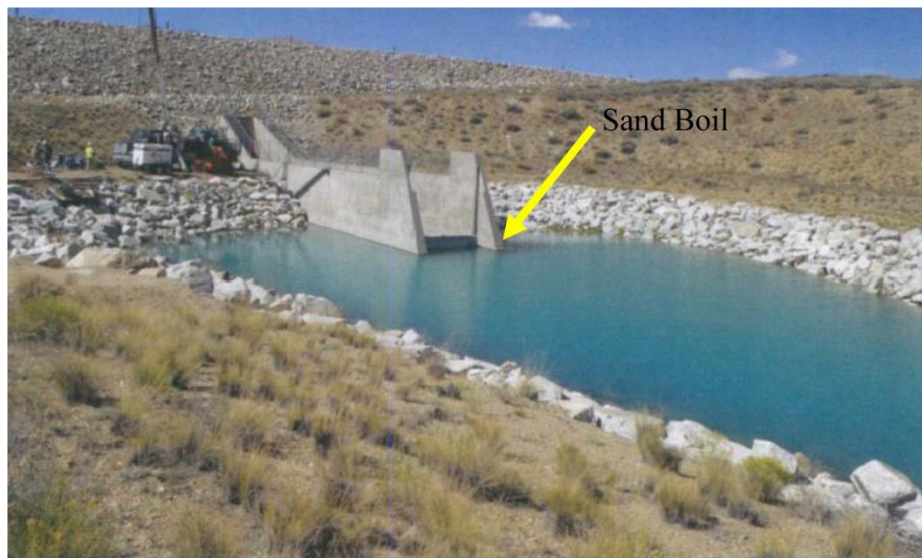
PHOTOGRAPH 5. Water in the Spillway Pool Dyed Blue Through Seepage at a Boil Adjacent to the Spillway.

Following the grouting, each boring was dry packed with concrete. The drain outfalls were also filled with concrete using a plywood hopper. The sand boil adjacent to the spillway was inspected following the grouting and the seepage at this location had stopped. However, some increased seepage was observed at other areas around the spillway, indicating seepage had found new paths near the structure. The frequency of visual inspection and instrumentation monitoring at the dam has been increased to twice weekly when the water is below the spillway crest and daily when the reservoir is spilling to monitor for any additional changes in the seepage at the facility.
