REPAIR & REHABILITATION II

Rooftop Plaza Rehabilitation

Repair Method for Salt-Damaged Reinforced Concrete Structures

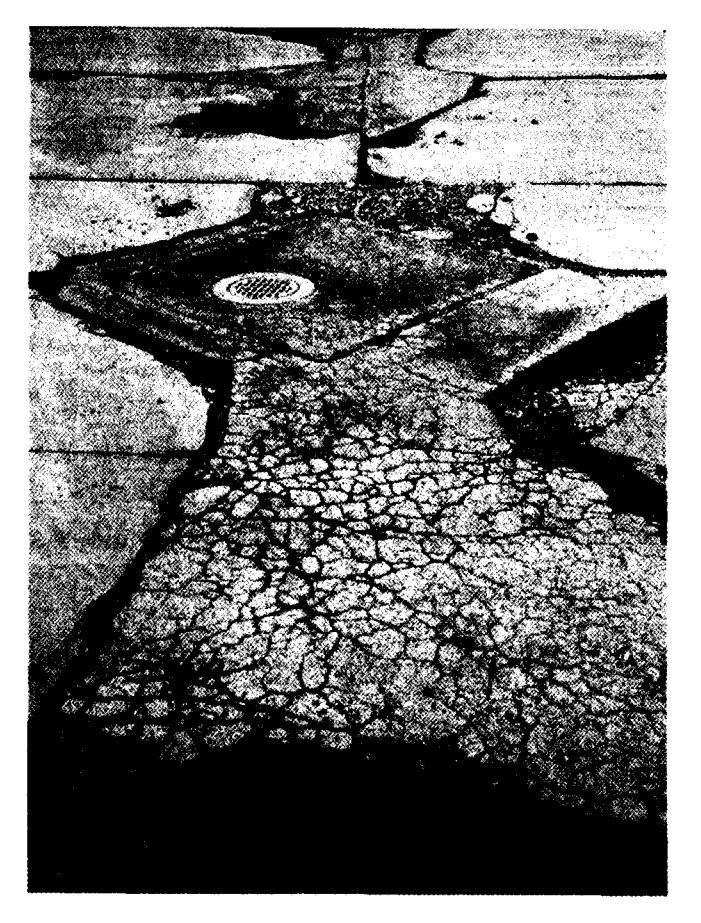
The study of the parking slab included visual observations, materials evaluation, nondestructive testing, and a review of original construction documents and field reports. Results indicated that the principal deterioration mechanism was the saturation of concrete surfacing caused by poor drainage along the interface between concrete topping and insulation. This led to damage by frost action that was so severe that many of the joint seals were rendered useless by the third and fourth winters.

(left) Original condition of parking slab. (above) Suitability of the filter/separation layer in the drainage net system was evaluated in a trial installation.

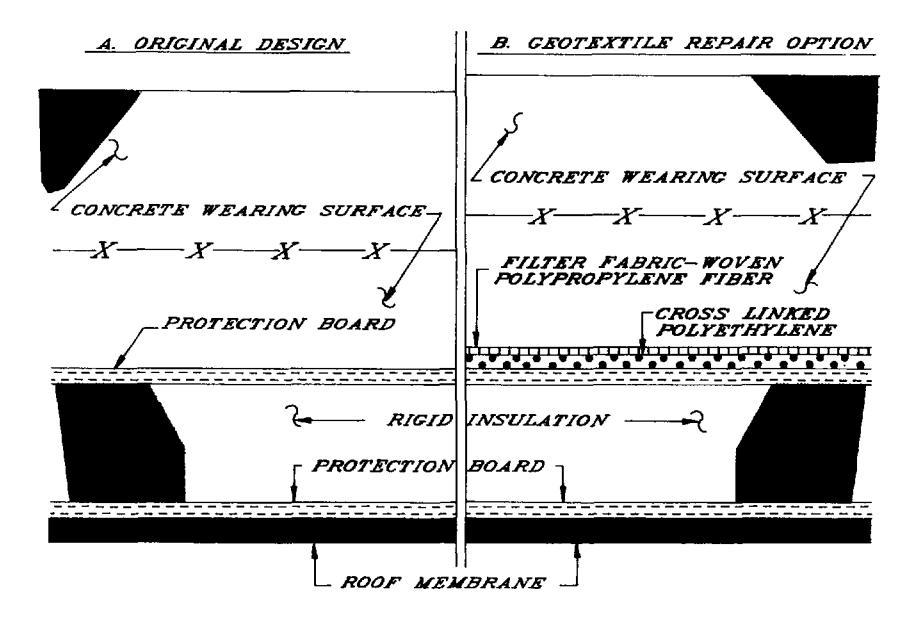
Fig. 1—Schematics comparing original design with geotextile repair option.

After reviewing the available data, including cost factors, the geocomposite drainage system was selected. The system was tested for flow capacities, load characteristics, and unrestrained or low topping/net slip potential. A polyethylene geonet was chosen for the underdrain with a polypropylene woven sheet for a slip sheet and separation layer immediately beneath the concrete (Fig. 1).

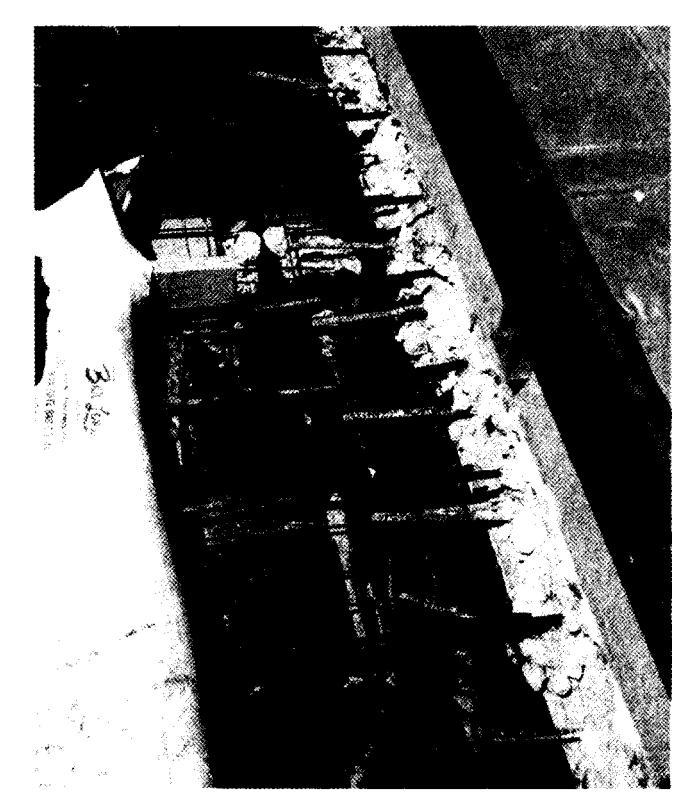
Damage to concrete parapet walls at the base of the slab was also found at isolated locations and a special closure detail was worked out to tie the new topping slab system to the existing parapet wall without unnecessarily damaging or disturbing the wall, which carried the building facade. Salvaging the existing wall realized considerable cost and time savings, while maintaining the building's outward appearance.

(bottom right) Damage to concrete parapet walls required a special closure detail to tie the new topping slab system to the wall.
