Defects, Damage, and Repairs Subject to High-cycle Fatigue: Examples from Wind Farm Tower Design

Nestor A. Agbayani, P.E., S.E., SECB, M.ASCE

Abstract

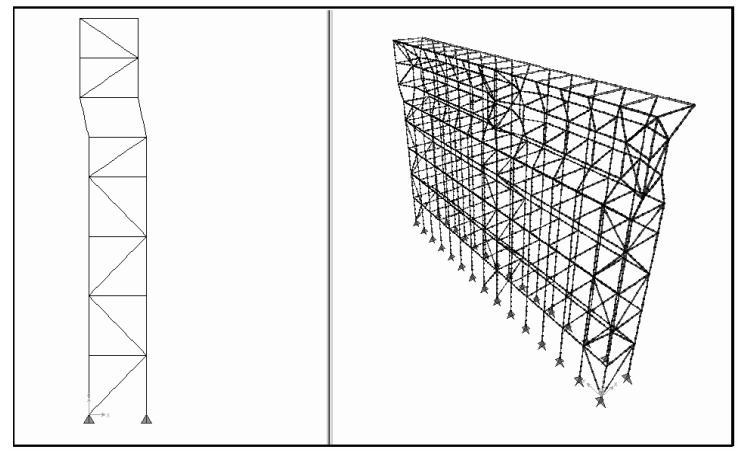
Figure 9. The supporting structure strip with inadequate lateral bracings.

- The lateral bracing for vertical scaffolding piers particularly in the 3-meter-high lower piers was performed inadequately and also diagonal elements were not used properly.

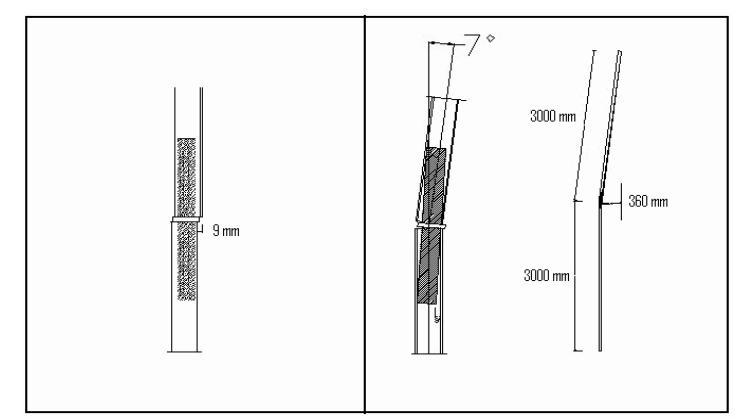
Figure 10. Relative rotation and resulted out of plumb between upper and lower elements in the joining location of piers.

- The use of a 32-milimeter-diameter steel bar to join the scaffold tubes with 44 mm internal diameter led to a 360-milimeter horizontal displacement for every 3-meter vertical pier and creation of P-Delta effects in these elements.

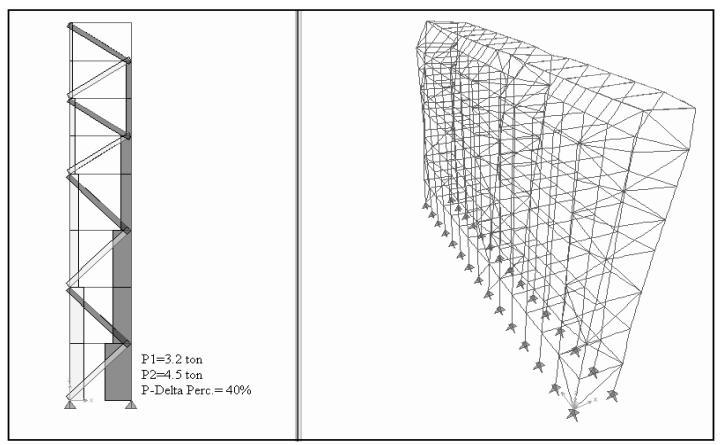
Assessment of P-Delta effects in the scaffolding piers. P-Delta is a non-linear effect that occurs in every structure where elements are subjected to axial loads. As structures consist of more slender and less resistant to deformation elements, the necessity of considering the P-Delta effects increases. Since the magnitude of P-Delta effects is related to axial loads as well as slenderness of individual elements, it seems that investigation of this effect in the accident of Bojnourd cement project would be valuable. As mentioned, the use of steel bars as connectors with diameter smaller than the internal diameter of scaffold tubes can be considered as a weak point during the formwork collapse. As it can be seen in Figure10, the relative rotation and resulted out of plumb about 7 degrees between upper and lower elements in the joint spots due to existence of the void space can lead to a 360-milimeter horizontal displacement from vertical axe for every 3-meter-high vertical pier; this can cause increase of internal stresses in elements or P-Delta effects due to vertical and horizontal loads. Therefore, corresponding P-Delta effects in the braced structure elements even in absence of lateral loads can result in decrease of elements strength in compression and formation of buckling in several elements situated in the lower elevations of the supporting structure. Thus, in order to investigate the P-Delta effects, one of the scaffolding strips has been modeled under applying only the vertical loads and relating effect of the 360-mm displacement occurred between two adjacent 3-meter-high piers. It was illustrated that the lower elements of the piers which support a 3.2-tone axial load in the common state, experience an axial load about 4.5 tones in case of this eccentricity existence (see Figure 11). Since the comparison of the results of two analyses, with and without P-Delta, illustrates the magnitude of the P-Delta effects (Rutenberg, 1982), for the mentioned structure with these improper connections, the contributions from the P-Delta effects are highly amplified and can change the internal forces by 40 percent or more. Consequently, this increase in displacements and internal forces could be one of the main causes of the formwork collapse.

Figure11. P-Delta effect on the internal compressive forces of a supporting pier.

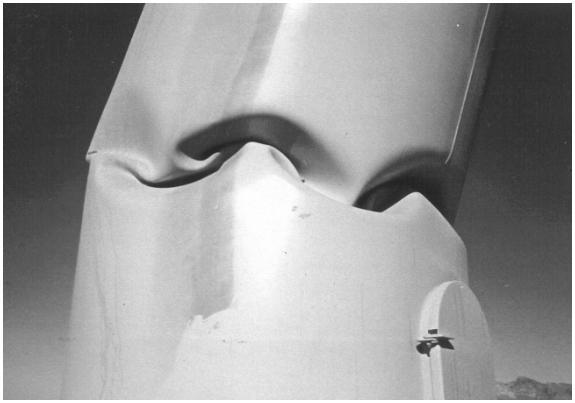
Turbine "Runaway." Near or total tower collapse can be caused by turbine "runaway," which is a condition of uncontrolled turbine rotor overspeed. The typical

scenario starts with a mechanical or electrical failure in the turbine's rotor braking systems. For example, the failure of a turbine's lightning protection system might leave other electrical systems susceptible to failure after lighting strike. Excessive blade rotation speed breaks off a turbine blade, resulting in both a blade projectile and a large magnitude eccentric rotor loading condition. By chance should the projectile miss the tower, the remaining blades can strike the tower due to the unexpected rotor deflections from the eccentric loading. Figure 3 shows a tower with local buckling damage due to a runaway turbine scenario.

Figure 3. A tubular tower with local buckling failure after a turbine overspeed condition due to lightning strike. (Photograph courtesy of MSKA.)

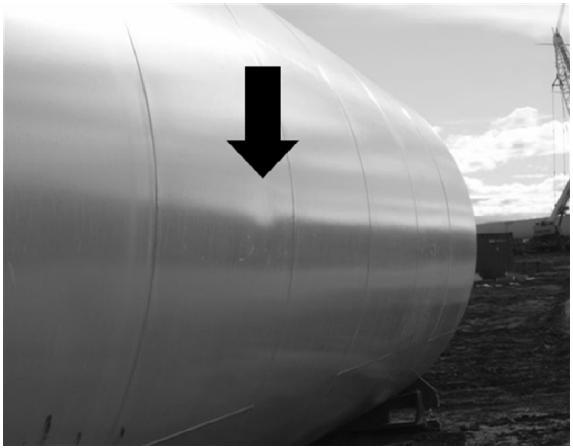
Tower Wall Dents. Towers occasionally are dented by mishandling or accidents during fabrication, transport, or erection. See Figure 4. Excluding fatigue failure and connection failures, the most likely design limit state (or failure mode) for a tubular tower structure is local buckling of the tower shell. See Figure 3. For this reason, a dent in a tubular tower shell is considered a serious problem, because a dent is like

the onset of a local buckle. With a dent, the very condition that the structural design attempts to avoid has already occurred. According to Troitsky (1990):

Figure 4. Dent in tower shell. (Photograph courtesy of MSKA.)

For these reasons, dents in the tower wall should be limited in size to that allowed by defined fabrication tolerances. Dent tolerances are found in various European standards such as DIN 18800. Should a dent's size exceed tolerances, then a repair is necessary. Repair involves the careful pushing out of the dent until it is either removed or at least until the dent's size is reduced below maximum tolerances. Where a dent affects a main tower weld, the weld is subject to NDT inspection after the dent repair.

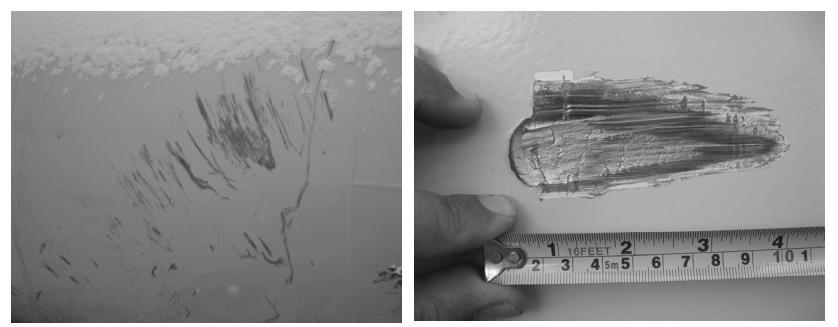
Tower Wall Surface Defects. Wall surface scratches, indentations, and gouges may result from accidents or mishandling. See Figure 5. Other examples of surface defects include: identification marks by physical indentation; miscellaneous streak indentations from unknown contact or rubbing; intentional fabrication marks; rolling marks, etc. While they may seem insignificant from the standpoint of tower ultimate

Figure 5. Scratches (left) and severe gouge (right) on tower wall. (Photographs courtesy of MSKA.)

strength, surface defects have the potential to be locations of fatigue crack initiation, so these otherwise minor defects are considered to be a serious problem when subject to high-cycle fatigue. At the very least, the small surface defects should be ground smooth to prevent stress-rising notch effects. Plate defect tolerances are usually based on engineering judgment informed by plate defect limits such as found in ASTM A6 or weld notch/undercut defect tolerances as found in AWS (2004). For deeper defects, base metal repair by welding is an option. However, in light of the high-cycle fatigue environment, repair by field welding should be considered a last resort and undertaken with great caution. The possibility exists that a low-quality repair by field welding may result in the weld material itself cracking or acting as an even larger notch. To prevent the "fix" from being worse than the problem, a repair procedure and welding specification should be developed in consultation with an expert welding engineer who can address weldability issues.
