A Study on Behavior of Ductile Iron Earthquake Resistant Pipeline in the Deformed Road at the 2011 Great East Japan Earthquake

Kiyoshi Kobuchi¹ and Nobuo Fujita²

ABSTRACT

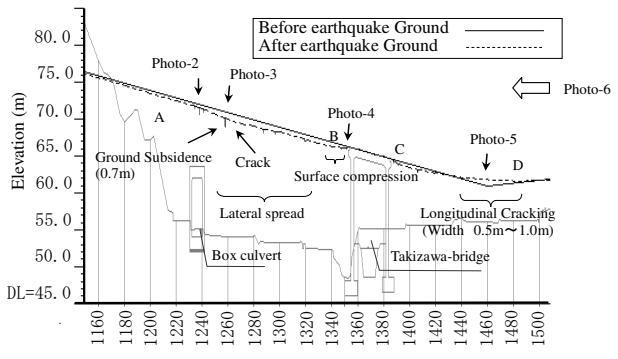
Figure 2. Ground elevation.

Figure 2 shows the ground elevations of the road embankment before and after the earthquake event. This road embankment has a 5% gradient.

As described below, the road embankment was damaged during the earthquake from surface cracks, subsidence, and lateral spreading of the embankment for over approximately 300m. There was a box-culvert, and a Takizawa-bridge in the damaged embankment.

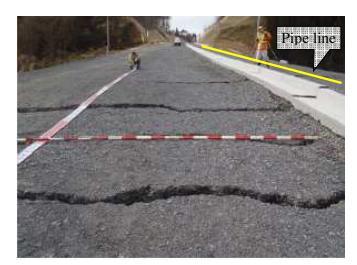
Photo 2. Transverse cracking OP. 1230m.

(1) A-B section in Figure 2. Regarding the road embankment, transverse cracking has been generated in the surface of earth fill beside the upper part of box culvert (Photo 2).

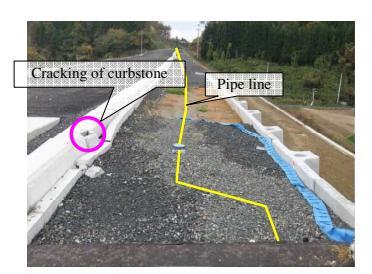
Photo 4. Compression of ground OP. 1350m.

Additionally, longitudinal cracking has been generated at a location about 30 m downstream of the box culvert, accompanied by ground subsidence of 0.7 m and lateral spread in the face of slope (Photo 3). On the other hand, it was found that cracking of curbstone occurred next to the Takizawa bridge (point B in Figure 2) (Photo 4), and the ground surface was compressed.

On the other hand, while the compression of the road embankment surface took place near the area about OP.1350 m, the result shows that the pipeline contracted to follow such displacement. Therefore, in the A-B section, localized expansion of joint was generated in the upper part of slope, and localized contraction of joint was generated in the lower part of slope.

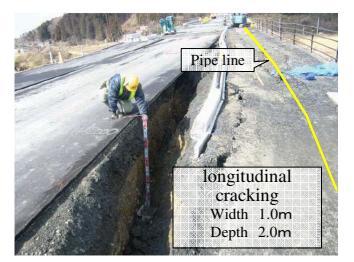
Photo 5. Longitudinal cracking OP. 1460m.

about OP.1460 m. Thus, the ground has exhibited displacement behaviors in the direction to restore the original flatness. Additionally, lateral displacement with a transverse cracking of $0.5 \sim 1.0$ m in width had also been generated at OP.1420 \sim 1480 m (Photo 5).

Moreover, in the C-D section, longitudinal cracking of 0.5 m or more occurred near the area about OP.1420 m \sim 1480 m. The joint located near the crack corresponding to this also shows regionally the maximum amount of expansion.

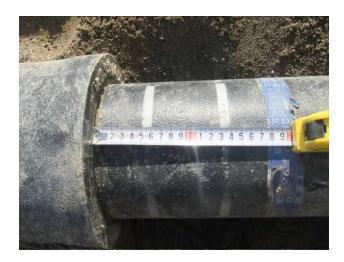
Photo 7. Survey situation OP. 1230m.

(4) Length of pipe. The length of each pipe was obtained from the as-built drawings for this work. Photo 7 shows the example of joint measurement situation. We found out that the expansion amount of the joint was approximately 50 mm.

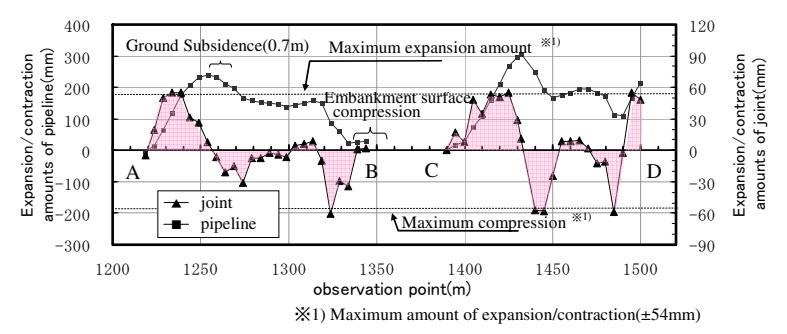
Figure 4. Expansion/contraction amounts of pipeline and joint.

(1) Longitudinal displacement of joint and pipeline. Figure 4 shows the expansion/contraction amounts of joint and pipeline, respectively. The pipeline expansion amount was obtained by Equation. 3 based on the joint expansion amount.

Three consecutive joints near the point OP.1230 m had reached the maximum expansion amount (Figure 4). Additionally, although the road embankment ground has shown subsidence up to 0.7 m near the area about OP.1260 m, the pipeline has also expanded to follow the displacement of road embankment.

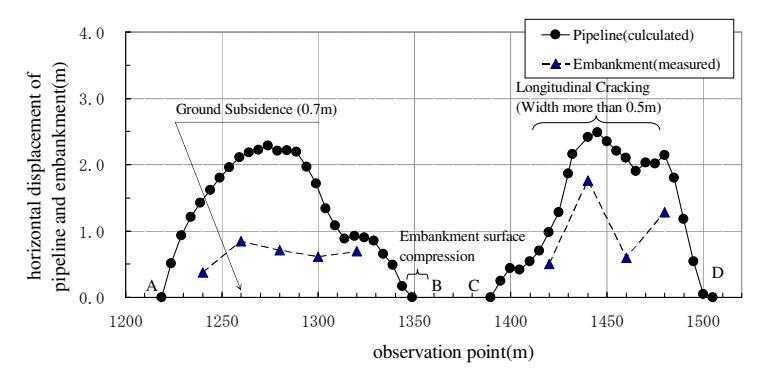
Figure 5. Horizontal displacement of pipeline and embankment.

(2) Horizontal displacement of pipeline and embankment. Figure 5 shows the displacement of pipeline and embankment in horizontal direction. The displacement of pipeline was obtained by Equation 4, which calculates the amount of displacement in horizontal direction with reference to the original location. The displacement amount shown in Figure 5 is corrected as the displacement for points A and D where the ground displacement are small and for points B and C where pipelines are connected to structures and displacements are assumed to be zero.

Moreover, Figure 6 shows the embankment before and after earthquake. In Figure 5, the horizontal displacement of embankment indicates the combined displacement of top of slope. At any observation point, the displacement of pipeline is larger than that of top of slope. Even at the observation point around OP.1440m where the displacement of embankment was maximum at 1.7m, it was found that the ERDIP had followed.

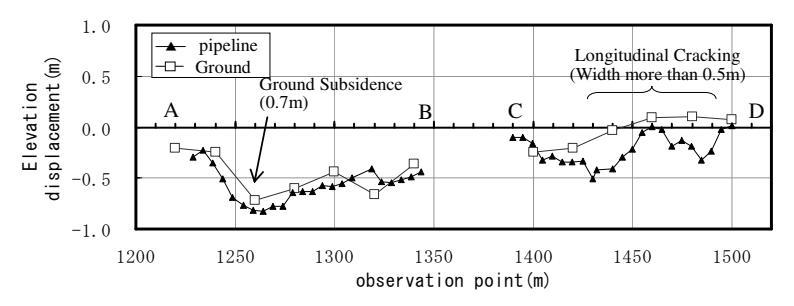
Figure 7. Vertical displacement after earthquake.

(3) Elevation amount of pipeline and ground. Figure 7 shows the vertical displacement of pipeline and ground after the earthquake. The vertical displacement of pipeline coincides with the ground displacement where subsidence and upheaval occurred after the earthquake, with the exception of some sections. Therefore, it is understood that the pipeline followed the ground deformation of road embankment. Especially in the A-B section, the pipeline displacement was practically the same as that of the ground. In the C-D section there is some difference between them. We considered that the difference was caused by the fact that not only ground subsidence, but also longitudinal cracking occured.
