Ancoa Substation

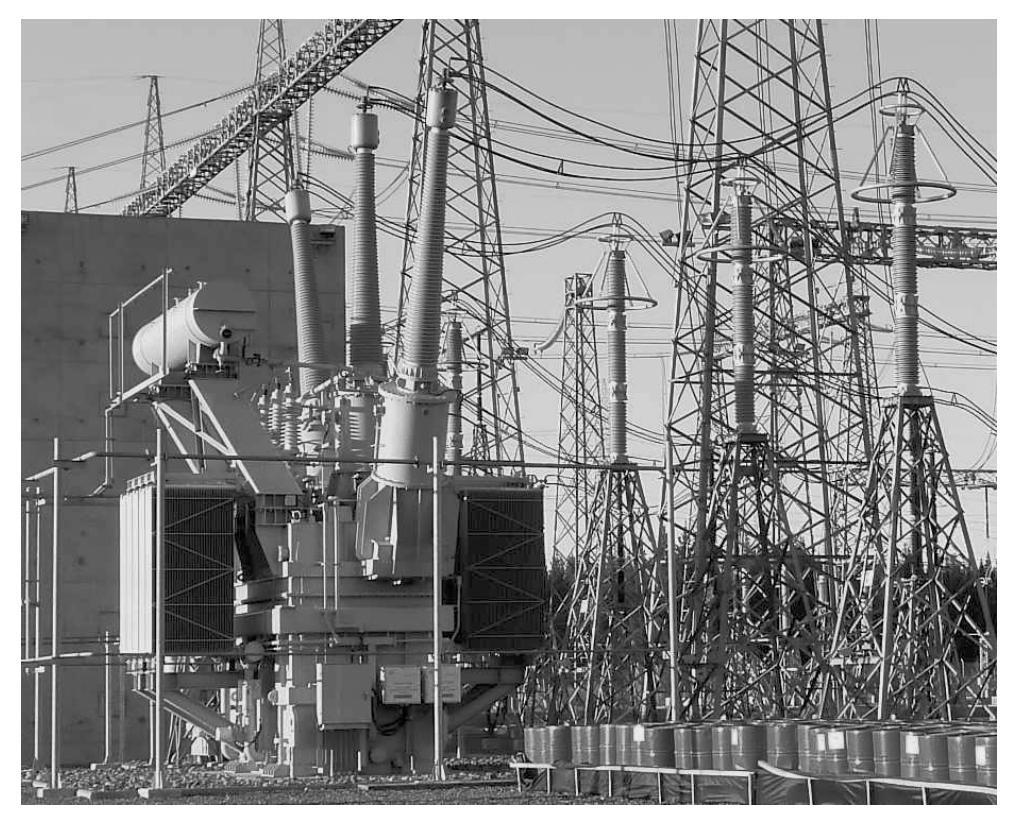
Figure 6.88. One of two 500 kV undamaged reactors associated with the transformers

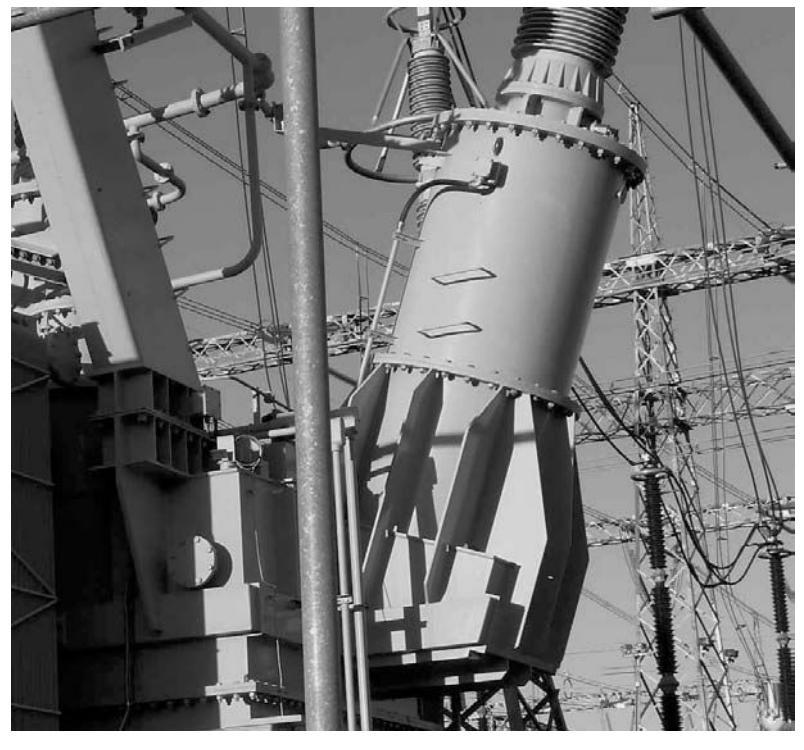
Figure 6.89. A large turret supporting the A and C phases on reactor

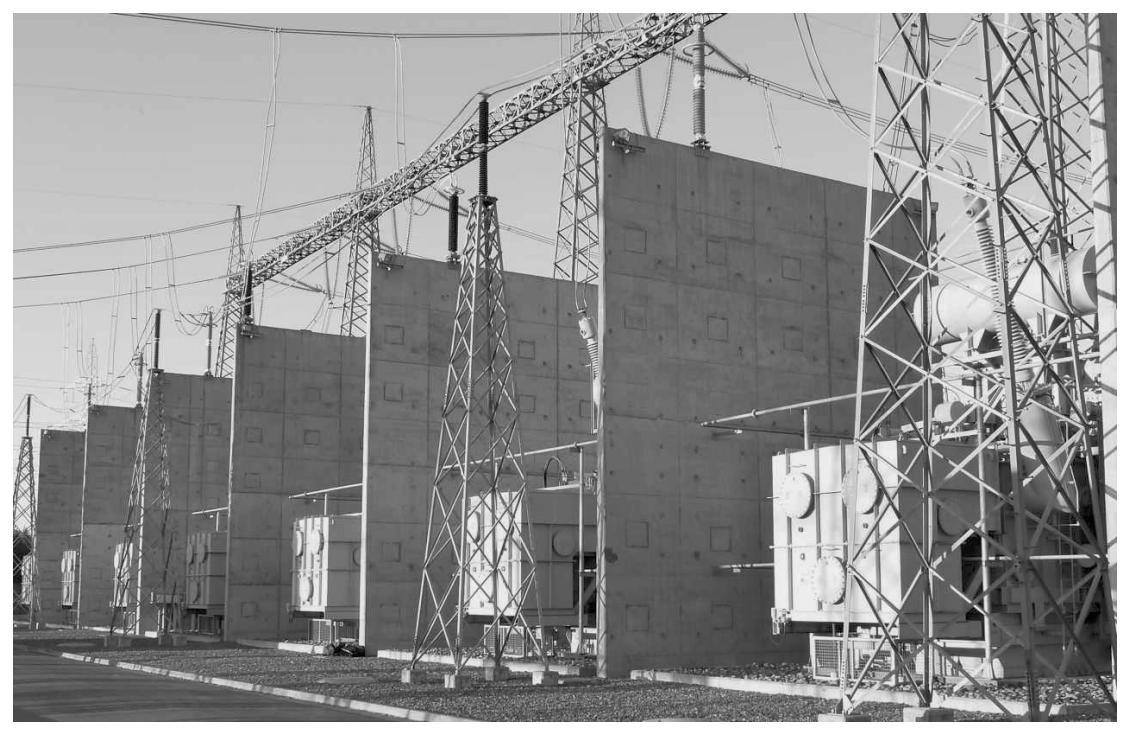
Figure 6.90. Seven transformers separated by firewalls that support surge arresters

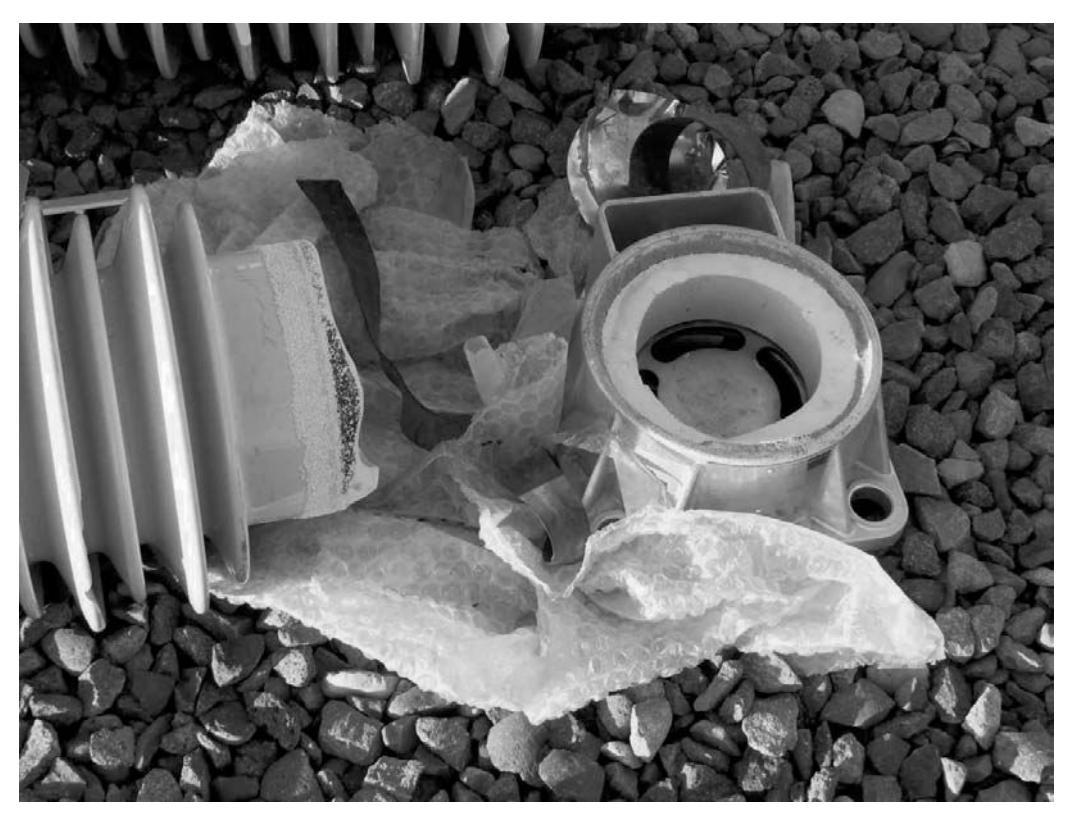
Figure 6.91. One of two surge arresters installed on top of firewall that failed

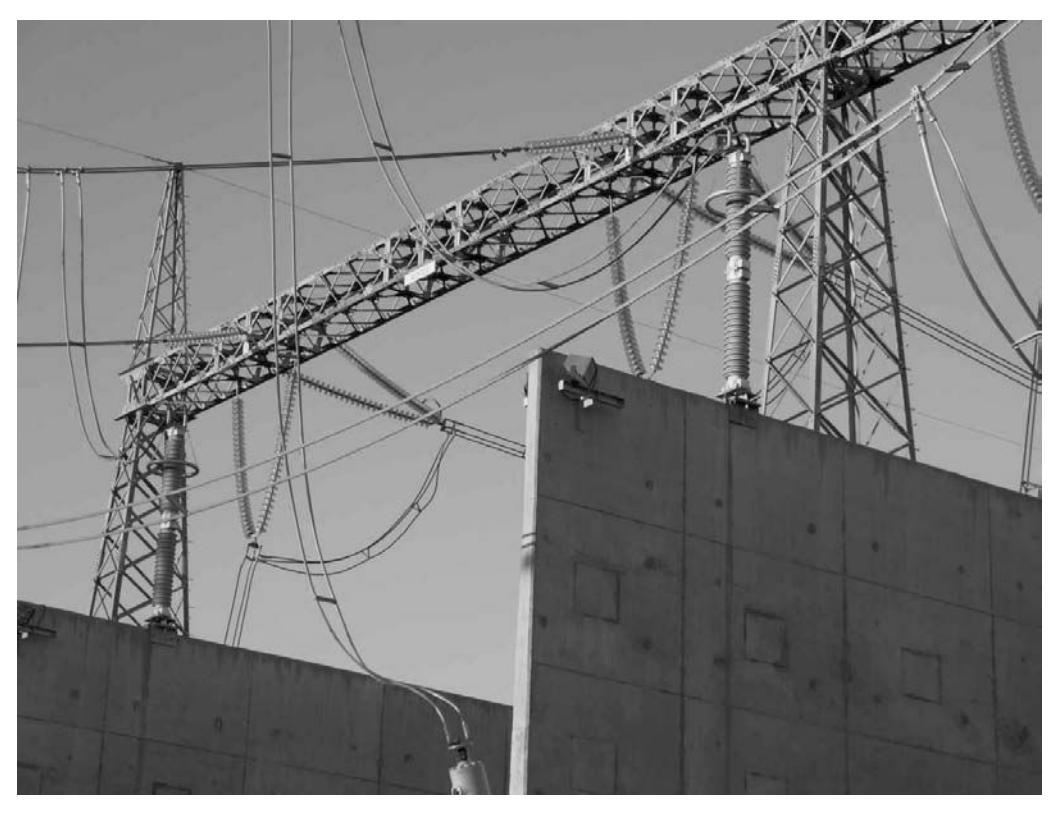
Figure 6.92. Surge arresters have generous slack

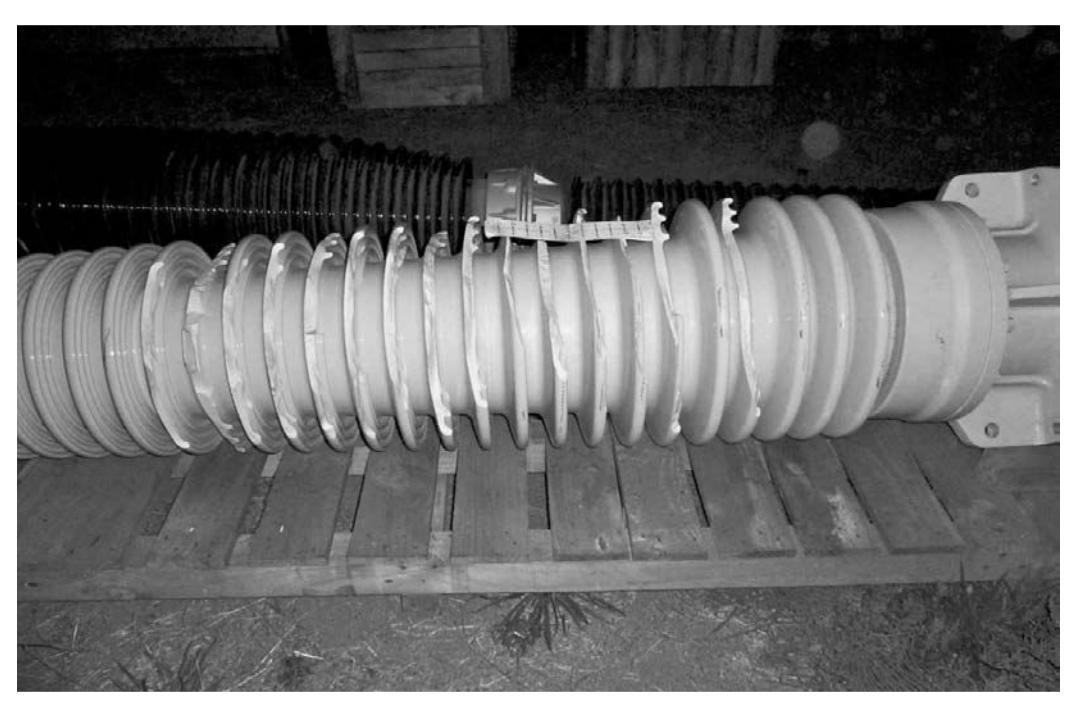
Figure 6.93. One falling surge arrester damaged the 220 kV transformer bushing

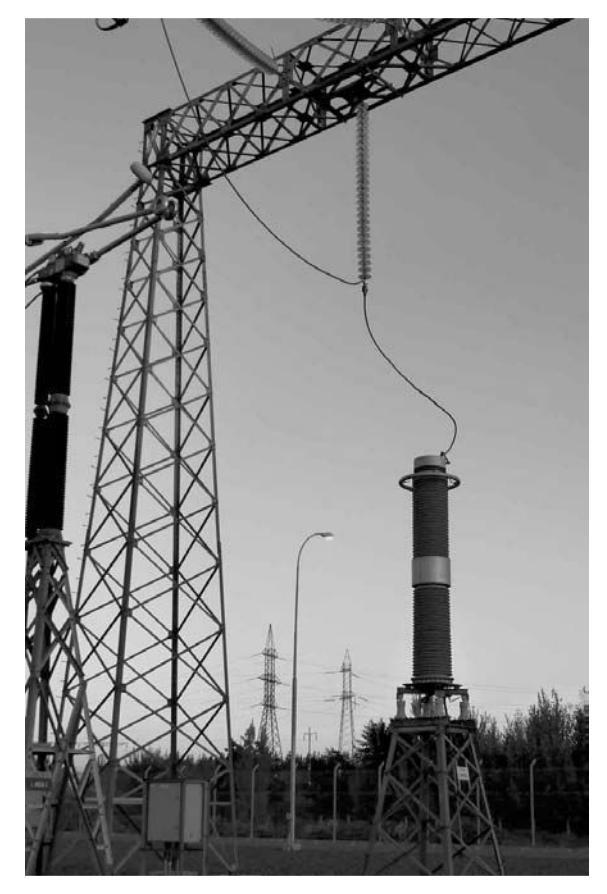
Figure 6.94. Glass suspension insulator replaced failed post insulator

There were several locations in the 500 kV switchyard where post insulators supported below dead-end structures failed. Figure 6.94 shows a suspension insulator that replaced the failed post insulator. While the lower end of the post insulator would not be expected to move much, the string insulator will swing and the slack provided, which is probably the same as that used for the post insulator, may not be adequate. The use of a composite suspension insulator, which would have one-third the weight as a porcelain or glass insulator string, would reduce the load on the instrumentation transformer. Figure 6.95 shows a dead-end structure in which the B-phase post insulator in the cross-under has failed. It may be interesting to calculate the load and compare it to the capacity of the insulator. The BIL of the pantograph disconnect switches in the switchyard is 1800 kV, so this value will be used to characterize the post insulator. Post insulators come in various strengths; from scaling the photographs, the insulator is estimated to have a 2,500-pound (1134 kg) cantilever strength. This unit has a weight of 908 pounds (412 kg) and is tapered. From Figure 6.76 the length of the span on each side of the insulator is estimated as being twice the insulator length, which is 152 inches (3861 mm). There are three conductors, and the weight per foot of each conductor is estimated to be 2.0 pounds. The total weight of the conductors is estimated as 304 pounds. The center of gravity of the conductor will be approximately at the center of the insulator, so the equivalent weight at the end of the insulator is 152 pounds (69 kg). The equivalent weight of the insulator concentrated at the end of the insulator is estimated as 400 pounds. Thus, the total equivalent weight of the conductor and post at the end is 552 pounds (250 kg). As the cantilever strength is 2,500 pounds (1134 kg), fairly large spectral amplifications would be required to fail the post insulator. Even if a lower strength post is used (cantilever strength of 635 kg [1,400 lbs.] and weight of 288 kg [636 lbs.]), a large amplification would be needed to fail the post (assuming a spectral amplification of 3.25 for 1 g ground motion and IEEE 693 RRS). This suggests that conductor dynamics may be involved, as dynamics can induce impact type loads. Figure 6.96 shows a frame in which two insulators have failed. These insulators are connected to grounding switches, have generous slack, and have less conductor weight than in the previous figure. Figure 6.97 shows the post insulators on the ground where they fell. Figure 6.98 shows a typical fracture at the base of a post insulator (i.e., a guillotine-type fracture across the insulator at the sand ring). The sand ring is a roughened part of the stub of the insulator that fits inside a pocket in the flange. Portland cement and sand is typically used to make the connection between the flange and the stub of the insulator. This is strictly a mechanical connection; there is no chemical bonding between the grout and the porcelain or the flange. This is why roughness is added to the porcelain stub, as can be seen in Figure 6.98. Secondary failures that result from the insulator striking the ground are also used in characterizing failure type.

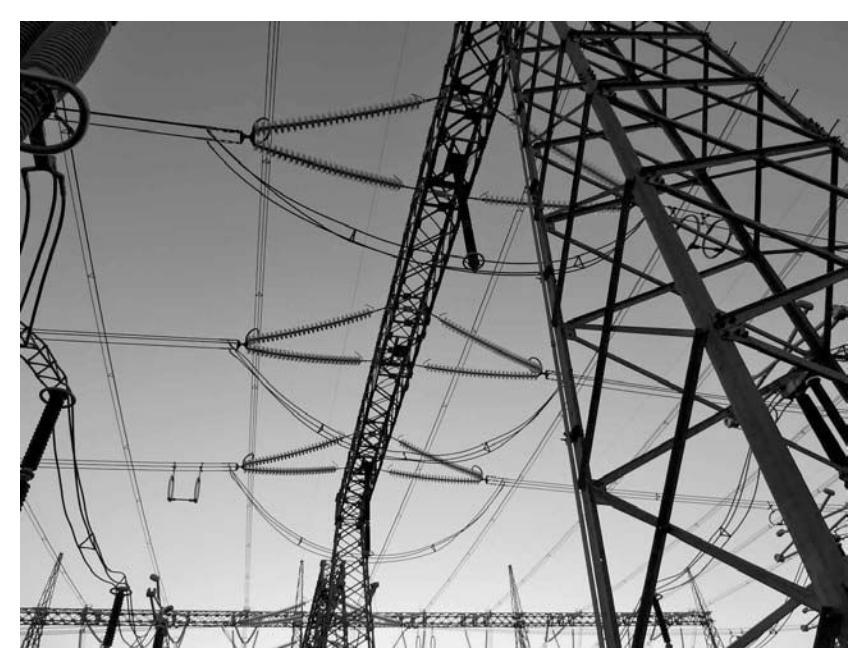
Figure 6.95. Failure that is not related to slack, but may be related conductor dynamics

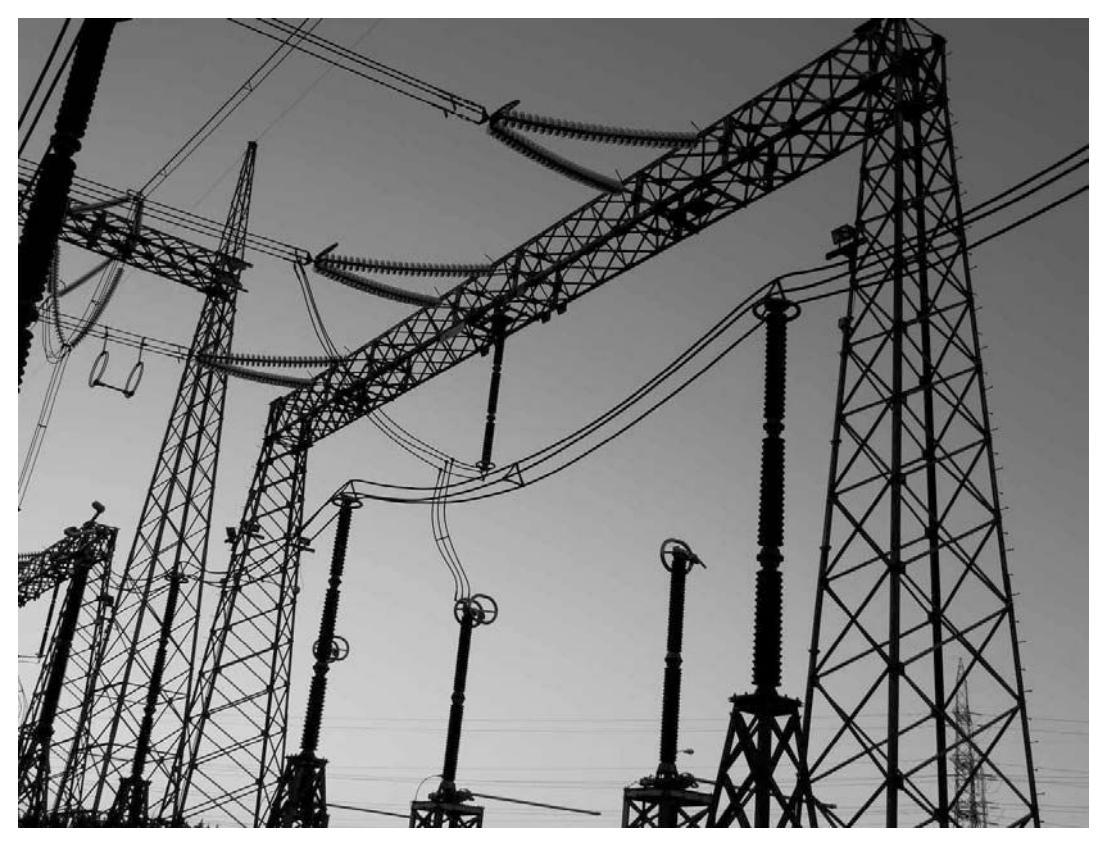
Figure 6.96. Drop with adequate slack in which two post insulators failed

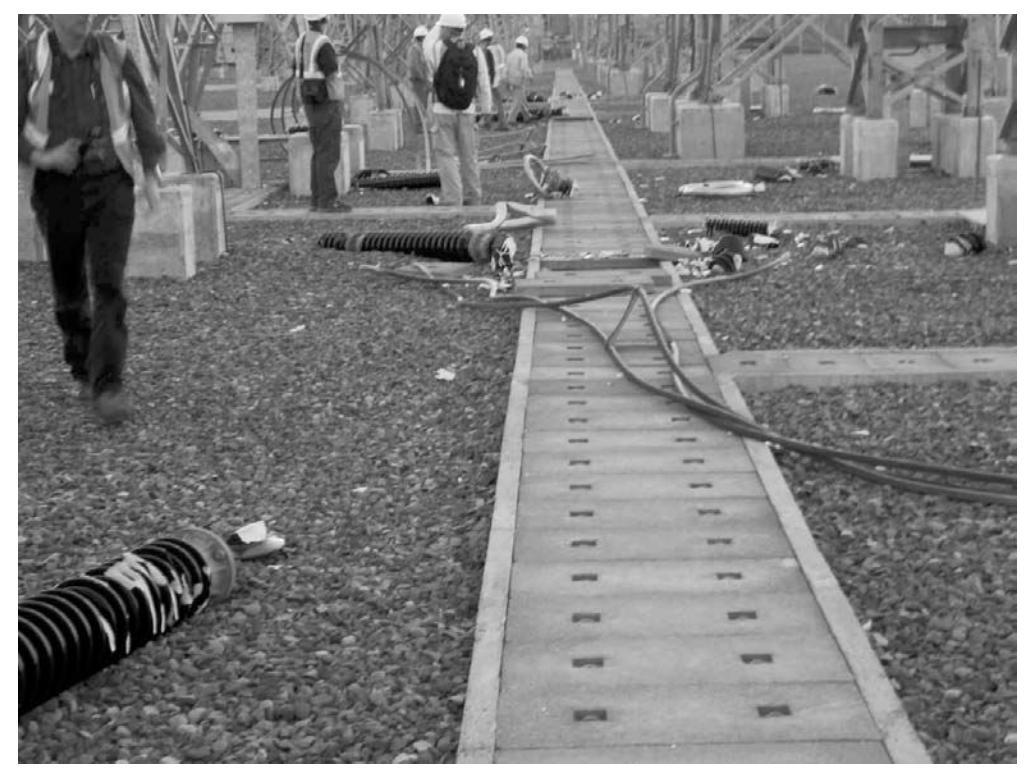
Figure 6.97. Post insulators on the ground after falling from dead-end structure

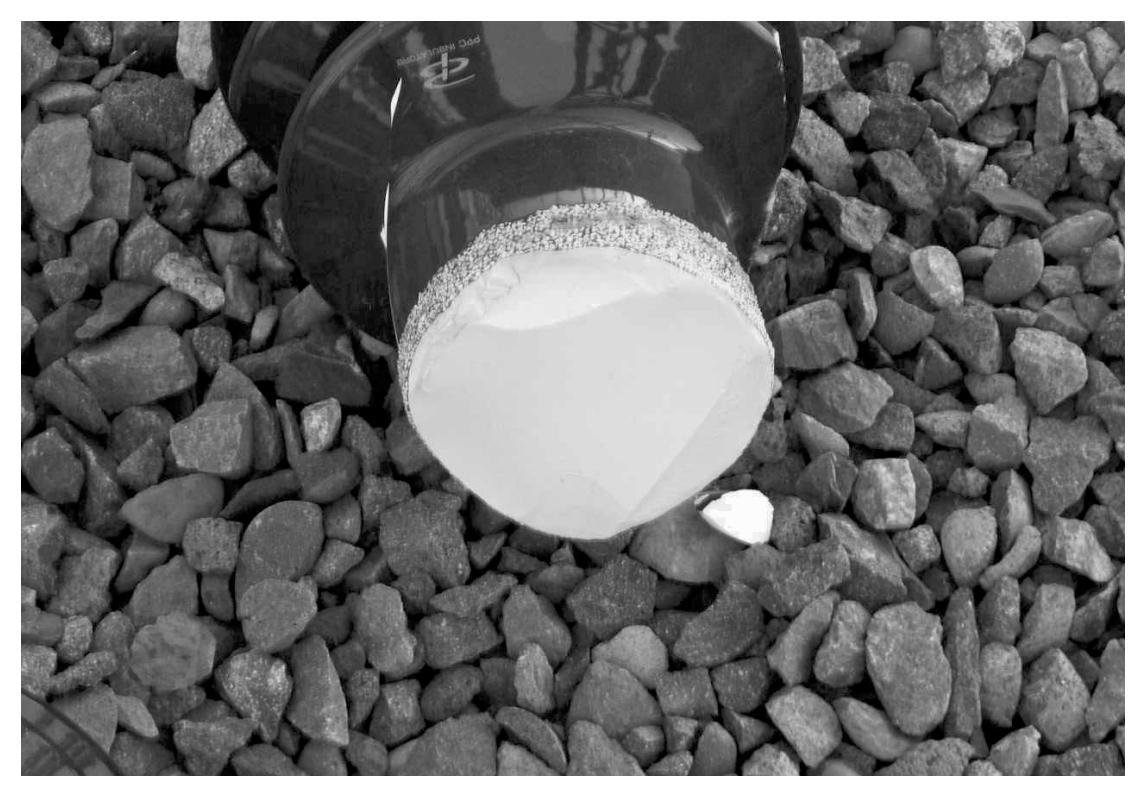
We learned through discussions with one major insulator manufacturer that in their testing to determine cantilever strength, in which a uniform pull test to failure is used to generate the failure, the crack in the porcelain usually starts at the sand ring and extends diagonally up though the body of the porcelain, and guillotine-type failures are rare. In lab tests of post insulators conducted in a research project by a utility at a university lab, a small number of post insulators were subjected to pseudo-dynamic cyclic loading. About half the samples had guillotine-type fails and half had fractures through the insulator body.

Figure 6.98. Typical guillotine-type failure observed of post insulator

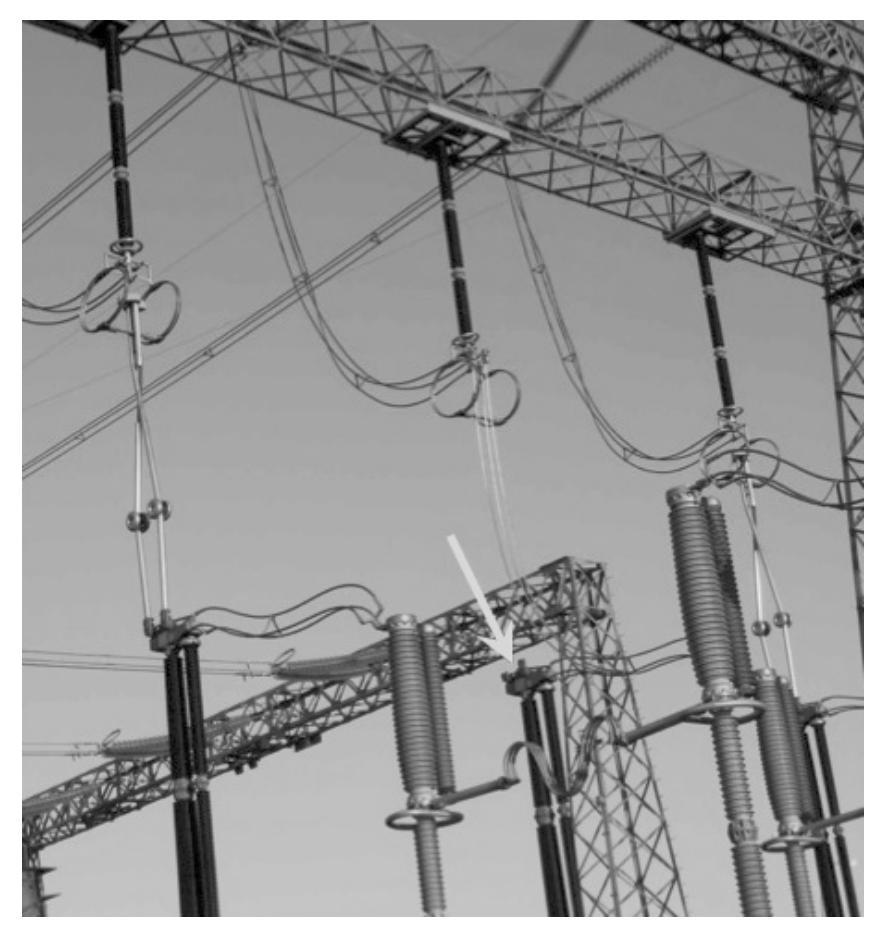
Figure 6.99 shows the upper part of the B phase of a pantograph disconnect switch missing and the connection being made with a jumper. Figure 6.100 shows a connection being fractured. It is not known if the other connection was removed or if the bolts making the connection failed. Figure 6.101 shows the arms on the ground with the arrow on the left with the fractured part still connected and on the right with a clean pipe. Figure 6.102 shows the fractured connection close up. While an exact count of pantograph disconnect switches is not known, a review of team photographs indicates that there were at least twenty-eight 500 kV disconnect switches. All pantograph switch failures were related to the character of the upper connection. All failures occurred in switches where the upper connection was to an inverted post insulator rather than from a flexible bus. Figure 6.103 shows a HVAC system in which the spring supports shifted.

Figure 6.99. The B-phase pantograph disconnect switch failed

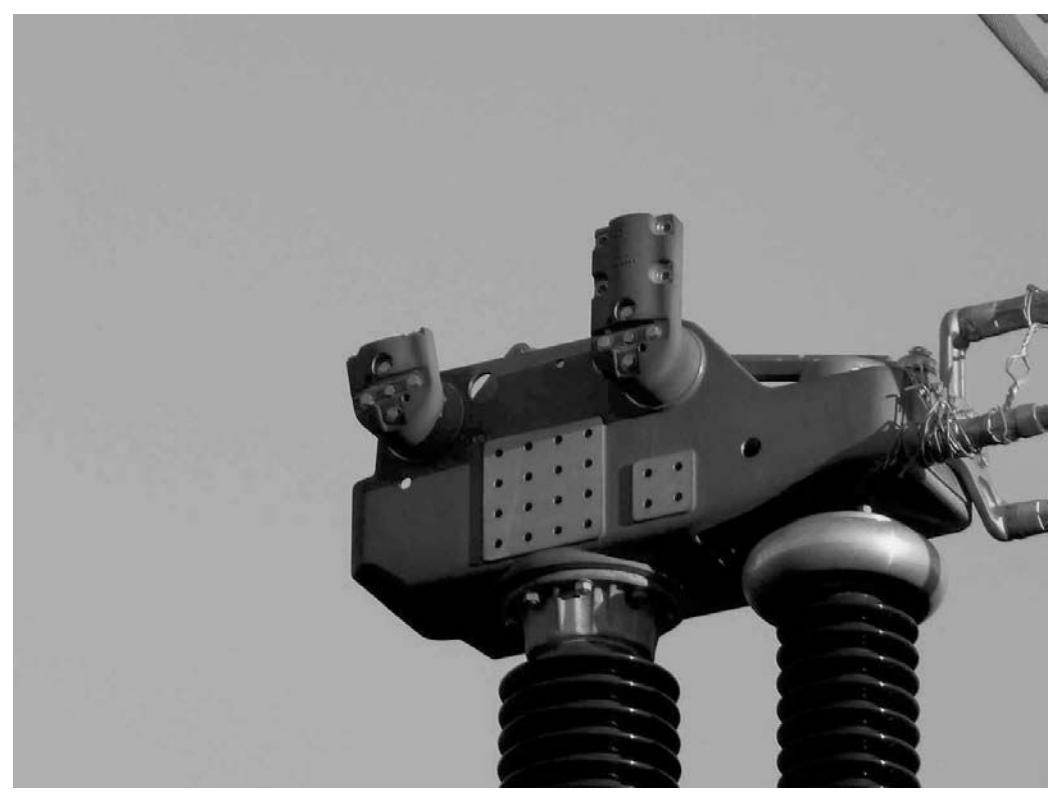
Figure 6.100. Top of pantograph switch with arms missing

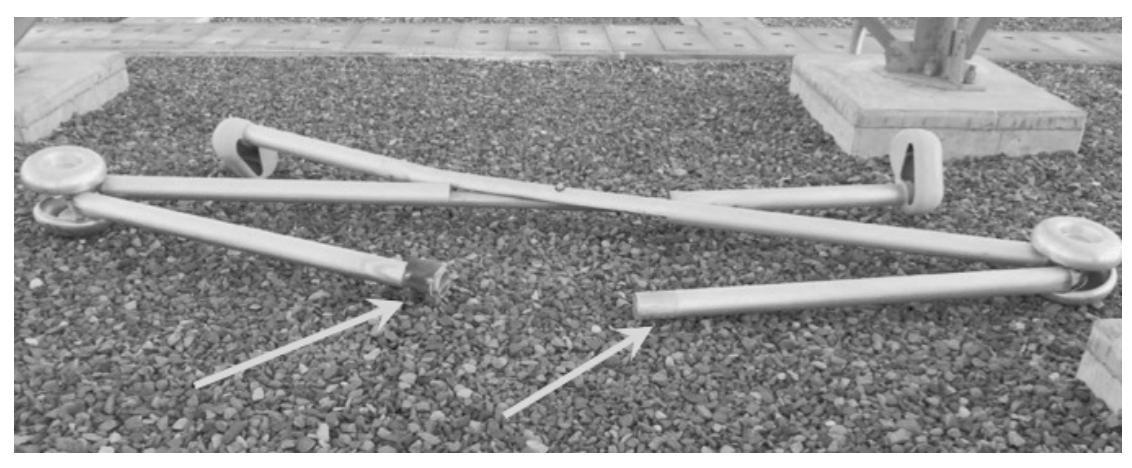
Figure 6.101. Pantograph arms on the ground

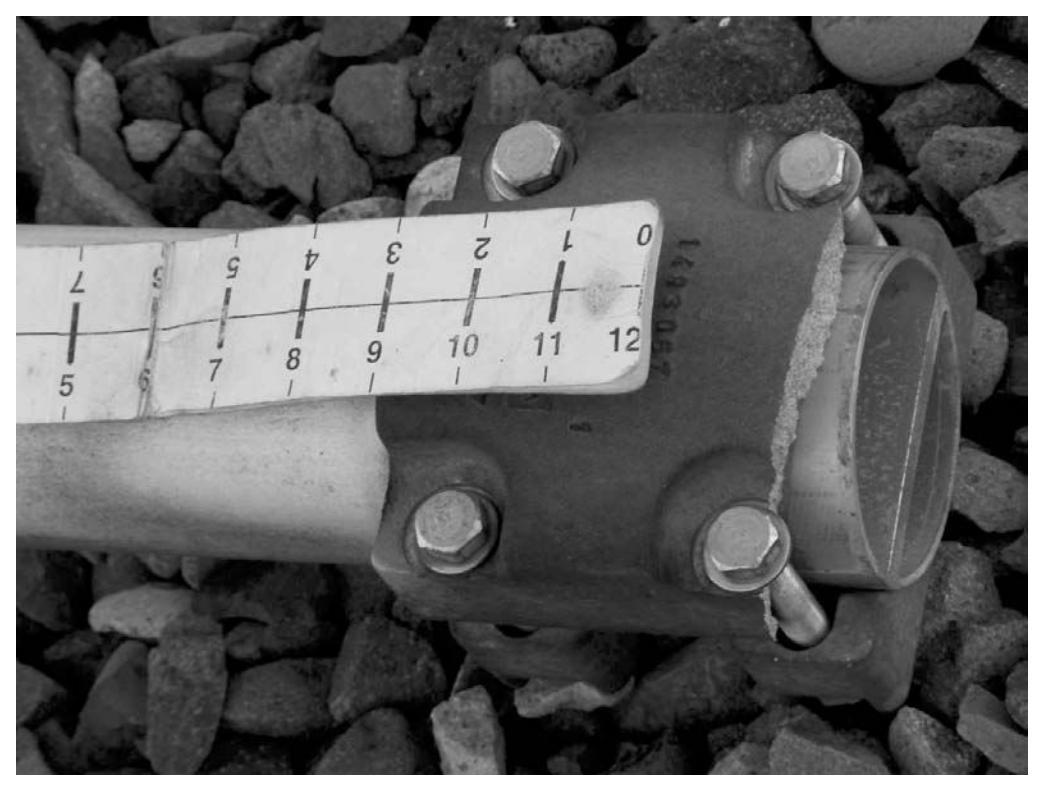
Figure 6.102. Broken coupling that connects arm to switch body

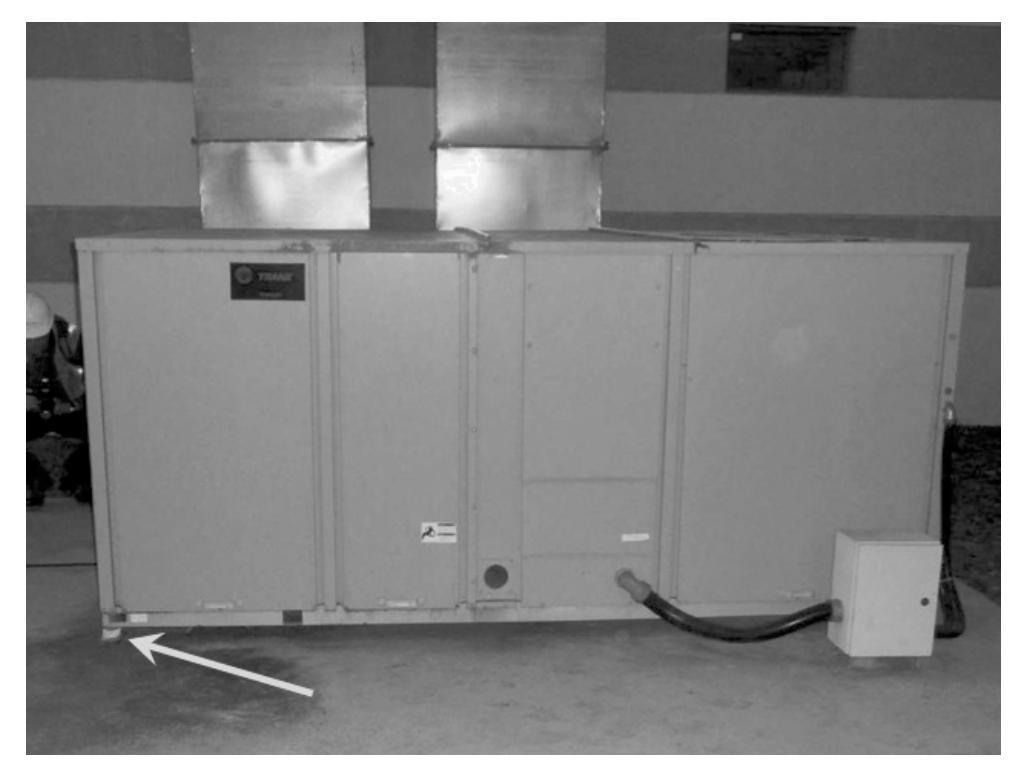
Figure 6.103. Support for HVAC system shifted
