The World Trade Center Attacks

The FEMA Investigation and Results

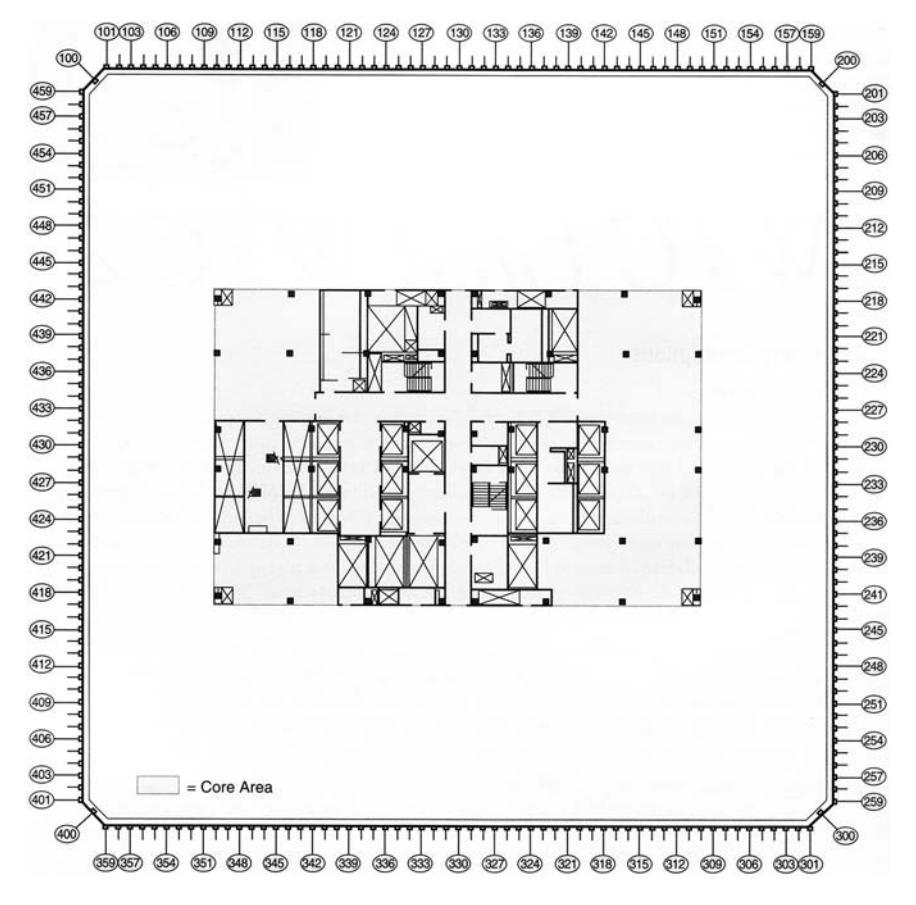
Figure 6-6. WTC typical floor plan. *Source:* FEMA (2002).

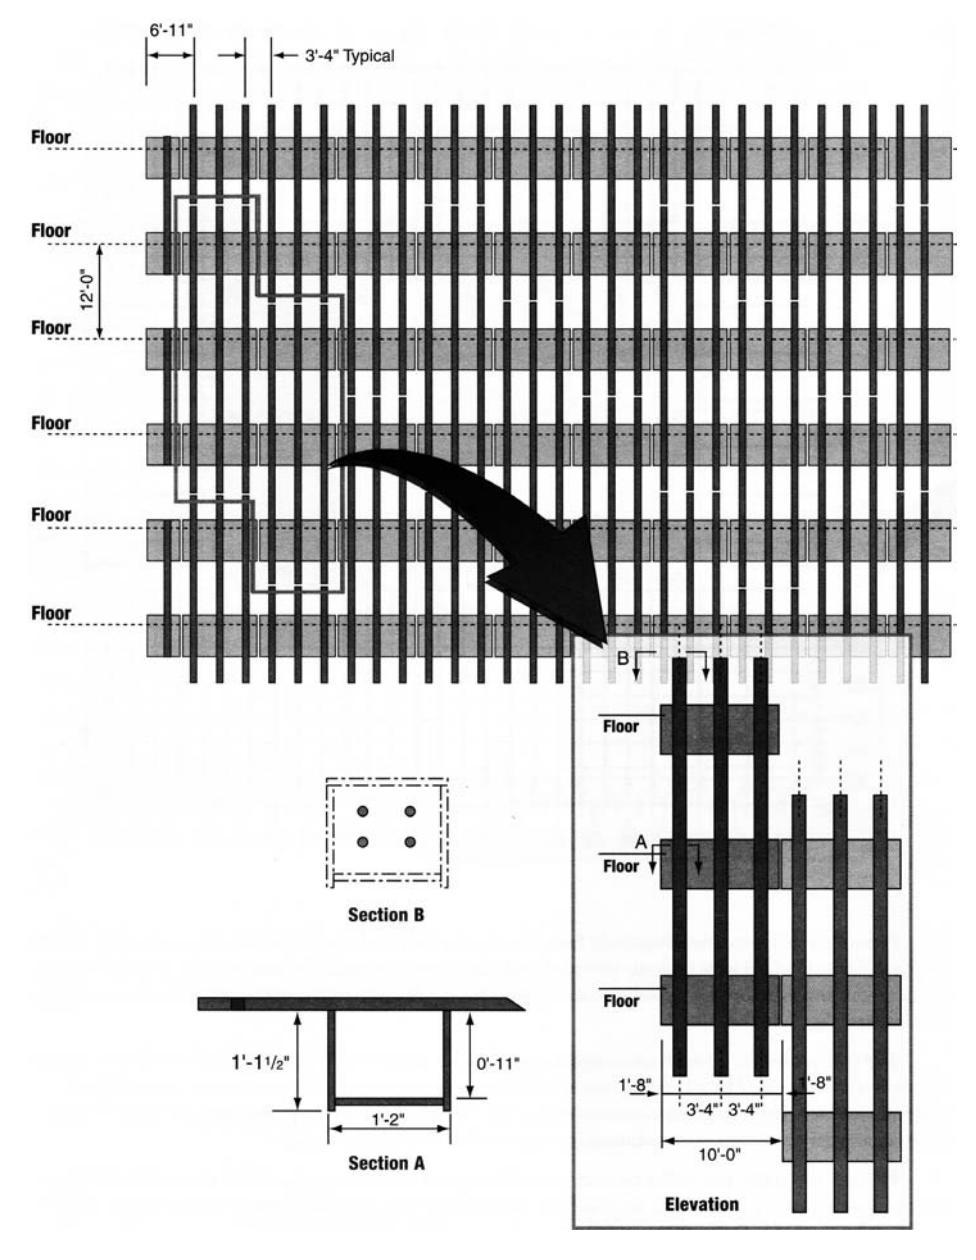
The basic structural form for the building was a tube of closely spaced box columns, with about 59 per face of the building. At each floor, they were connected by 1.3-m (52-in.) deep spandrel plates. The outer steel frame was made of overlapping three-story-tall segments. Splices between segments were staggered, so that no more than one-third of the splices were on any one story. Plate thicknesses and grades of steel were varied to accommodate different loads. Under wind loading, the tube acted similarly to a box beam in flexure, with windward and leeward walls acting as compression and tension flanges connected by a Vierendeel truss web (FEMA 2002, pp. 2-2–2-3). Figure 6-7 shows the outer steel frame, and Fig. 6-8 shows the structural behavior under lateral loading.

Figure 6-7. WTC bearing wall steel frame. *Source:* FEMA (2002).

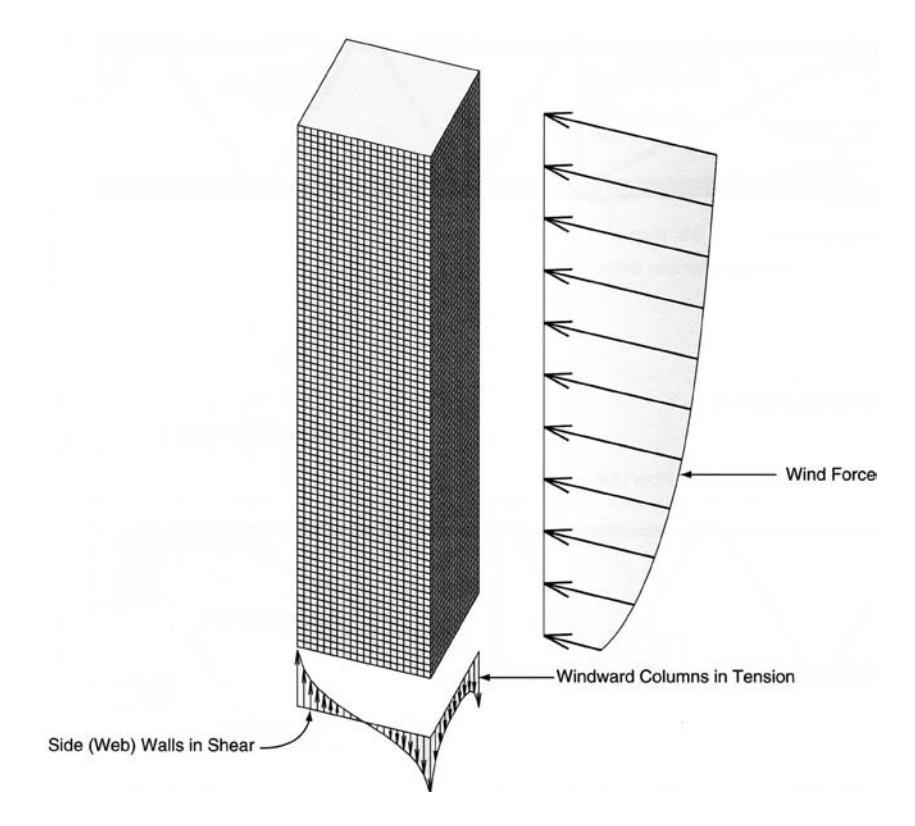
Figure 6-8. WTC structural behavior under lateral loading. *Source:* FEMA (2002).

Because of the structure's high degree of redundancy, the area of immediate collapse was limited to the general area of the impact. The loads previously carried by the destroyed columns were transferred to alternate load paths, through the Vierendeel truss. The most heavily loaded columns were probably near, but not over, their ultimate capacities. The inherent robustness of the structural system allowed it to remain standing for 1 hour and 43 minutes after the impact (FEMA 2002, pp. 2-16–2-21).

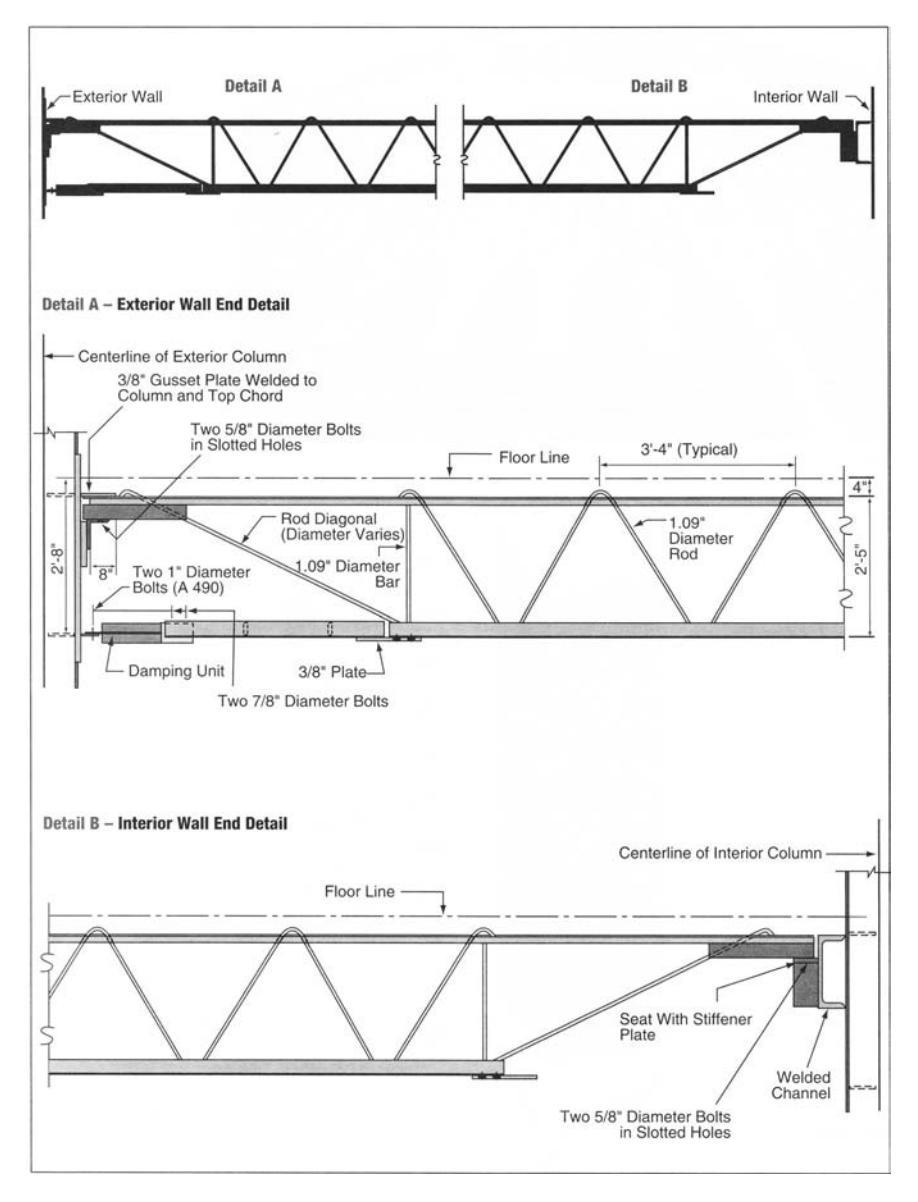
The floor slab and framing system connected the outer tube to the inner core. The floor was 100-mm (4-in.) thick lightweight concrete on 38-mm (1½-in.) noncomposite steel deck. The floor rested on a series of composite floor trusses. The trusses were similar to open web joists but had more redundancy and better bracing. They were placed in pairs, approximately 2 m (6 ft 8 in.) apart. Transverse trusses ran between these main trusses. Truss spans were approximately 18 m (60 ft) to the sides and 10.7 m (35 ft) to the ends of the central cores. The truss top chords were supported at the outer wall in bearing by seats attached to alternate columns, and on seats at the central core (FEMA 2002, pp. 2-3–2-4). Figure 6-9 shows the trusses and end connection details.

Figure 6-9. WTC trusses and end connection details. *Source*: FEMA (2002).

- As the floor framing and slabs were heated, they expanded. This effect alone may have caused some structural members or connections to fail.
- With increasing temperature, the floor and slab assemblies became less stiff and sagged into catenary action. Loading from debris would have increased the forces caused by sagging. The sagging imposed tensile forces on horizontal framing and floor elements, possibly causing end connections to fail. Because the floor and slab assemblies braced the exterior columns, as these connections failed, the unbraced length of the columns would have increased and their buckling loads would have decreased substantially.
- As the temperature of steel increases, its yield strength and modulus of elasticity decrease. Therefore, the elastic and inelastic buckling strength is decreased (FEMA 2002, pp. 2-24–2-25).
