WFC Foundation Observations

Investigation of the Fragment Impact and Blast Shock Wave on Window Breakage

Sebastian Mendes, Ph.D.¹; Liling Cao, Ph.D., P.E.²; Elisabeth Malsch, Ph.D., P.E.³; and Gary Panariello, Ph.D., P.E., S.E.⁴

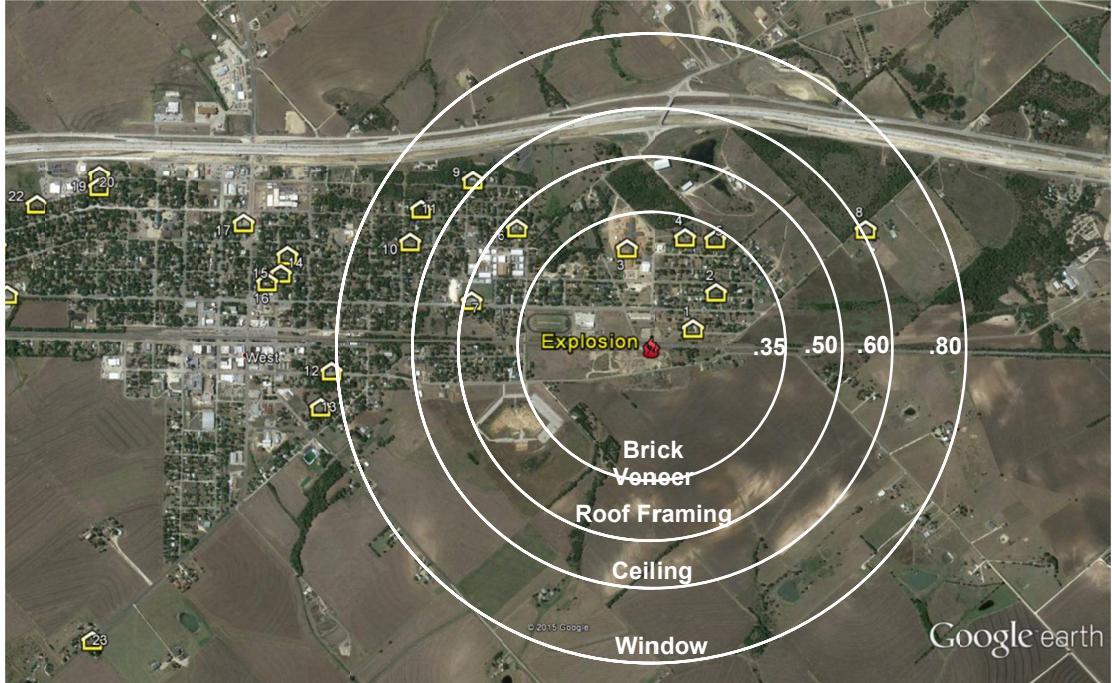
Figure 7. Overview of Evaluated Structures and Extents of Distress Propagation

A pattern of significant and widespread brick veneer distress, including diagonal fractures, separations/fractures at exterior building corners, and/or collapsed portions of the veneer, occurred up to approximately .35 miles from the explosion origin. A significant gap of over .1 miles existed in the distance data points farther out than .35 miles, which may have caused error in the extent estimate for the brick veneer damage indicator.

A pattern of structural roof distress was consistent at structures located within approximately .5 miles of the explosion origin, but some structures exhibited roof framing distress up to approximately .7 miles from ground zero. Due to the inconsistency in the framing distress for structures farther than .5 miles from the blast origin, the authors assumed an extent of .5 miles. One structure located more than .6 miles from the origin exhibited fractured framing. This structure had a clear line of site to the origin and, consequently, was likely subjected to increased loading relative to structures at a similar distance from the blast origin but in more densely developed areas.

A pattern of collapsed ceiling finishes was evident up to approximately .6 miles from the explosion origin. A significant sample size of data points from sites farther than .6 miles exists to support the estimated extent for this damage indicator.

A pattern of distress to windows, doors, and/or glazing was evident up to approximately .8 miles from the explosion origin. The pattern became less consistent farther than .8 miles from the origin; however, a significant cluster of window/door damage data points was evident up to 1.0 miles from the origin.

Figure 7 shows the locations of select structures evaluated by the author's firm. Radial distance markers are overlaid on Figure 7 to show the extents of distress mechanism propagation as determined by the authors from the collective review of the 35 evaluations. Table 3 summarizes key observations from the 35 evaluations and can be correlated to the structure numbers in Figure 7.

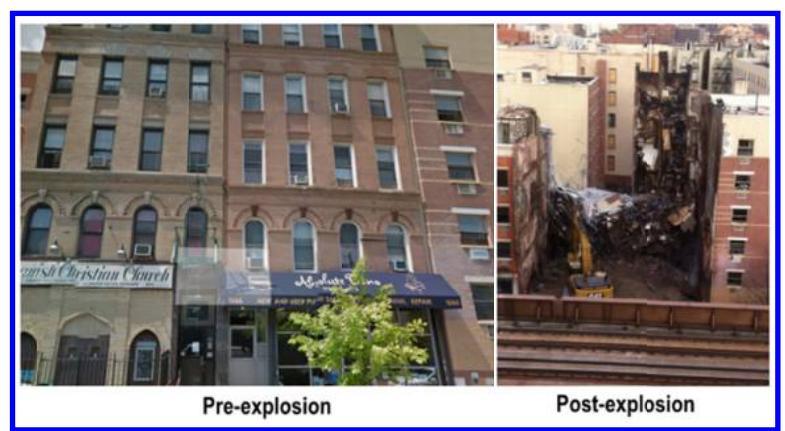
Figure 1. Buildings prior to explosion and after collapse (Mullings, 2014).

A natural gas explosion occurred on March 12th, 2014 in East Harlem, NY causing deaths of several people and wounding numerous others (Kiger, 2014). The explosion resulted in the progressive collapse of two five-story brick buildings (see Figure 1), and neighboring buildings sustained different levels of damage from the reflection of the blast wave and fragment impact.

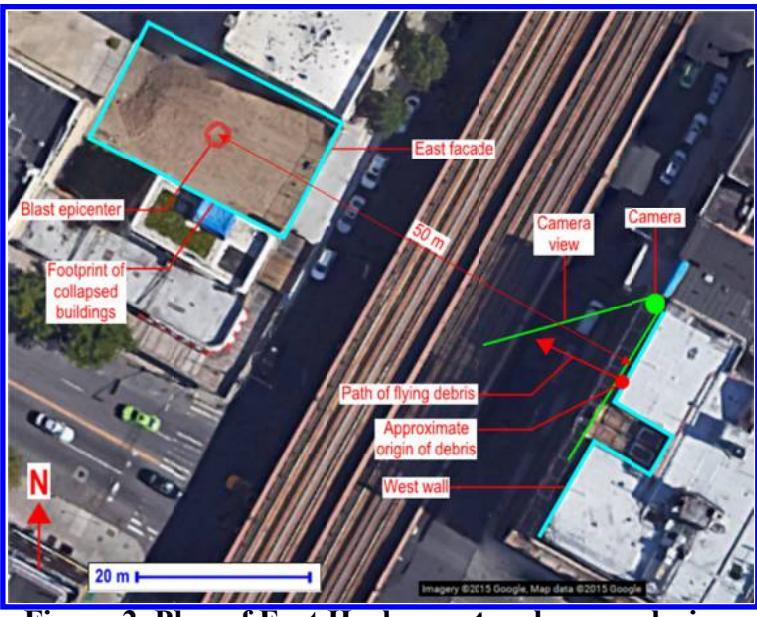
Figure 2. Plan of East Harlem natural gas explosion.

The explosion epicenter is assumed to be located at the center of the site covered by the two collapsed buildings. The estimated range and incident angle between the epicenter and the origin of the west wall debris are determined from a plan view taken from Google maps (see Figure 2). The difference in elevation between the blast epicenter and the debris is assumed to be negligible with respect to the horizontal range. The range is found to be approximately 50 m and the incident angle is effectively zero degrees.

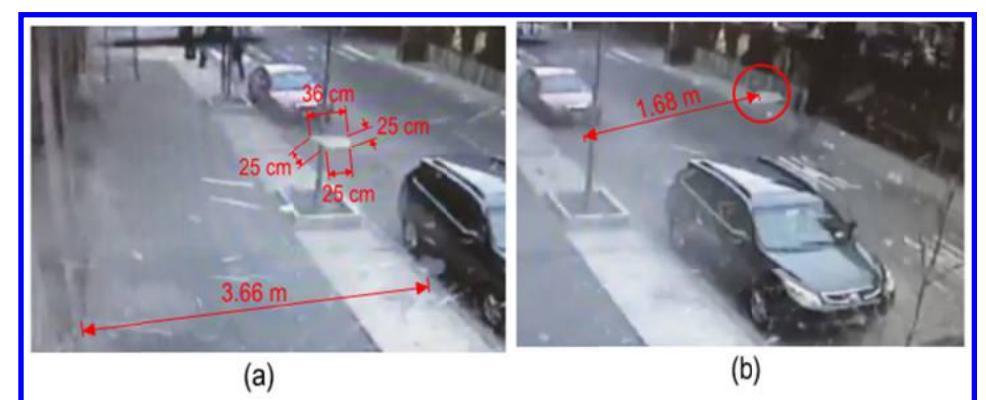
Figure 3. (a) Glass shard flying off west wall showing estimated dimensions and (b) the same shard shown two frames later.

The reflected impulse at the origin of the flying debris can be predicted given the estimated mass and velocity of one of the fragments observed in the video. The larger chunk of debris indicated in Figure 3 appears to be a glass shard shaped in the form of a trapezoid. Its dimensions are estimated by scaling in Bluebeam the shard size with respect to the width of the sidewalk in the background. The width of the sidewalk is determined from a plan view taken from Google maps. The windows on the west wall are assumed to be composed of 6 mm annealed glass (ASTM E1300-12a, 2012) as it was the typical facade construction for the year when it was built. As a result, the shard thickness is assumed to be 6 mm. Given the dimensions measured in Figure 3a along with the density of glass taken as 2.579 g/cm³, the mass of the shard is estimated to be 1.25 kg.

The glass shard appears to fly off the building in a direction normal to the west wall. Also, the video recording is found to have a frame rate of 30 frames per second, or 1/30 seconds between each frame. The distance traveled by the shard over

three frames is estimated by scaling in Bluebeam that distance with the width of the sidewalk. This distance is found to be approximately 1.68 m. Dividing this distance by 1/15 seconds results in an estimated shard velocity of 25 m/s.
