Challenges with a Roof Collapse:

Causation, Subrogation, and Structural Rehabilitation

David A. VanDerostyne, P.E., SE

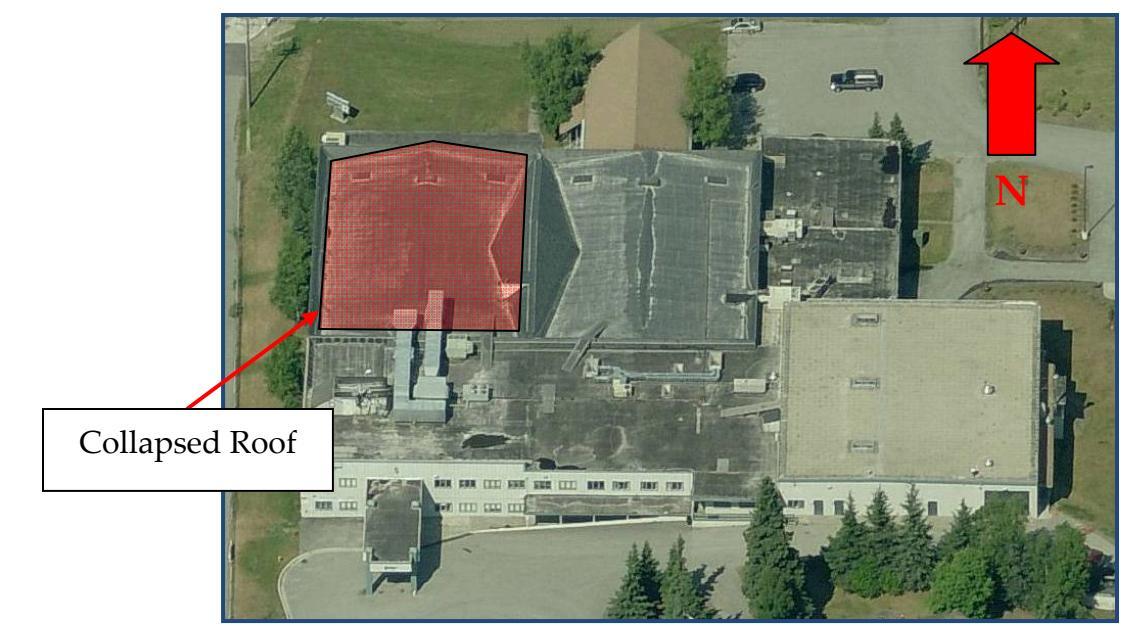
Figure 1- Aerial picture from Pictometry showing the complex prior to the collapse.

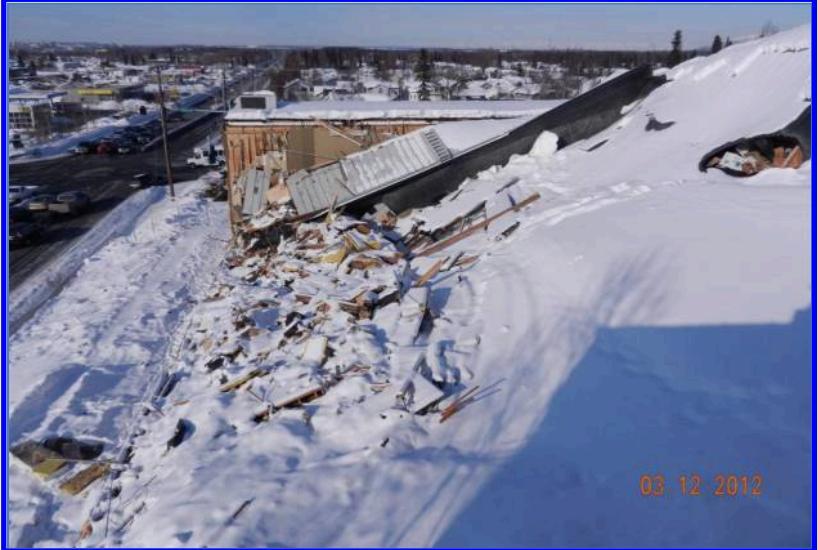
At 6:02PM on March 2, 2012, a partial collapse occurred within the main sanctuary of a church complex, fortunately while that portion of the church was unoccupied. The collapse caused the west perimeter wall to fall outward and caused the western portion of the collapsed roof to drop to the ground while the eastern portion of the roof remained attached to a steel girder truss (*see Figures 1 and 2*).

Figure 2- View looking north of the collapsed portion of the roof.
