Case History: The Estrondo Landslide Stabilization in Encino, California

Daniel Pradel, Ph.D., P.E., D.GE, G.E., F.ASCE¹

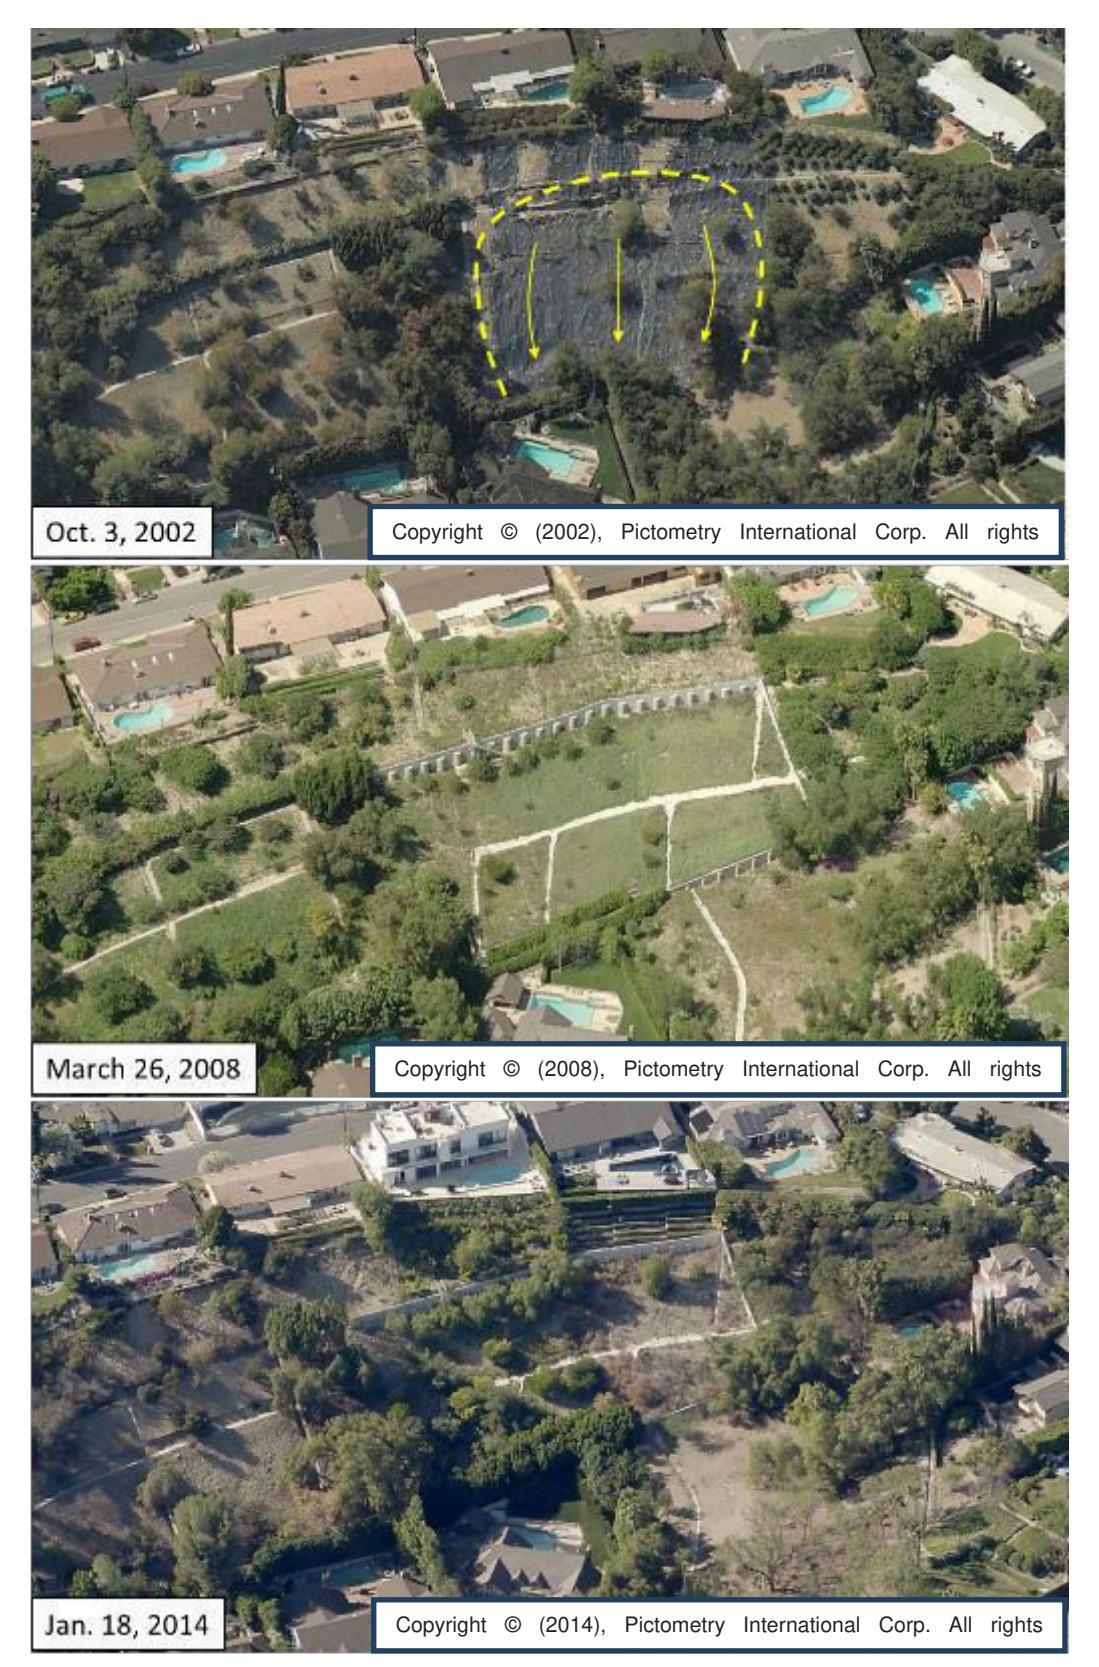
Figure 1. Aerial photographs from <u>www.Pictometry.com</u> showing the failed slope covered with plastic (top), the repaired slope (middle), and the slope recently (bottom).

- Although the slope had been covered with plastic on several occasions, it tended to quickly deteriorate (as shown in Figure 1), exposing landslide debris to incident rainfall. Hence, there was the concern that a debris flow could occur which would endanger the lower slope residents and their properties.

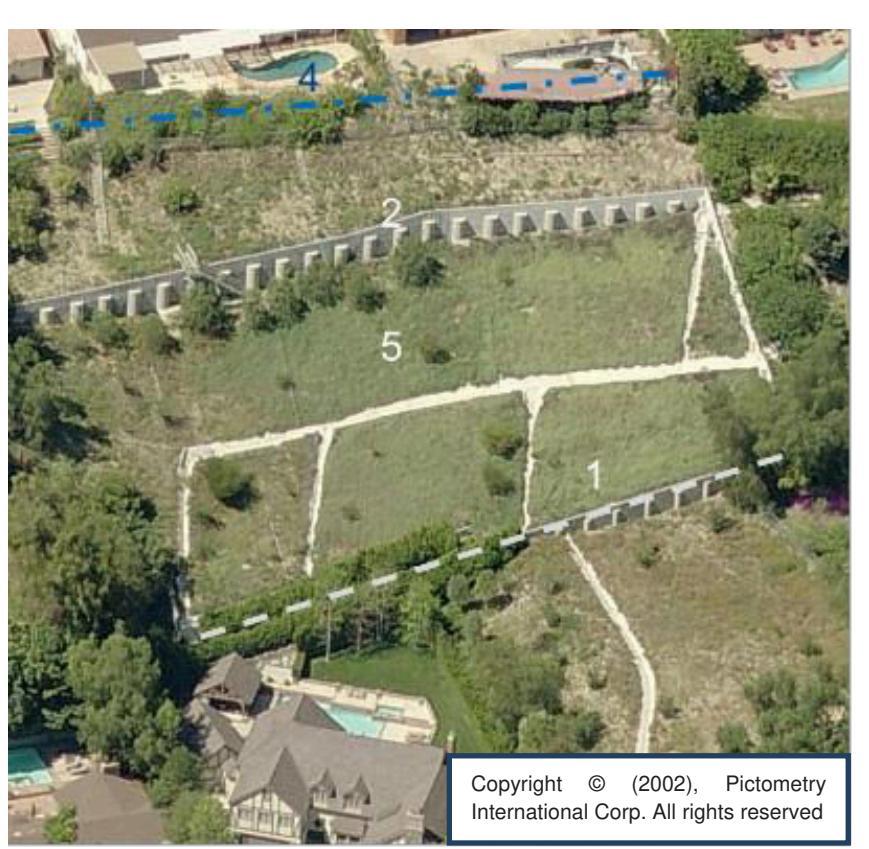
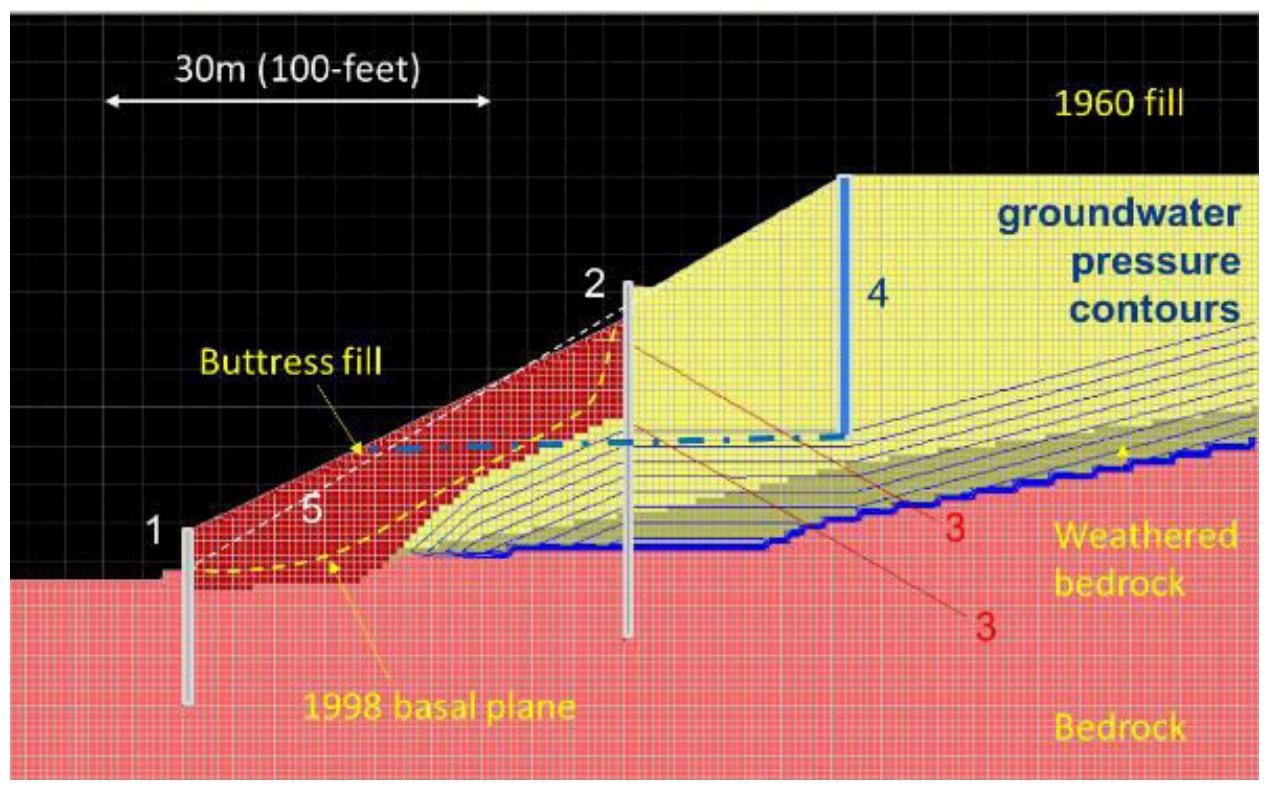
Repair elements: 1: Pile supported impact wall 2: Mid-slope retaining wall 3: Two rows of tieback 4: Drainage curtain 5: Compacted fill buttress

Figure 2. Elements of slope stabilization (aerial photograph from <u>www.Pictometry.com</u>).

By 2003, the landslide shown in Figure 2 had moved significantly and there were significant concerns about its short term effect on nearby residences; hence, the necessity of urgently implementing a slope repair.

- A toe of slope wall with 0.75 meter (2.5 feet) diameter drilled shafts (up to 13 meters deep), which served as an impact/protection wall during the earliest stages of construction, and, later, would laterally retain the lower end of the fill buttress (Figure 2).

- Two rows of approximately 30 meter (100 feet) long tiebacks (Figure 5). The upper and lower row of tiebacks had ultimate capacities of 520 kN/m (36 kips/ft) and 1,230 kN/m (85 kips/ft), respectively.
- A compacted fill buttress that was placed between the two retaining walls (Figure 2). The finished slope of the buttress was graded at a 2:1 (horizontal to vertical ratio) gradient and reinforced with geogrid within 2 m (6 feet) of the final surface to prevent surficial failures.

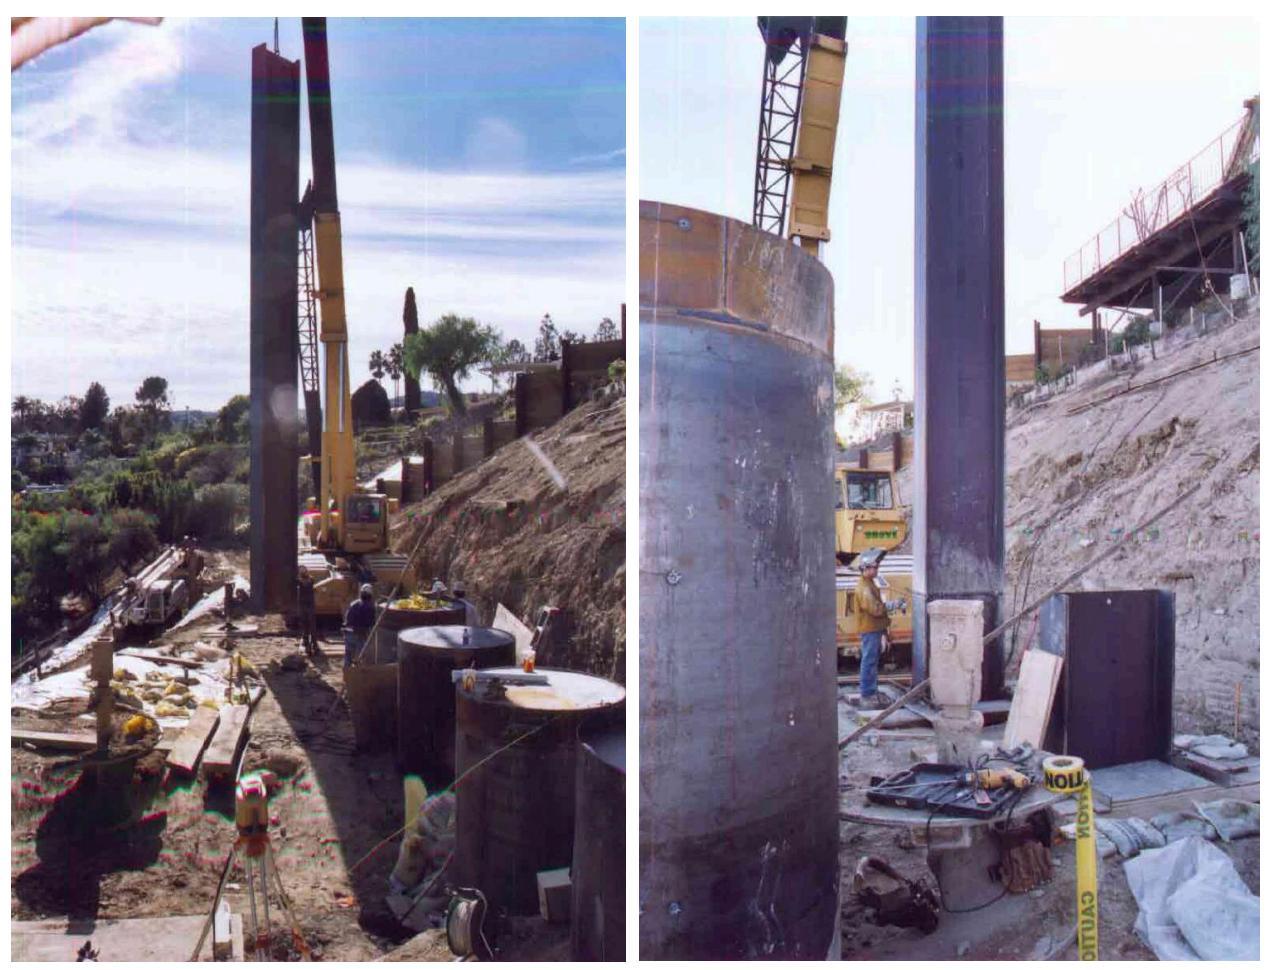
Figure 3. Elements of the slope stabilization.

- A wall at mid-slope with 1.4 meter (4.5 feet) diameter drilled shafts, up to 30 meters (100 feet) deep, strengthened by two rows of tiebacks (Figures 2 and 3). To avoid the difficulties associated with assembly of rebar cages, we opted to reinforce them with large steel beams instead. The beams were delivered in up to 15 meter (50 feet) segments and welded on-site (Figure 3).

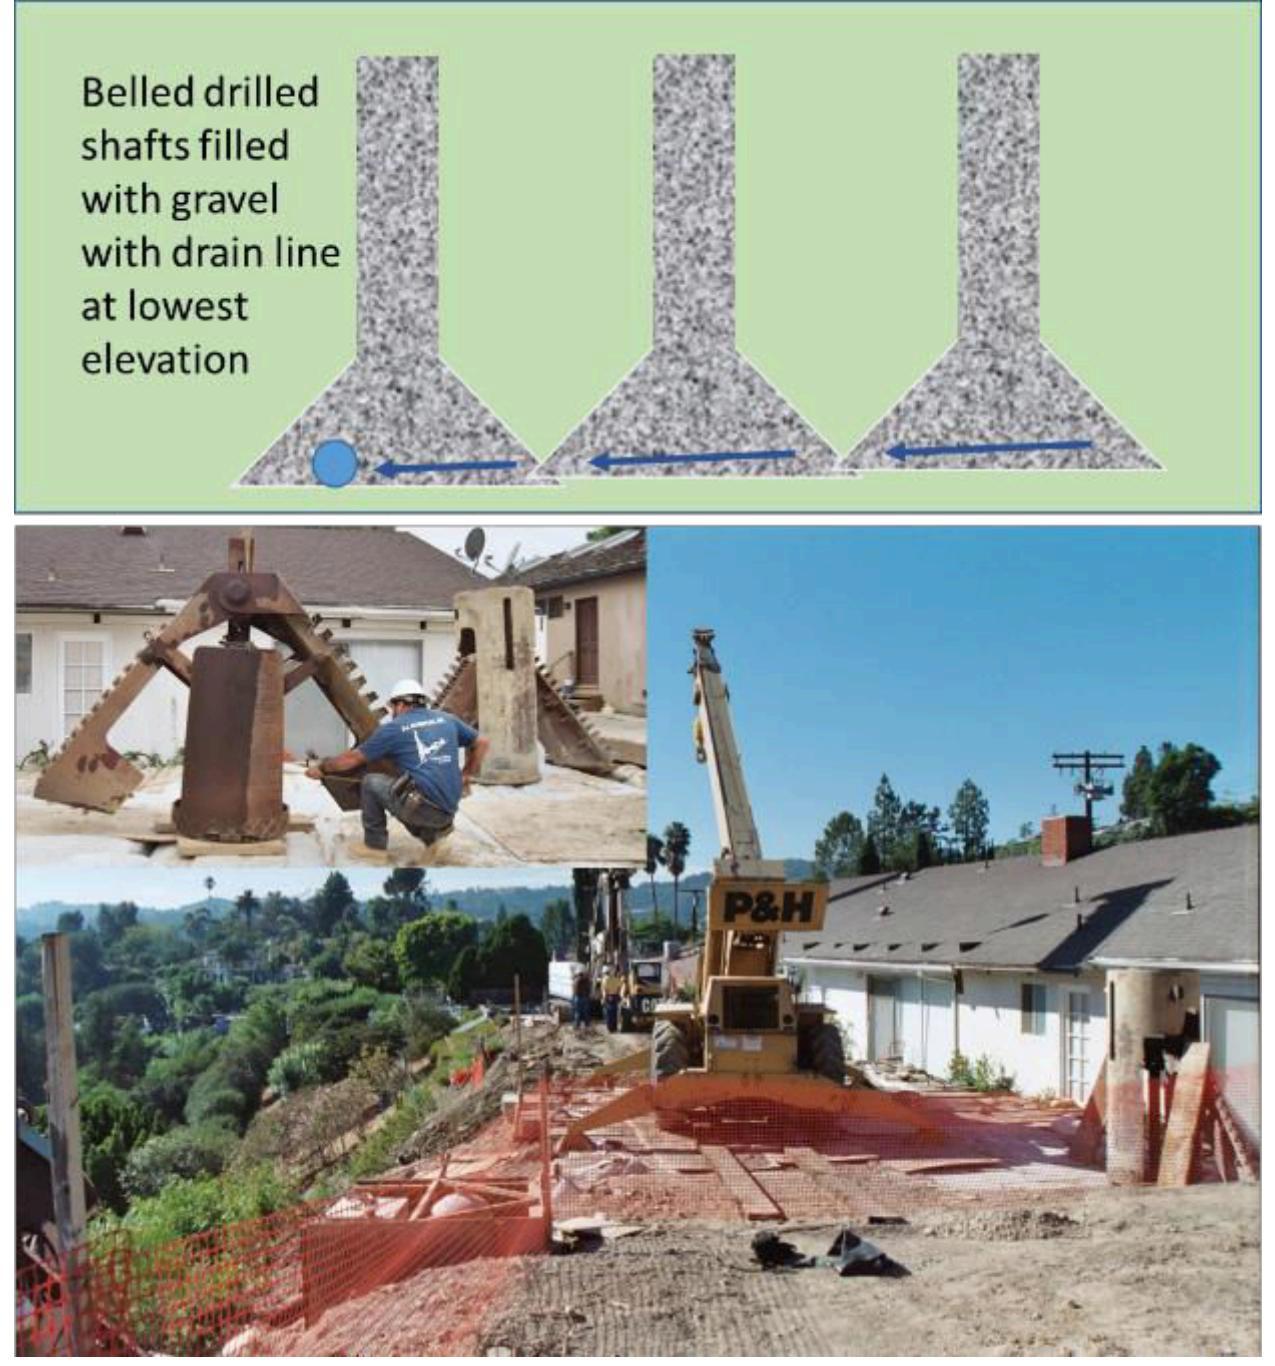
Figure 4. Construction of the drainage curtain.

- A 20 meter (65 feet) deep drainage curtain along the top of slope, to lower the groundwater pressures that lead to the previous failures of the slope (Figures 2 and 4). The drainage curtain was built using conventional drilling equipment of the type used to construct belled drilled shafts. After connectivity between the bells was verified, the holes were filled with gravel. Drilling was performed such that base of the bells had a gentle slope, and at the lowest bell elevation, an outlet pipe was installed by directional

drilling (Figure 4). A secondary pipe was installed from the slope to the middle of the drainage curtain for backup an maintenance purposes.

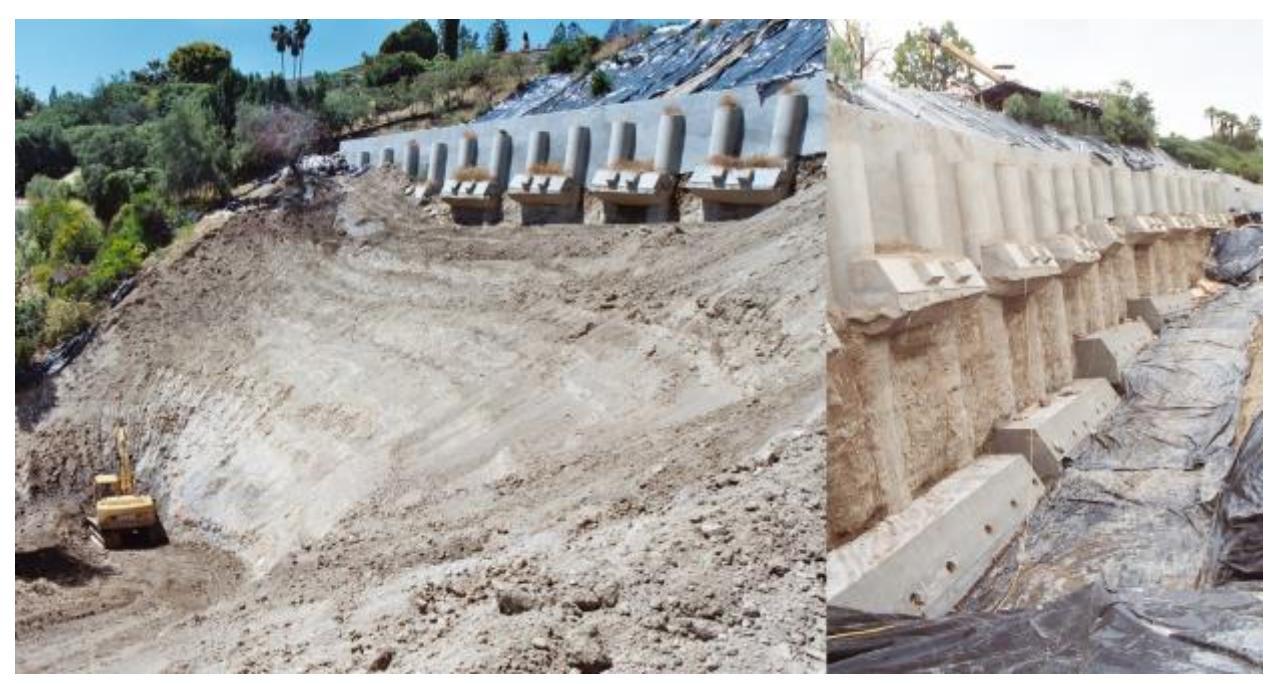
Figure 5. Excavation for tieback installation and buttress construction.

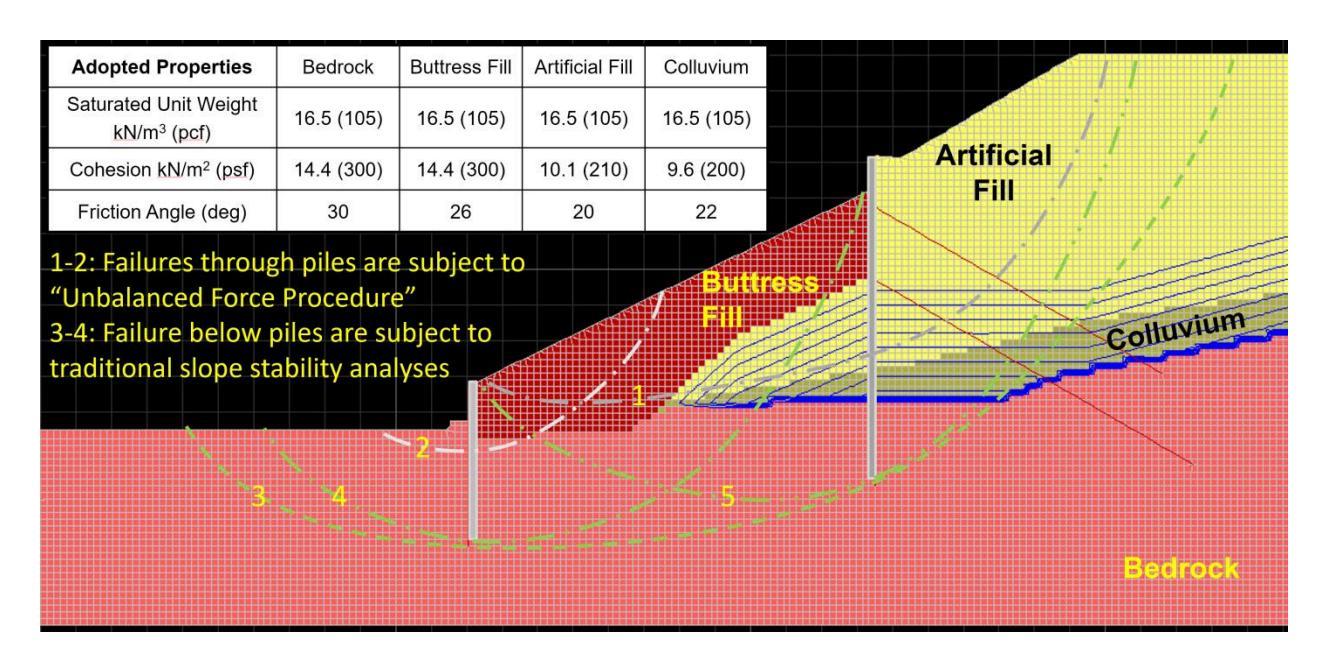
The various materials encountered under the subject slope are depicted in Figure 6. The soils for the original fill was derived from the underlying diatomaceous bedrock and near surface colluvial soils. The diatoms in the bedrock consist of fossilized skeletons of microscopic marine life which create lattice like structures with large internal empty spaces/voids. Typical dry densities of the local bedrock are very low, and at our site typically ranged from 8.8 to 11.9 kN/m³ (56 to 76 pcf). Compacted fills derived from these diatomaceous rocks are low plasticity silts and clays (ML to CL) that have low drained shear strength, and low permeability. The unusual combination of low dry density and low permeability results in dry bedrock fragments that often float in water for several minutes.

Using the shear tests from all the geotechnical consultants, a conservative composite strength envelope was derived for the different materials; the shear strengths adopted in our analyses are summarized in the table included within Figure 6.

Figure 6. Excavation for tieback installation and buttress construction.
