Marshy Area and Seepage Collector Drain

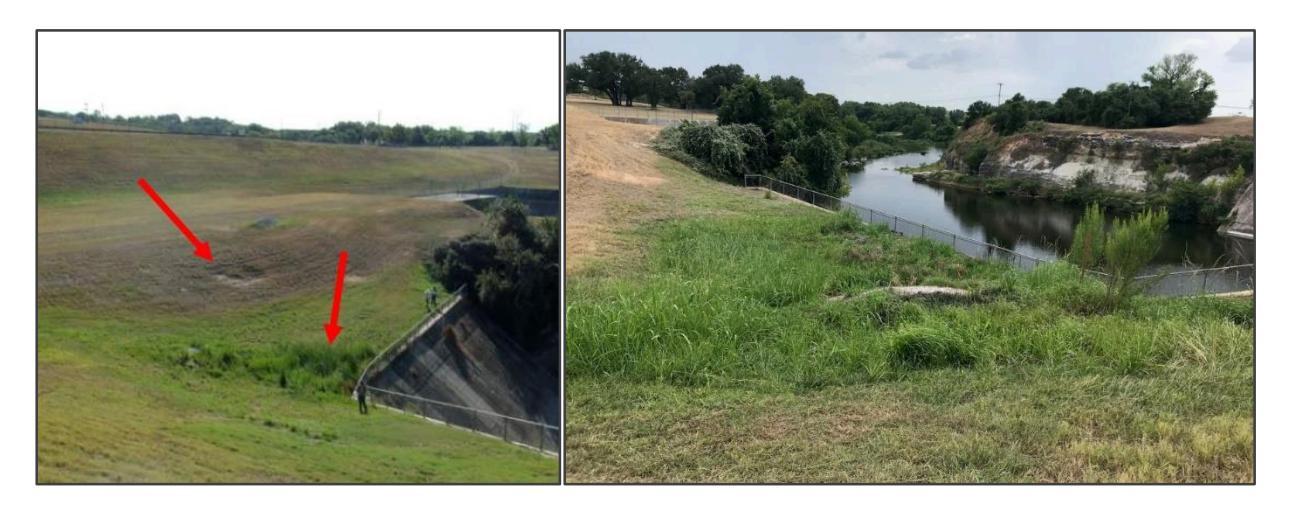
Figure 9: Marshy area on left side of Service Spillway basin

Seepage has been documented in the area between the Service Spillway and the left end of the Spillway Levee since at least the 1940s. The seepage continued at higher quantities after construction of the Side Channel Spillway. This seepage has developed a perennially marshy area beside the left training wall of the Service Spillway (**Figure 9**).

The 1969 final grading plan shows a trapezoidal flat area left of the left training wall at Elev. 626. The flat area is about 95 feet long, matching the stilling basin wall. Considerable fill was placed at some time, raising the grade at the northeast corner of the flat area to about Elev. 631 and flattening the slopes somewhat north and east of the flat area. The north 40 feet of the

previously flat area is perennially wet. Water seeps to the ground surface and runs over the top of the training wall into the stilling basin. The wet area is generally un-trafficable to mowing equipment. The wet area extends north up the slope another 10 to 20 feet. Green vegetation extends northwest along the chute wall about 70 feet from the corner and extends northeast up the groin about 40 feet. From the air, the green area is Y-shaped.

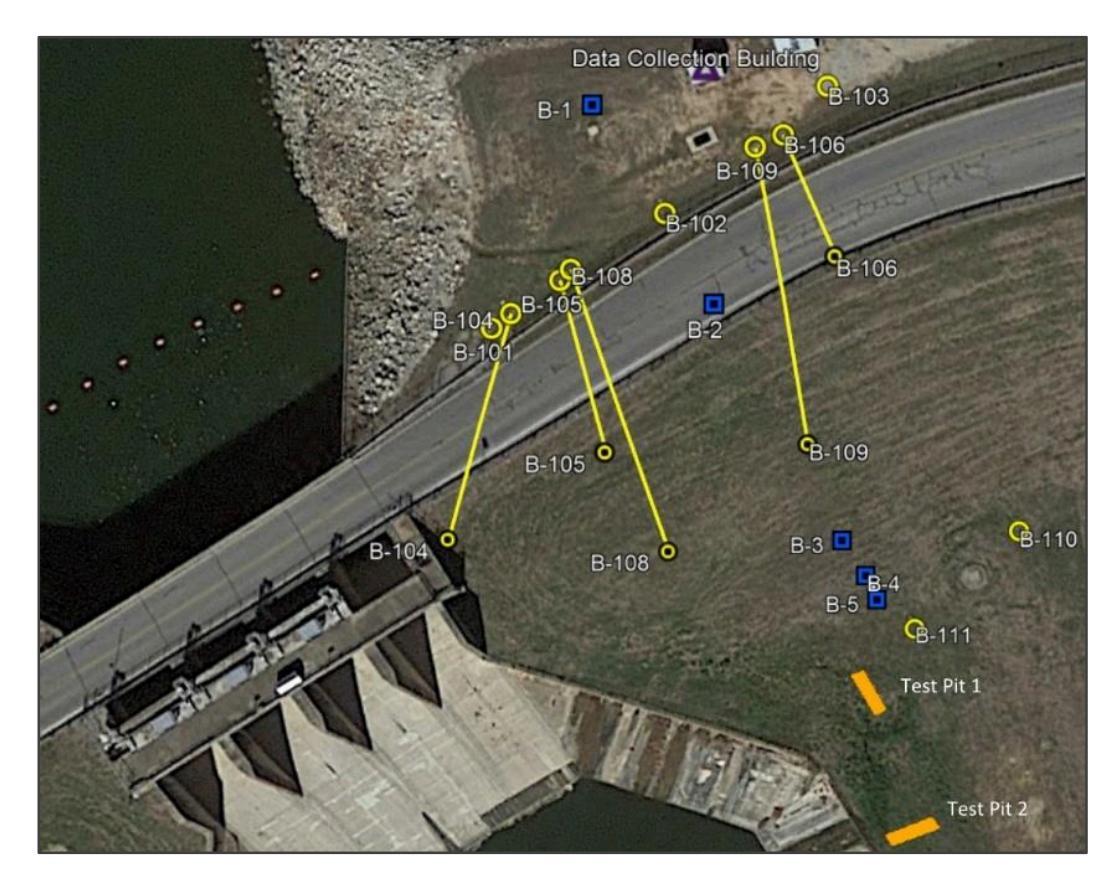
Figure 10: Plan of borings and test pits

Two test pits were excavated in 2014 using a tractor-mounted backhoe. Test Pit 1 was excavated in the slope immediately north of the north end of the east wall of the stilling basin and roughly 25 feet east of the wall. The trench was two feet wide, about 17 feet long, and had a maximum depth of about 4-1/2 feet. It encountered clay over clean, fine-grained, white sand over fine-grained, white sandstone (Packsand B). Water entered the pit rapidly, and the sides of

the trench began to slough. To minimize instability, the trench was backfilled promptly after the data collection. With the surface clay layer disrupted, the seepage developed at the surface, and a small sand boil developed. An inverted filter consisting of a mound of concrete sand covered by a mound of concrete gravel was constructed to filter the boil and control internal erosion. Water continues to flow across the marsh and over the stilling basin wall at this location.

Test Pit 2 was excavated about 56 feet north of the south end of the east wall of the stilling basin to locate and examine the perforated pipe drain. The pit uncovered the drainpipe, a white, 4-inch diameter PVC pipe with 3/4-inch-diameter perforations. It was surrounded by limestone gravel with significant clay. There was a mat of small roots around the pipe. The pipe sat on a surface of shale (likely Shale C) and there was no evidence of filter sand or geotextile filter material.
