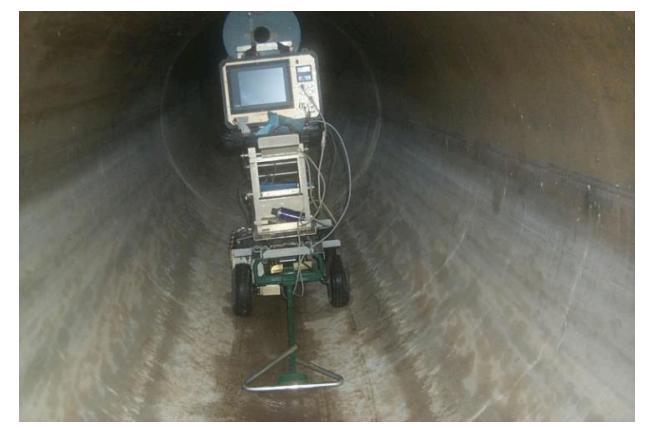
Fig. 11 PPIC RFEC/TC (Electromagnetic Survey)

broken wires that wrap the City's embedded cylinder 66-inch, 78-inch, 84-inch and 96-inch PCCP (Figure 11 and Figure 12). This new "tool" in Tucson's toolbox became an important part of Tucson's asset management program plans. Nine pipe segments were located with broken wires ranging from 5 wire breaks to 30 wire breaks.

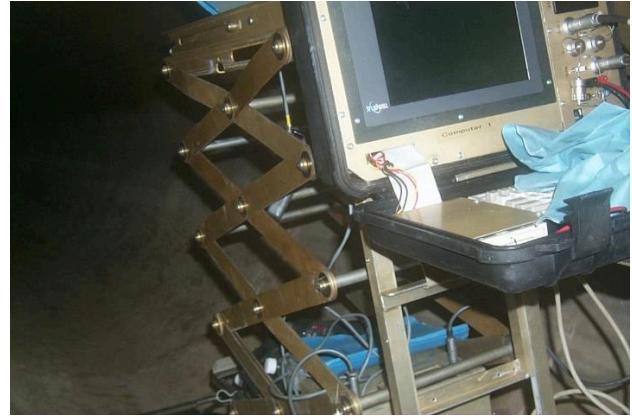
Fig. 12 PPIC REC/TC (Electromagnetic Survey)

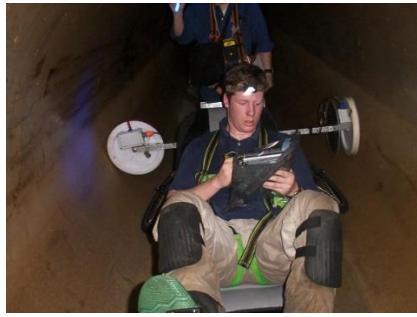
Fig. 15 Pure Tech. 66" EM Survey

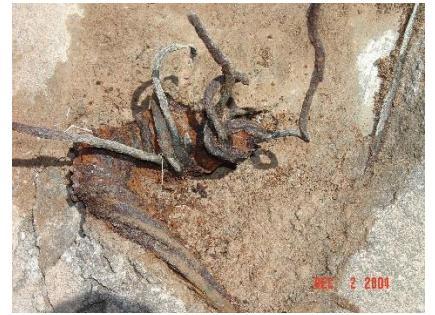
Fig. 16 Damaged Wires 66" PCCP

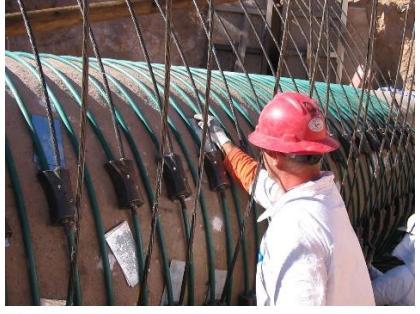
Fig. 17 66" Dia. Tendon Repair

Pipe with Broken Wires" (Zarghamee et al. 2003). As a participant in the study, Tucson received its first "risk curve" and was ready to apply this new tool to one of its monitored distressed pipes. The risk curve allowed Tucson to either intervene or continue to monitor distressed PCCP with broken wire regions. The transient pressure monitors allowed Tucson to measure the adverse effects of transients and surges on its PCCP inventory, especially areas of distressed pipe. In addition, Tucson had the transient events and knowledge control and could mitigate the damaging effects of pressure transients and surges. Equipped with a toolbox of tendons for repairing and rehabilitating distressed PCCP, transient pressure monitors (TP1 and TP3), and a GIS based pipeline risk management software system, Tucson began to pursue distressed pipe and proactively intervene when the risk of failure was determined too high. Beginning with a 66inch PCCP with an estimated 30 broken wires based on Electromagnetic (EM) results, coupled with the risk curve produced by SGH, Tucson excavated and validated a damaged 66-inch embedded PCCP (Fig. 15). Upon excavation of the pipe, Tucson had located and validated the damaged pipe, caused by a third party drill rig many years earlier (Fig. 16). The repair method chosen was "tendon repair", a method of using 3/8" braded steel protected by a lubricant filled nylon sheath, installed in circumferential hoops, approximately 3" apart and coated with shotcrete (Fig. 17).

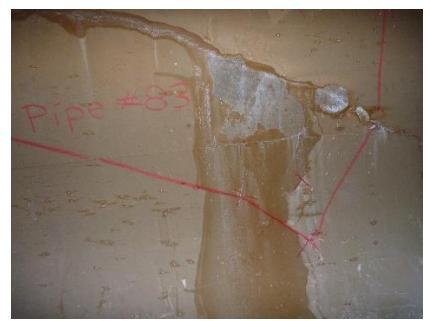
Fig. 21 Internal Crack 96" PCCP

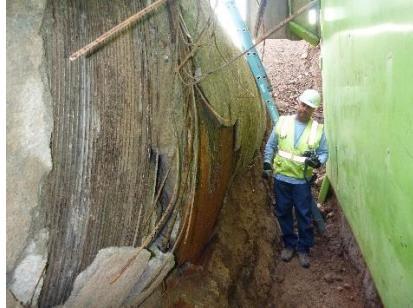
Fig. 22 Incipient Failure 96" PCCP

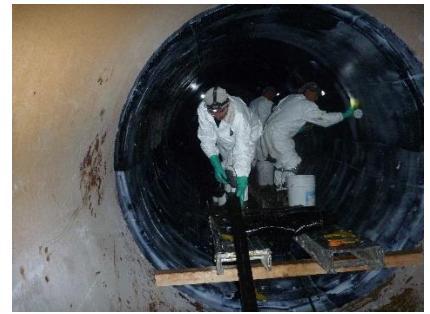
Fig. 23 Structural CFRP 96" Rehab

On August 17, 2012, 13 years following the catastrophic failure of the City's largest, most important water transmission line, Tucson Water experienced its biggest return on investment (ROI) since the implementation of its Pipeline Protection Program. Its single most important investment to date, acoustic fiber optics (AFO) for monitoring PCCP, alerted the City to 21 successive wire breaks over a 24-hour period, prompting the City to once again, shut down its largest most critical water transmission line (Fig. 21 and Fig. 22). However, this outage was without a catastrophic event that had previously cost the City approximately five million dollars in litigation and damage to infrastructure and private property. After promptly shutting the critical transmission line down, it was drained, inspected and the damaged area rehabbed with CFRP (Fig. 23)
