Innovative Methods for Rehabilitating Sanitary Sewer Service Laterals

Gregory K. Anderson¹
Daniel A. Riley²

Because of the City's aggressive attitude concerning rehabilitation of its wastewater infrastructure many state-of-the-art techniques for performing sewer rehabilitation have been initiated on their projects. This paper discusses a recent project, West Ghent Sanitary Sewer Rehabilitation, in which several innovative methods for rehabilitating service lateral piping has been implemented.

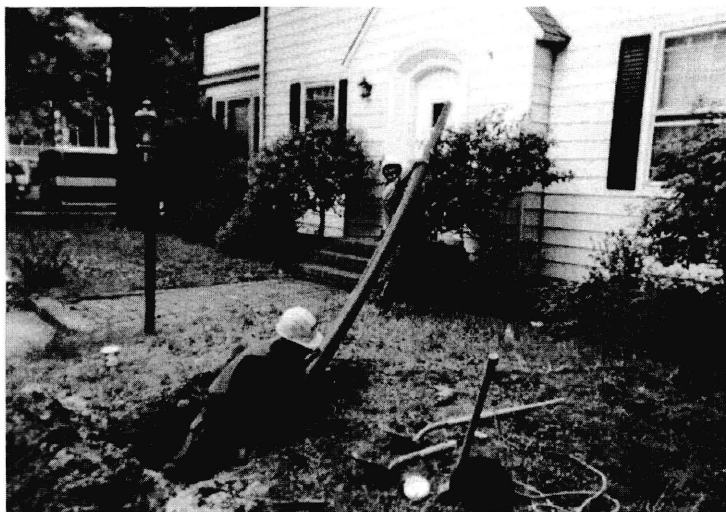
Preparatory work included marking the underground utility locations adjacent to the sewer main and the property line cleanout. Once all utilities were identified excavation at the main and at the property line were made. The pipe bursting equipment, pipe and pipe fittings were then mobilized to the excavations. The contractor then disconnected the lateral at both the property line and at the main and the bursting cable was pulled through the lateral to be bursted. Any necessary dewatering equipment was then placed in service and the contractor began the pull. Figure 1 shows the polyethylene lateral being pulled to the main through the access pit at the property line.

Figure 1. Polyethylene Lateral

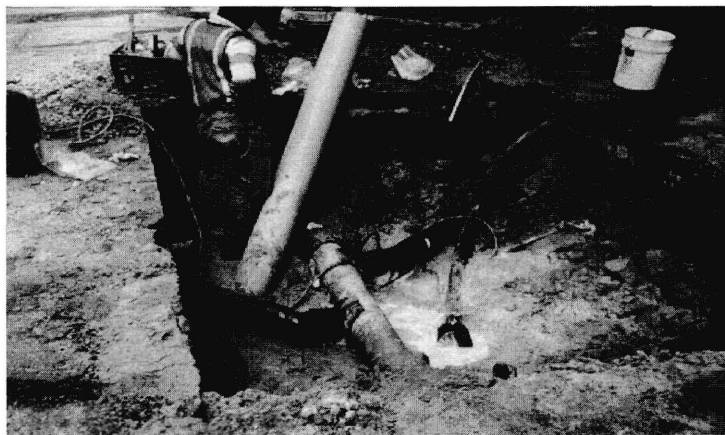
When the lateral is pulled to the main the bursting head is removed from the lateral and the contractor would then breakout the host pipe to expose the polyethylene liner. The new polyethylene lateral was then joined to the main utilizing an electrofusion polyethylene saddle and necessary electrofusion fittings. Figure 2 shows the final connection to the main with the saddle already connected and the lateral piping being joined to the saddle utilizing an electrofusion fitting.

Figure 2. Final Connection

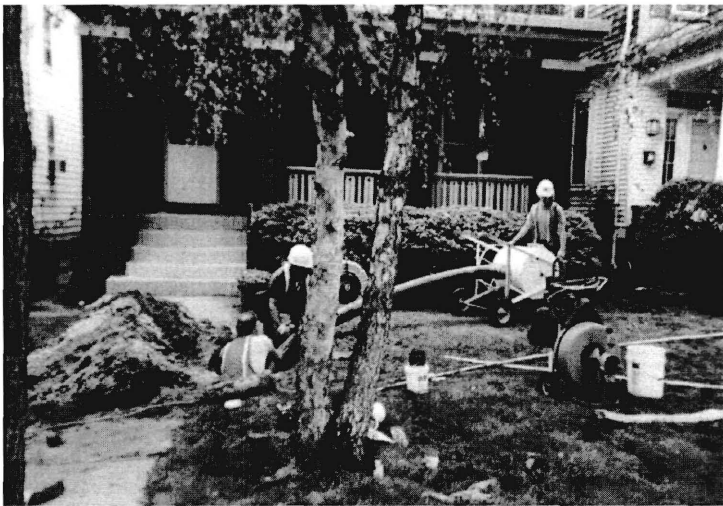
A calibration hose (bladder) is inverted by air into the liner by the blower expanding the bladder and molding the liner to the host lateral piping. Ambient air is provided by the blower at approximately 10 psi, and the liner is cured for approximately 30-45 minutes. After the lateral is cured, the bladder is deflated and removed from the lateral. Figure 3 shows the blower inverting the bladder into the liner.

Figure 3. Inverting Bladder
