The Effects of Poor Design and Construction Workmanship on a Mechanically Stabilized Earth (MSE) Segmental Retaining Wall (SRW) in North Carolina

Antonios Vytiniotis, Ph.D., P.E., M.ASCE¹; David W. Sykora, Ph.D., P.E., D.GE, M.ASCE²; and Brendan Casey, Ph.D., P.E., M.ASCE³

A two-tiered mechanically stabilized earth (MSE) segmental retaining wall (SRW) system with a maximum height of approximately 90 feet along its curving, concaved section was built at a new residential development near Asheville, North Carolina, in 2011. The two-tier section of the wall was approximately 400 feet in length where the upper wall was nested within the lower wall to account for a topographic depression and the site-specific grading. During the last layers of fill placement of the two-tier portion, substantial bulging, vertical deformations, and cracking along the face blocks of the wall were observed. As a result, the owner of the wall decided to demolish a significant portion of the upper wall. A detailed field investigation was performed, before and during the wall removal, to evaluate the as-built conditions of the MSE/SRW wall and to assess the potential factors that contributed to the observed

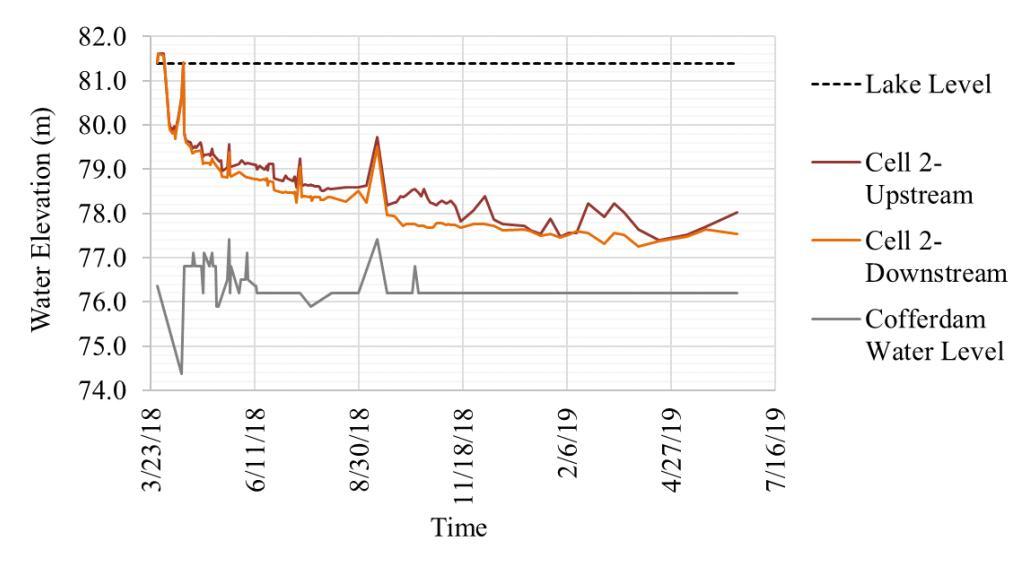
Figure 6: Comparison of Observation Well Readings, Cell 2

- Observation well readings showed, even with free draining cell fill materials, that it took several months for the saturation level in each cell to reach equilibrium. During this time period, weep holes continued releasing water and the pumping efforts were coordinated to maintain the water levels within the cofferdam area at a target elevation. It is very important to have backup power and spare pumps on site during the dewatering phase and throughout the entire spillway re-construction project in order to be prepared for storm and other unexpected events.

- A geomembrane bag, positioned on top of the cellular fill material, was used for collecting the water pumped from the cofferdam system before depositing it back into the lake. During one instance, a steady increasing trend of the water level within an observation well indicated that damage had occurred to one of the geomembrane bags which was causing water leakage back into cell. This problem was resolved simply by replacing the damaged geomembrane bag.

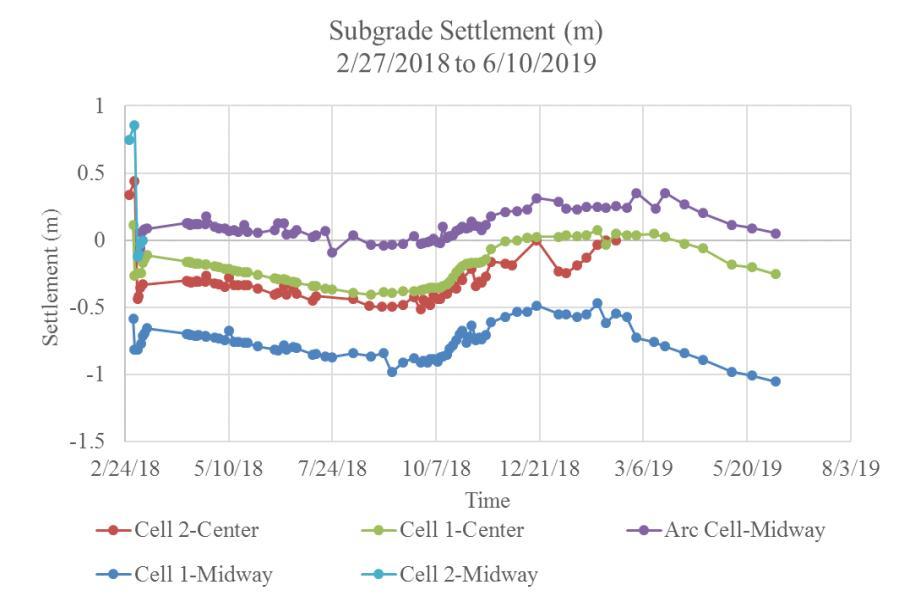
Figure 7: Comparison of Settlement Plate Readings

Settlement plate readings presented in Figure 7 show an immediate settlement up to 90 cm during cell filling followed by heave up to 17 cm during cell dewatering. Two of the settlement

plates stopped functioning while the remaining three settlement plates continued to collect data. The settlement plate readings changed steadily at a slow rate as the cell saturation levels reached an equilibrium and consolidation settlement of the foundation soils under the weight of cell fill slowed down. The elevation of fill material at the top of the cofferdam cells was also surveyed to identify if any area settles more than expected and if additional fill would be necessary. Field surveys showed no significant change in cell fill elevation.

- Settlement plates shifted during construction. However, the data were still valuable as they provided information about the overall trend and rate of settlements, and also the differential settlements between different cells.

- Although the measured settlements of the settlement plates exceeded the estimated settlement limit of 30 cm, an evaluation of the settlement data along with data from other instruments indicated no significant concerns for the stability of the cofferdam cells and no significant settlement was observed at the top of the cofferdam cell fill during site inspections.

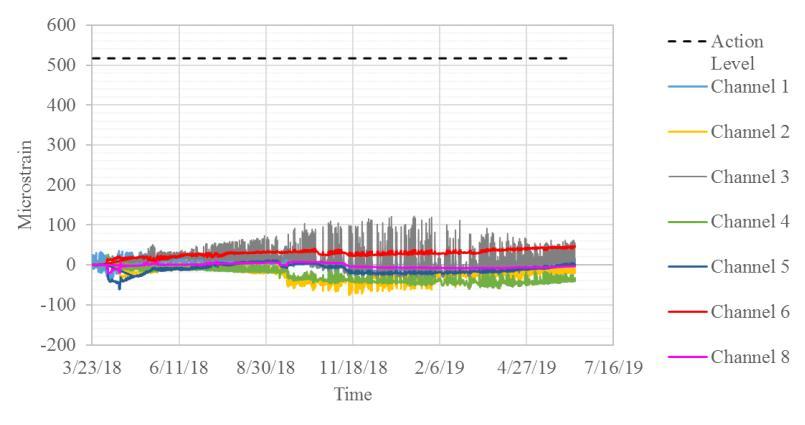
Figure 8: Strain Gauge Data

Vibrating wire strain gauges were used to monitor bending stresses and interlock tensions. They were installed at multiple elevations on the inside and outside faces of the sheet piles and readings were compared with pre-determined action levels to inform whether any interlocks in the vicinity of the strain gauges were subjected to excessive tensions. While some of the strain gauges produced continuous data, others experienced temporary malfunctioning or provided data with a low signal-to-noise ratio. An example set of strain gauge data (presented in Figure 8) show that channels 2, 3 and 4 had significant noise in data and data in other channels were reasonably clear and steady. Several strain gauges showed sudden spikes or had temporary malfunctioned. The overall goal was to capture the steady changes in strain levels of the sheet piles. Only in one channel did the strain level reach the action level throughout the monitoring program. However, comparing the readings from that gauge with readings from other strain gauges in the vicinity indicated that particular strain gauge might have malfunctioned. As an additional precautionary measure, field surveys were performed in this area to monitor movements during this timeframe.

- Field surveys were performed at a location where the vibrating-wire strain gauges stopped functioning. A couple of the vibrating-wire strain gauges were recovered after temporary malfunctioning while others failed and were inoperable for the duration of the construction. Some of the instruments continued to have a signal noise. However, having

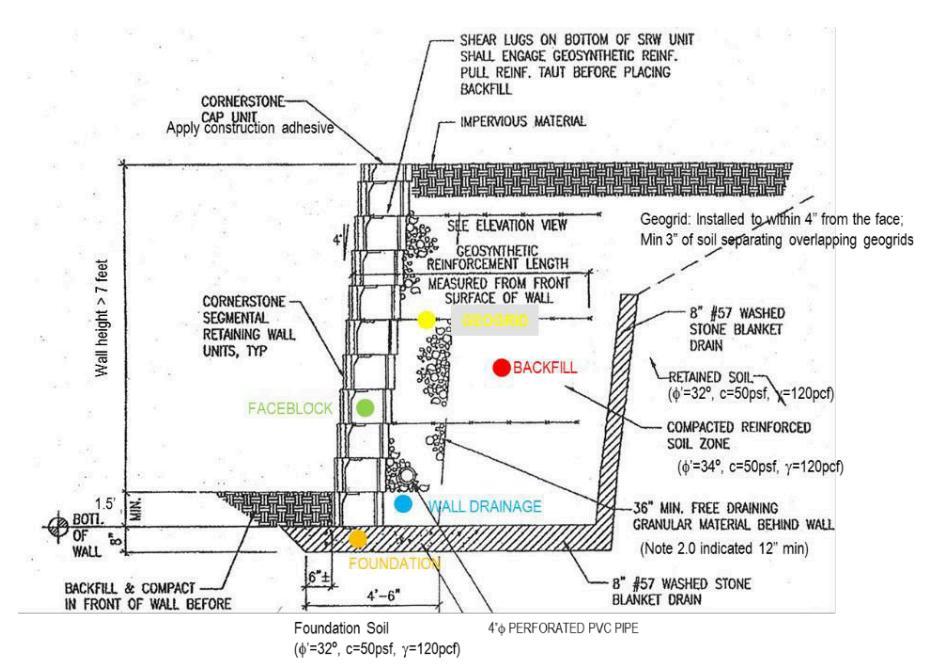
Figure 2. Typical MSE/SRW cross section. Noted points indicate features evaluated during the forensic investigation.

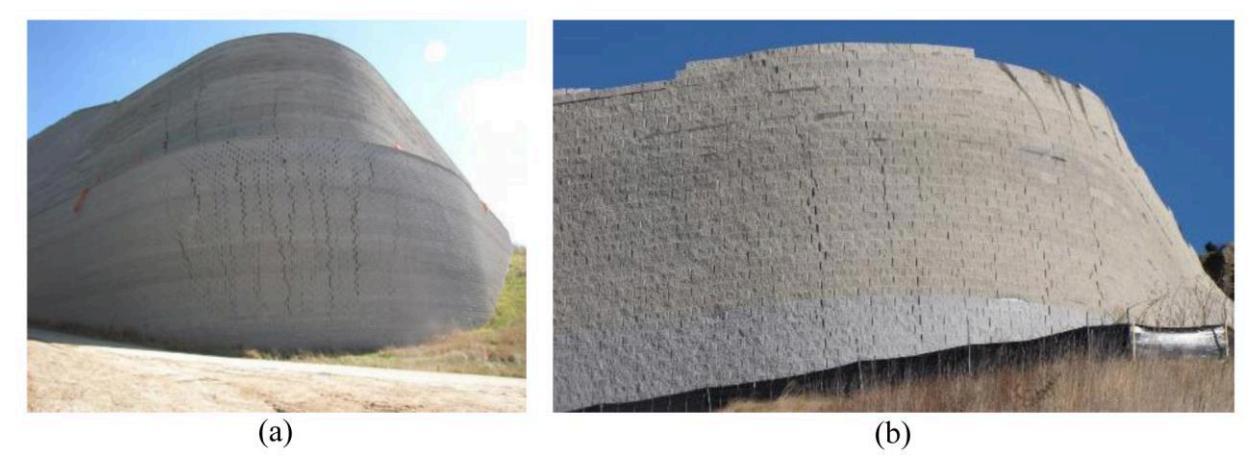
Cracking of the concrete facings of the Lower Wall continued to worsen and facing blocks on the Upper Wall also began to crack. Example photos of these cracks are shown in Figures 3a and b. By January 2011, multiple cracks were conspicuous along the facing blocks and the Lower Wall was noticeably bulging as shown in Figure 3. Differential settlement of both walls was visible. In response, Buncombe County building officials issued a stop work order on

Figure 3. Cracks in and widened separations between facing blocks: a) Northeast corner showing Upper and Lower Walls (photo date: 09/29/2011); and b) Southwest corner of Lower Wall (photo date: 12/02/2011).

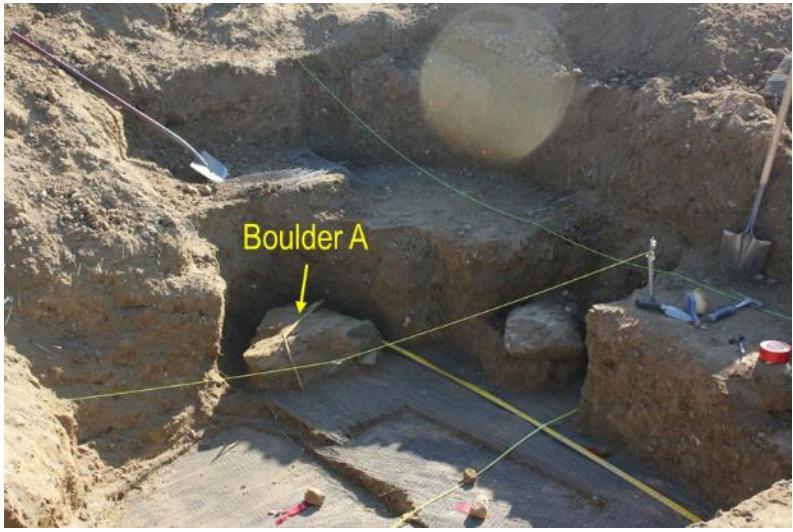
As part of the authors' field investigation of the backfill zone, 13 test pits and 13 sand cone field density tests were performed and in the process, 60 geogrid samples, 15 bulk soil samples and 4 masonry block samples were collected. Laboratory analysis consisted of moisture content testing (per ASTM D2216) of samples collected in sand cone testing (ASTM D1556) and standard compaction testing (ASTM D698) on collected bulk samples. Table 1 shows a summary of the field dry unit weights and the percentage compaction based on the measured compaction tests. Density measurements showed that the in situ fill density was well below the design specification of 95% relative compaction. Moreover, a significant percentage of fines was found in the samples. Five out of six samples tested were found to have more than 20% fines. In multiple locations, cobbles and boulders were encountered within the backfill (Figure 4). In some cases, boulders as large as 29 inches were observed. Large boulders are known to severely

damage the geogrid during construction and cause difficulties with achieving the required backfill compaction. In other locations, roots were observed (e.g., STA 7+80). The conditions of poor compaction and backfill, not in compliance with material specifications, appeared to be the result of poor workmanship and inadequate inspection.

Figure 4. Cobbles and boulders in reinforced zone backfill. "Boulder A" has maximum triangular dimensions on sides of 28"x29"x23" and a height of 10" (photo date: 12/10/2011).
