7. Ports, Marine Oil Terminals, and Airports

Port, marine oil terminal, and airport facilities were investigated during the ASCE-TCLEE post-earthquake reconnaissance following the January 2010 Haiti earthquake. Many of the waterfront facilities near Port-au-Prince suffered significant damage during the earthquake and aftershocks, with the majority of the structures damaged and many unusable for weeks or more following the earthquake due to strong ground shaking and liquefaction.

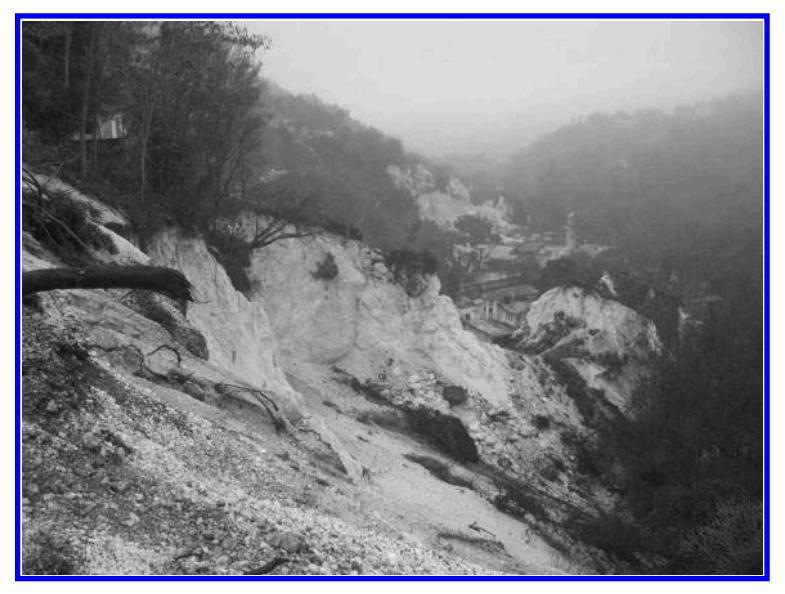
Figure 6-36. Extent of slide (Photo by Curt Edwards)

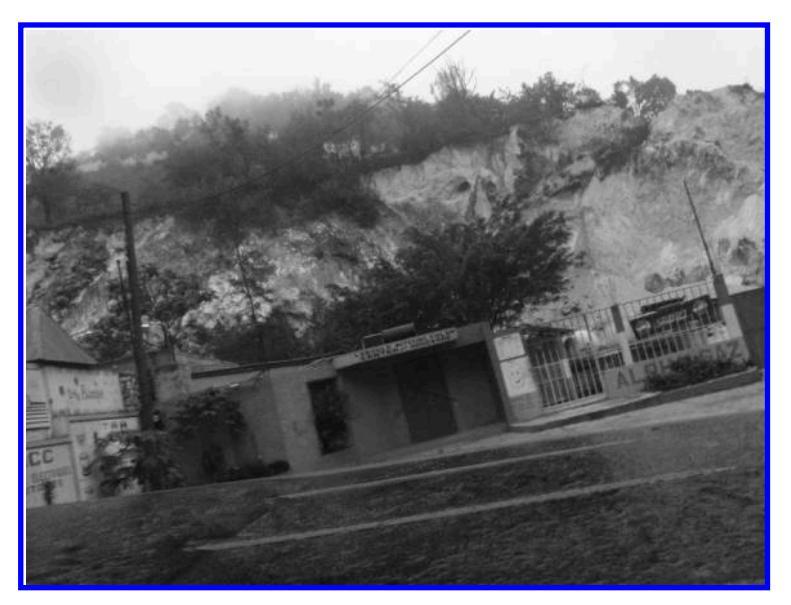
Figure 6-37. Slide from below (Photo by Curt Edwards)

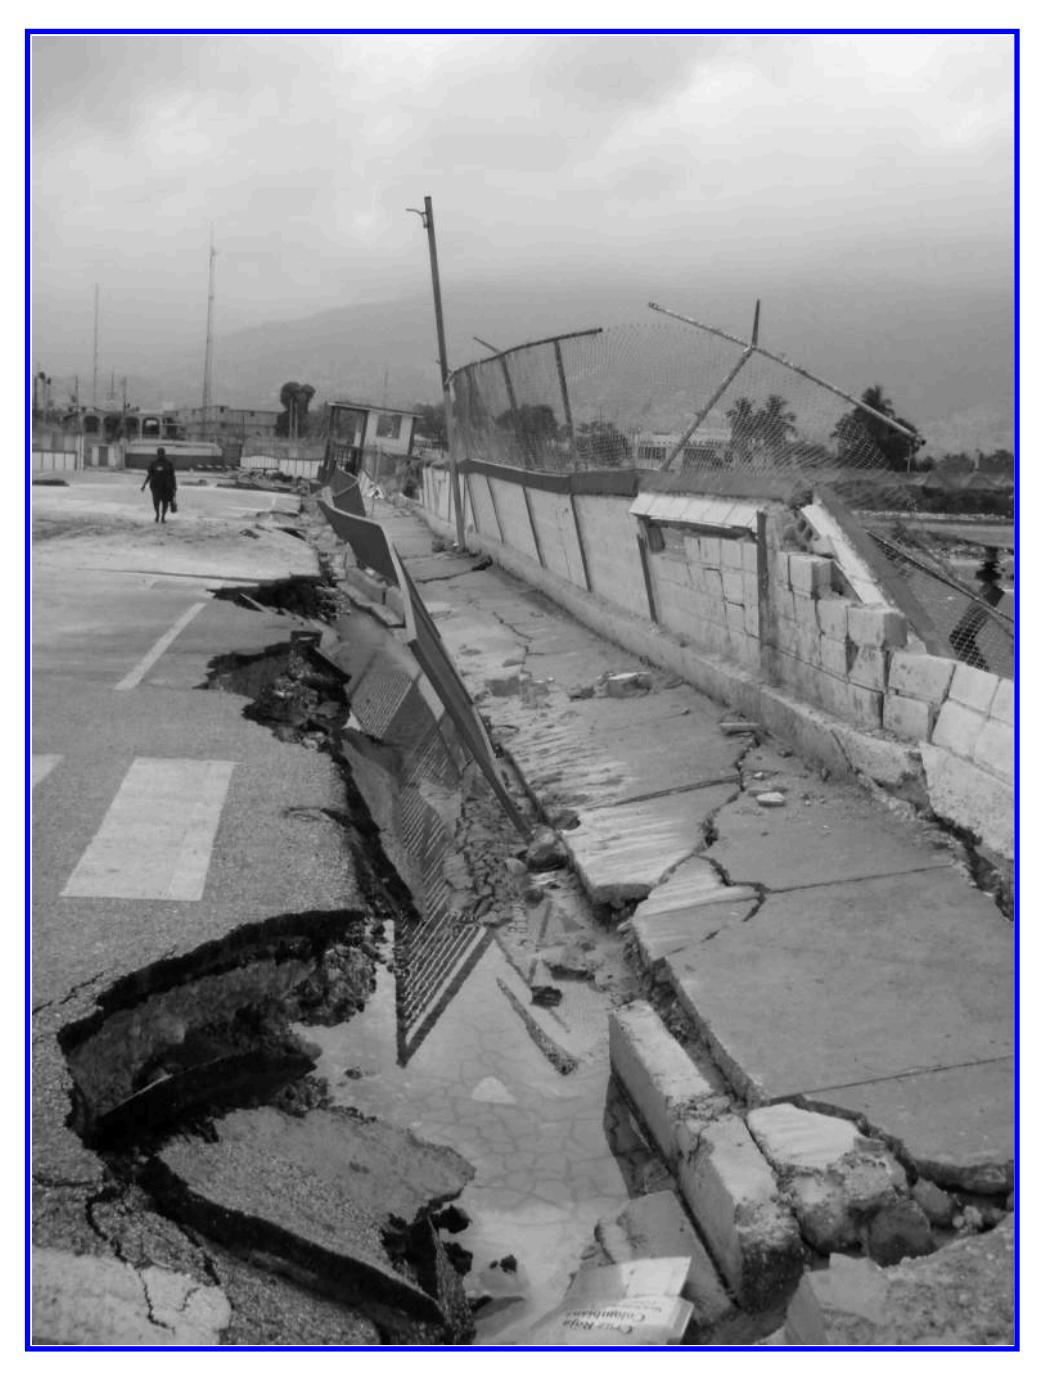
The main port entrance was significantly damaged during the earthquake and became unusable afterwards. Liquefaction evidence and lateral spreading were observed along the port entrance road (Fig. 7-3).

Figure 7-3. PPAP port entrance damage (Photo courtesy of Nason McCullough)

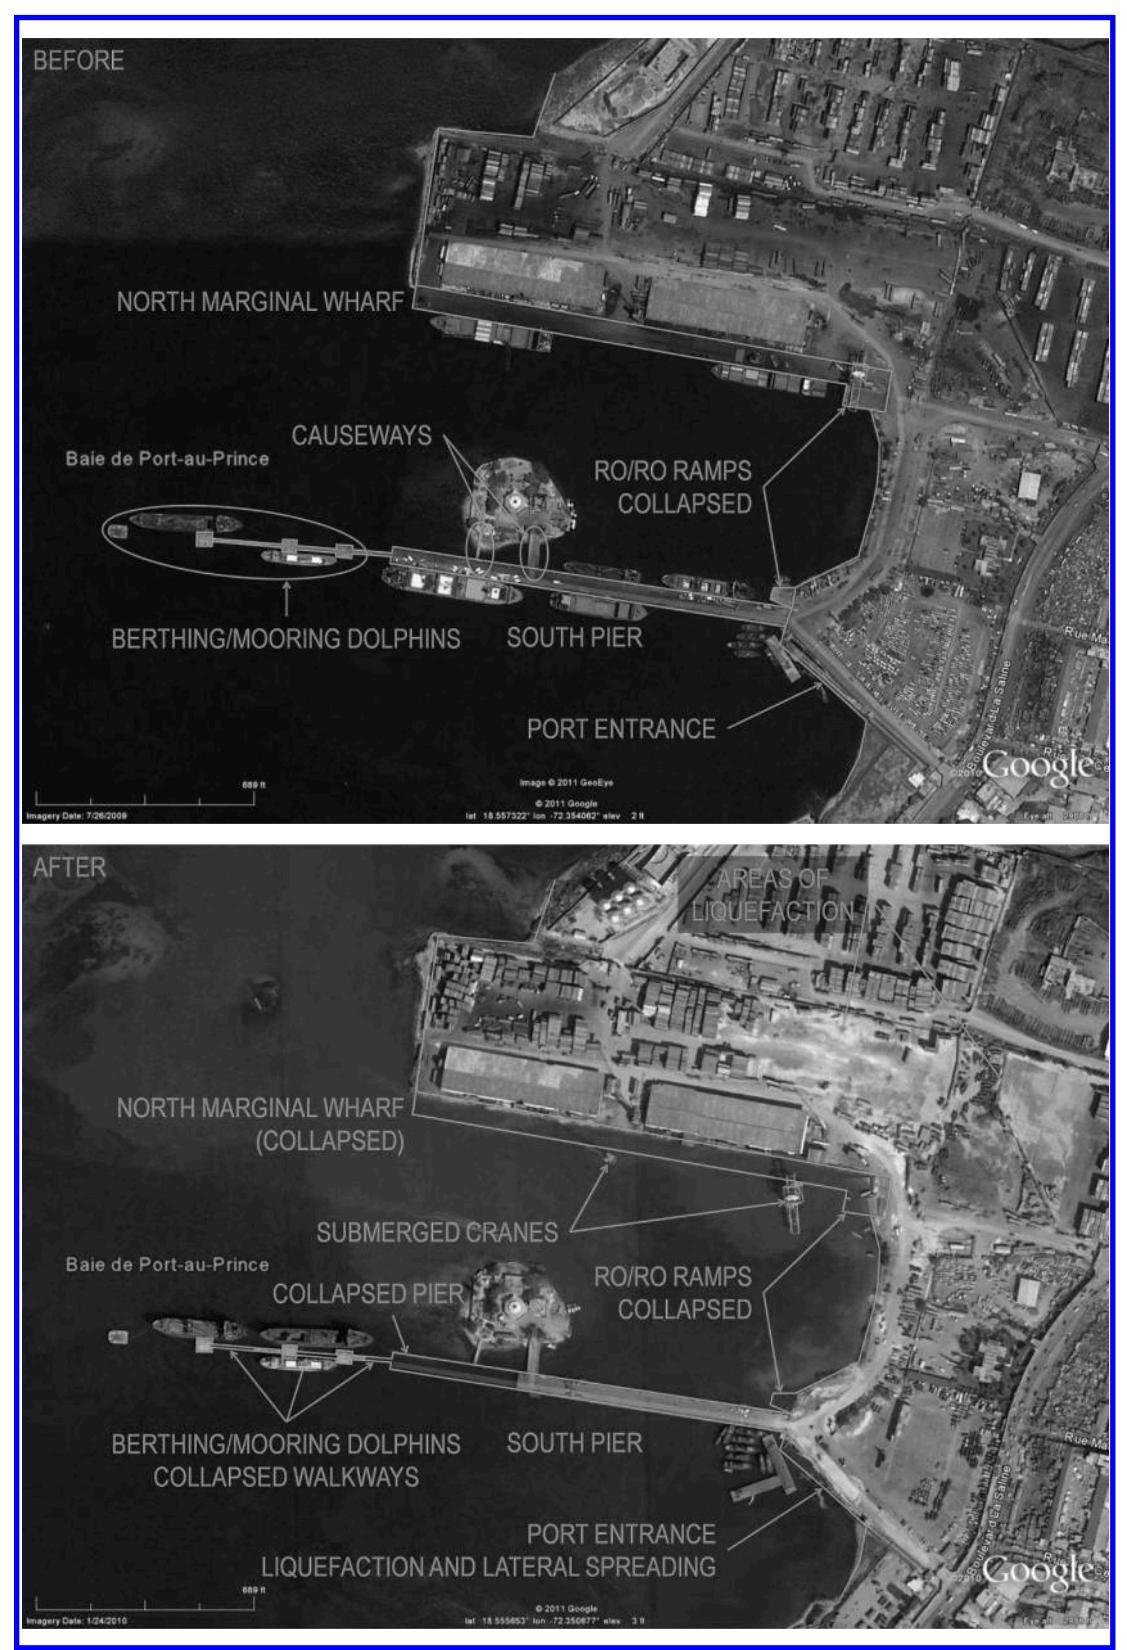
The north wharf and Ro/Ro ramp collapsed during the earthquake (Fig. 7-4), and two of the three cranes were submerged in the water. During the earthquake, two vessels were moored to the north wharf, and a crew member from one vessel took several photographs of the immediate post-earthquake damage. Figures 7-6 through 7-9 are photographs taken from the moored ship following the earthquake. The photographs provide evidence that the wharf did not initially collapse completely: After strong shaking the wharf was still above water and gradually collapsed into the bay. Figure 7-6 provides an aerial view of the North Wharf several days after the earthquake and shows complete collapse of the wharf into the bay.

Figure 7-4. PPAP North Wharf and South Pier before and after the earthquake (Image © 2011 Google, GeoEye, with permission from GeoEye)

There was evidence of liquefaction in the backland areas (Fig. 7-4). Large ground cracks were also observed along and near the edge of the waterline (Fig. 7-7 through 7-8), presumed to be caused by the significant liquefaction.

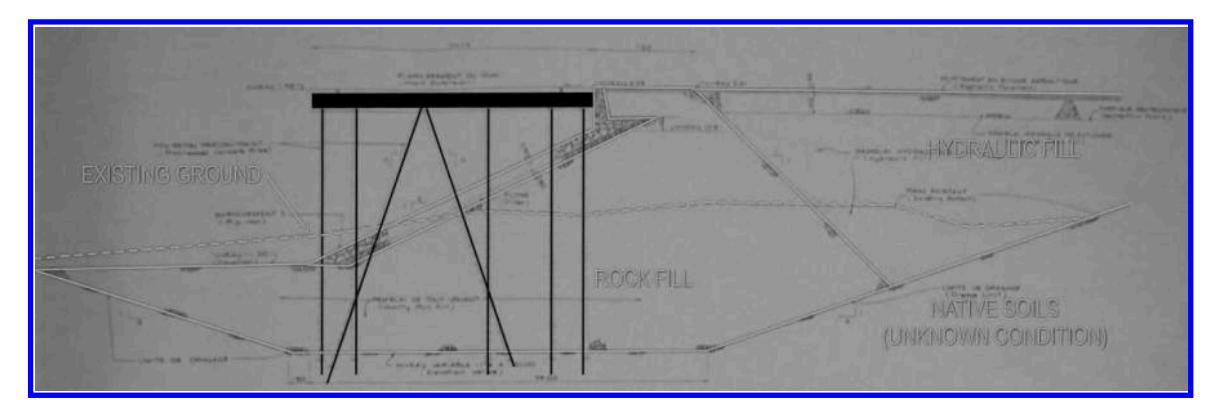
Figure 7-5. PPAP North Wharf as-designed geometry

The North Wharf was a marginal wharf constructed in 1979 approximately 457 m (1,500 ft.) long and 12 m (70 ft.) wide supported by 45 cm (18 in.) square pre-stressed concrete piles with plumb and two batter piles per bent (Fig. 7-4, 7-5). There were five plumb piles and two batter piles per bent (NAVFAC 1994). The wharf supported a rail-mounted gantry container crane and two mobile harbor cranes. The water depths along the berth line ranged from 10 to 12 m (33 to 39 ft.) before the earthquake. A Ro/Ro ramp was located adjacent to the wharf on the east end.

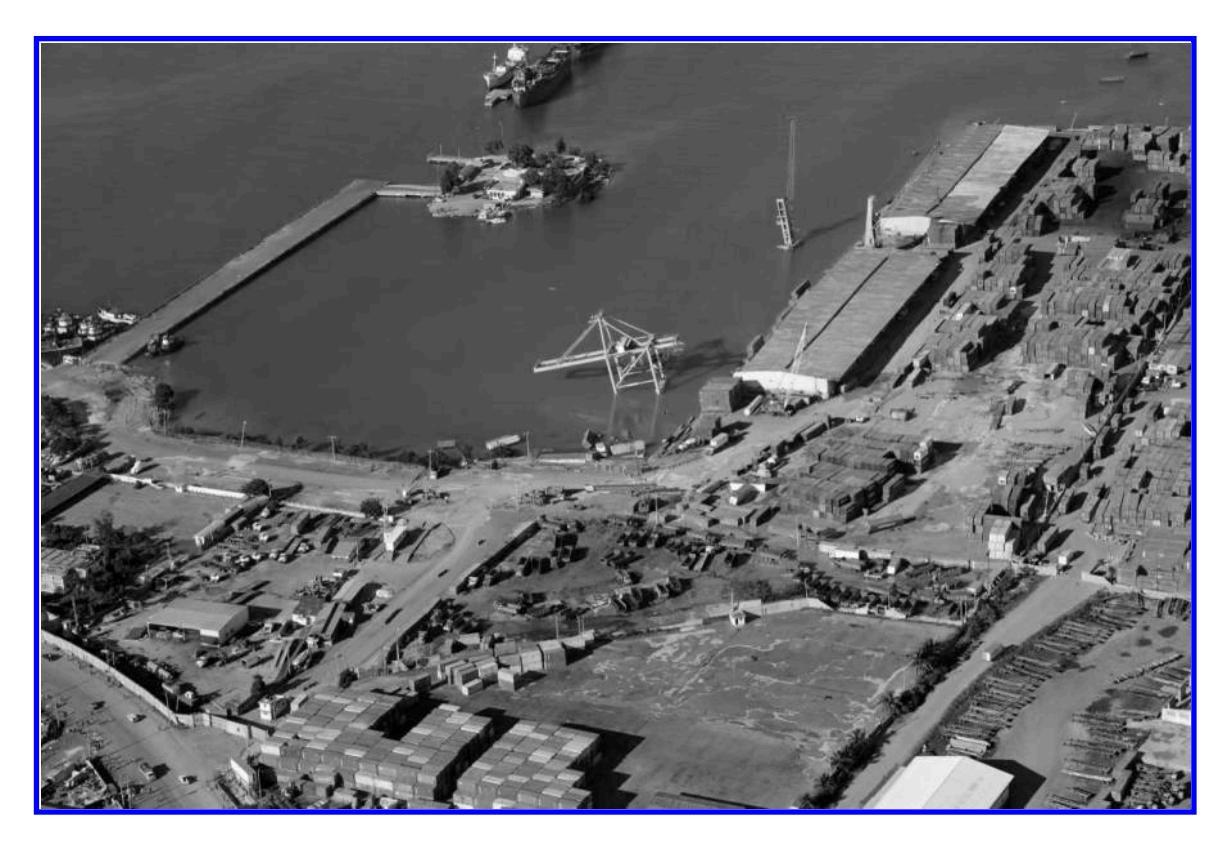
Figure 7-6. PPAP North Wharf damage 4 days after the earthquake (Photo courtesy of the Department of Defense)

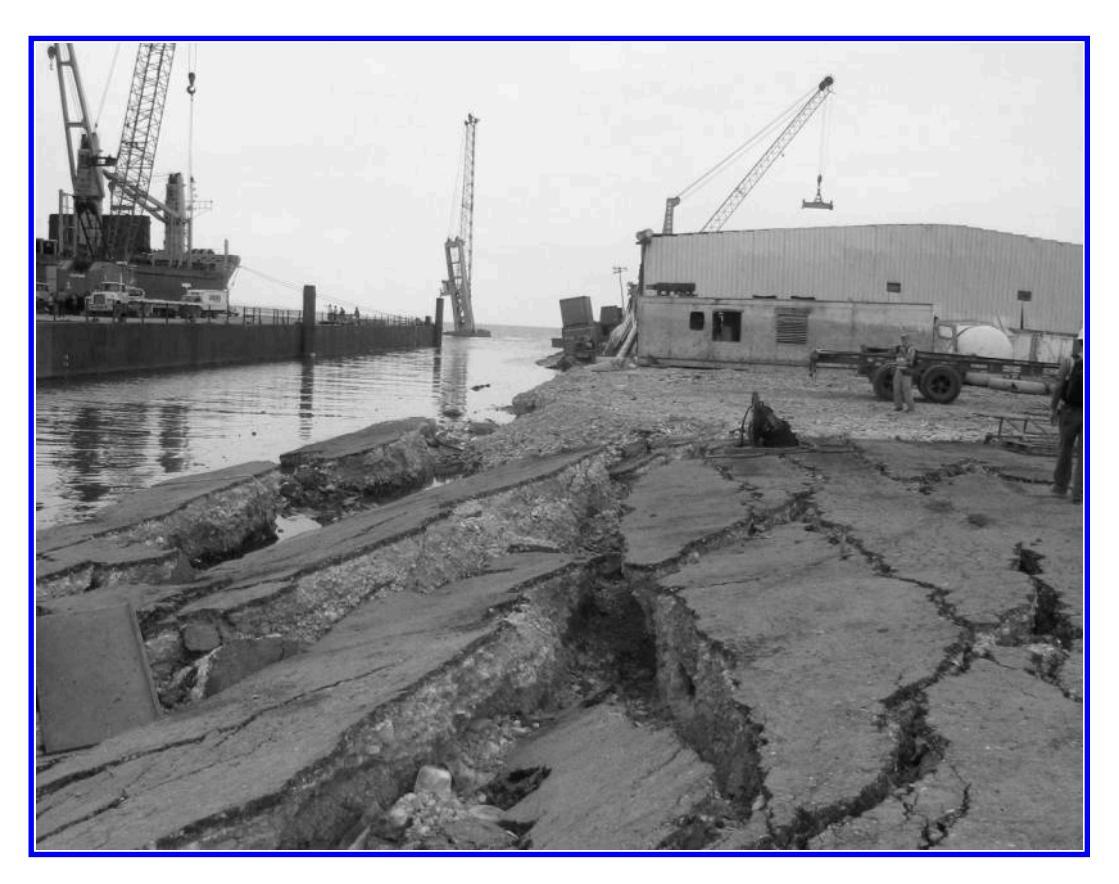
Figure 7-7. PPAP North Wharf damage and ground cracks (looking west) (Photo courtesy of Alex Augustin)
