Advances in Acoustic Methods for Locating Leaks in Plastic Pipe and Trunk Mains

Marc Bracken¹, M.A.Sc., P.Eng., Dave Johnston¹ B.A.Sc.

¹ Echologics Engineering Inc., 50 Ronson Road, Toronto, Canada M9W 1B3, email: marc@echologics.com

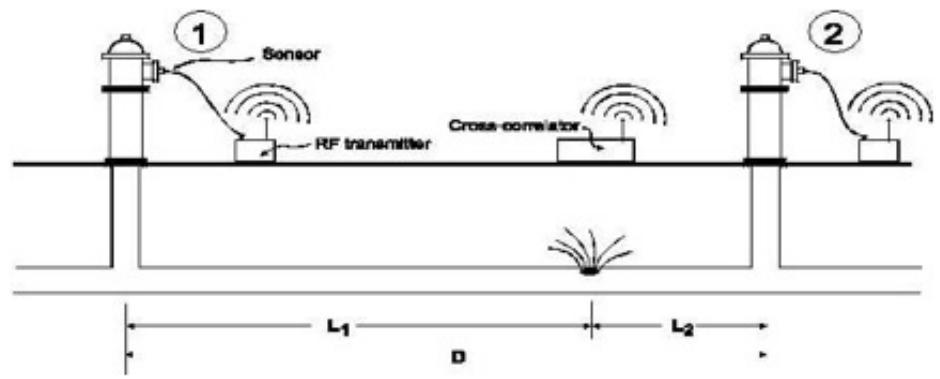
Figure 1: Correlation Background

The background theory for the cross correlation method is a simple time of flight as shown in figure 1. Essentially, the leak makes noise, and it will take longer for the acoustic wave from the leak to reach point 1 than it will point 2.

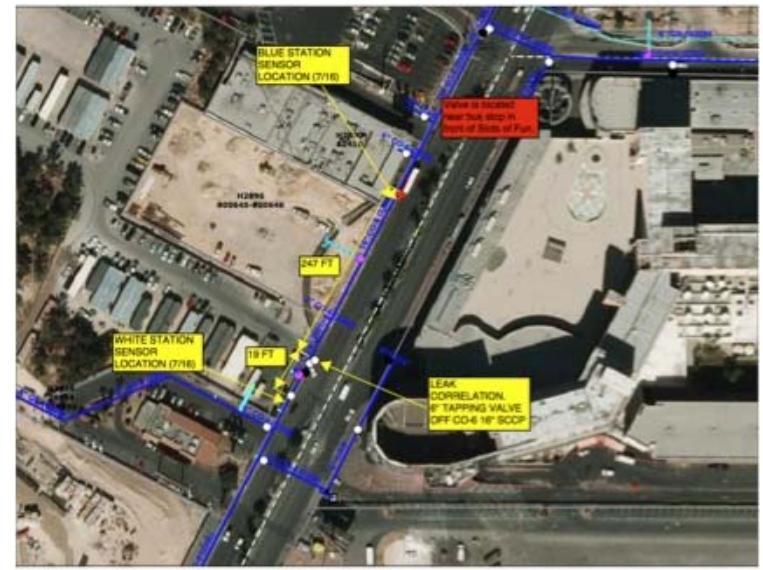
Figure 2: Site Location, Las Vegas Boulevard.

Figure 2 shows the site plan of the area where the leak was located on Las Vegas Boulevard. Once the correlation was obtained, it was clear that there was obvious dipping of the pavement in the area as shown in Figure 3.
