## TANK DESIGN

## PRESTRESSING STEEL FOR WATER TANKS

## PRESTRESSING STEEL FOR SEWAGE TANKS

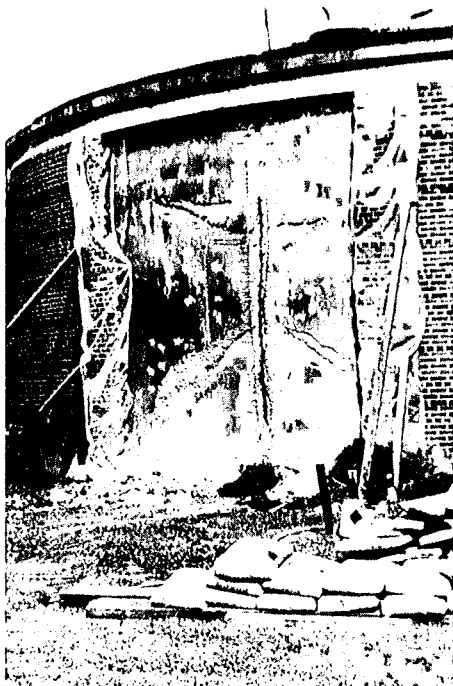
It is also worth mentioning that in another sewage digester which suffered a failure, but not of a catastrophic type, the corrosion of the wires were generally limited to those areas where the sewage had access to the wire. Fig. 10 shows a crack pattern in a small digester that manifested this type of failure after about 11 years of use. Note that the failure lines follow approximately the yield lines of a plate

supported on four sides. The first indication of leakage this tank indicated by the vertical cracks. But during inspection, the yield line cracks of the concrete were traced.

An initial crack in this tank was caused by the type of vertical prestressing unit used. The vertical unit was placed on the inside face of the wall and quite often it cracked the wall from top to bottom. Generally, after circumferential prestressing, these cracks were closed up so that they could not be found. Apparently, the failure of the crack did not close up completely and sewage found its way into the crack. It apparently, with time, corroded the prestressing wire in the immediate vicinity of the vertical crack.

It was most interesting to note that when one removed the mortar on the outer side of the crack, the wires were exposed. In this particular instance, the color of the corrosion was black. This apparently indicated that a ferric sulfide was produced. The corewall crack itself also indicated that it must have been acted on by some rather strong acid. The cracked area in-

Fig. 10—Sewage tank failure
