# FRP Application in Underwater Repair of Corroded Piles

by R. Sen, G. Mullins, K. Suh, and D. Winters

**Synopsis:** The poor durability of conventional corrosion repairs has led to increased interest for its replacement by fiber reinforced polymers (FRP). Over the past decade, several highway agencies completed demonstration projects in which FRP was used to repair corrosion damage on surfaces that were dry. These repairs have held up well and show little sign of deterioration. The availability of resins that can cure in water has made it possible to explore the application of FRP for the underwater repair of corrosion-damaged piles. This paper presents findings from three demonstration projects in which corroding reinforced and prestressed piles at two contrasting locations were repaired using two different FRP systems. Several piles were instrumented to allow long-term corrosion monitoring. The projects confirm the feasibility of conducting underwater FRP repairs in tidal waters. Preliminary data suggests that the wrap leads to a reduction in the prevailing corrosion rate.

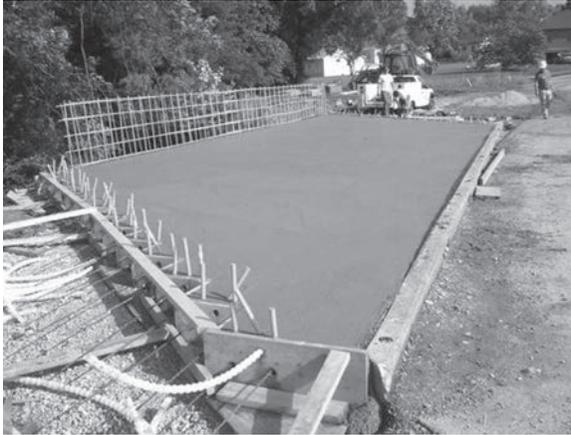
Figure 11—Poured FRP Bridge Deck

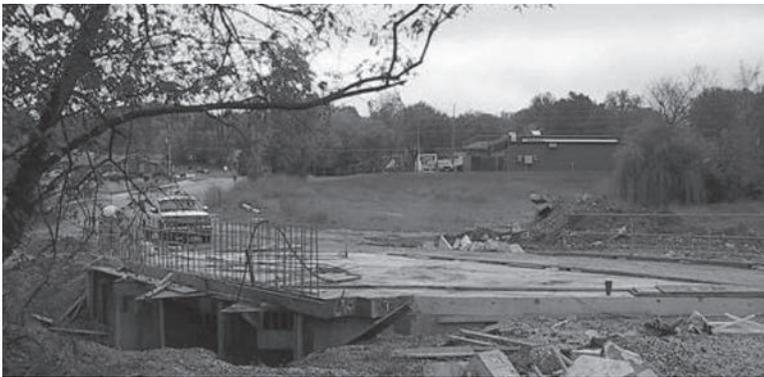
Figure 15—Southview Bridge-Deck Completed
