Concrete Mix Design: Key to Excellence in Performance of New Concrete Structures

By Jose M. Izquierdo-Encarnacion

Synopsis: In honor of Dov Kaminetzky, two case stories are discussed; one to reflect his passion for the correct usage and design for concrete and the other his other great passion, the forensic and technical evaluation of existing structures.

PCC PAVEMENT RESTORATION PR-22, PUERTO RICO

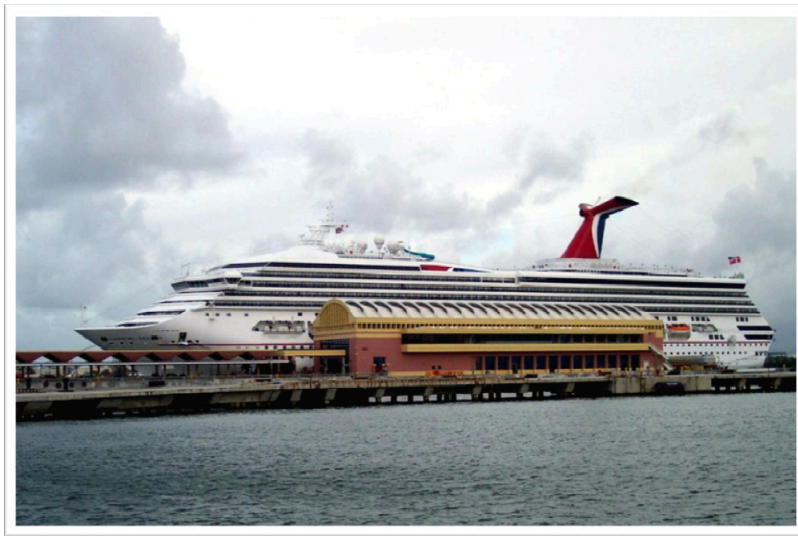
Figure 1 - East view of Pier#4

Several new technologies were used for the design of Pier#4, but in particular was a new bumper system that dramatically absorbed up to 90% of the docking forces. The architectural designs for the roof of the building consisted of twenty four (24) concrete shells, each 94 ft (28.66m) in span and 6 in (150mm) thick. This building, compared to those used for modern cruise ships now looks quite small.

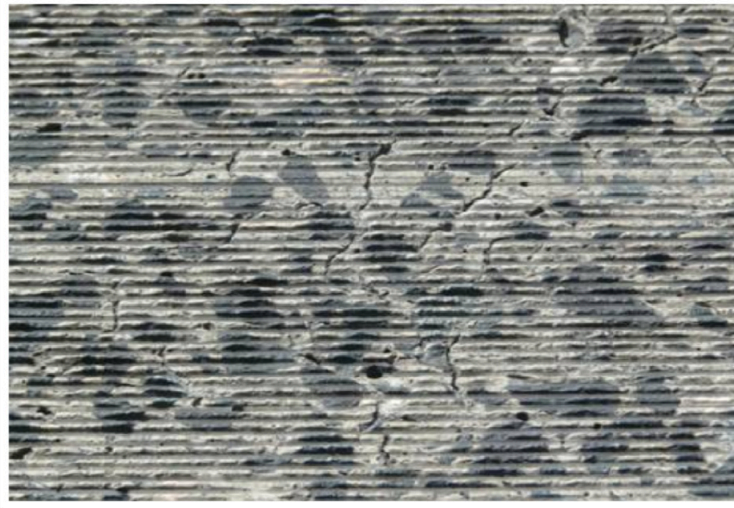
Figure 5 – Plastic shrinkage cracks

After a few months of operation the pavement showed cracks on several of the repaired segments. Some of the cracks were superficial and some were full depth.

As a reaction to the cracks, the curing process was improved by combining the use of curing compound and burlap cure. This action improved the performance, but did not solve the cracking problem.

1. Change the Concrete Mix Design to produce a concrete suitable at 36 hours without high volumes of cement.
2. Study alternative concrete mix designs with more compatibility with the existing pavement:
3. Eliminate reinforcement to match substrate properties.
4. Integrate partial slabs with repair materials and not dowels.
5. Change the shape of the cut sections for replacement, eliminating the creation of corners.
6. Schedule concrete placement to 4:00 am Saturday to force compatibility of expansion between existing concrete and new concrete.
7. Replace fully cracked slabs
8. Repair slabs with surface cracks with a High Molecular Weight Methacrylate (HMWM)

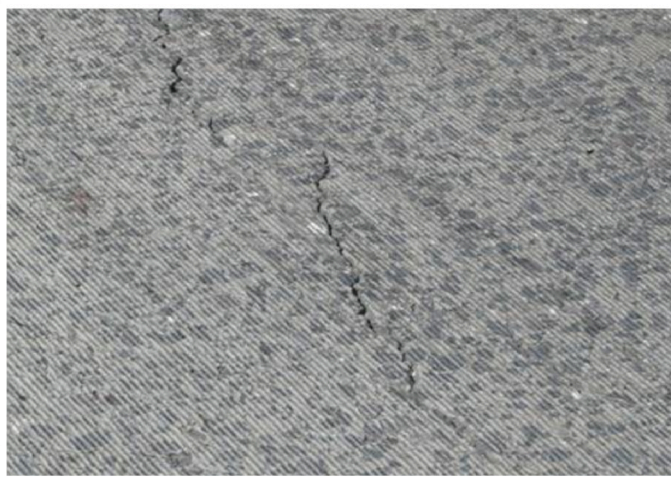
Figure 6 – Full depth cracks

Core samples were taken on several pavement slabs. All slabs were inspected to observe the type of distress shown. Combining the inspection with the study of the core samples, the slab segments were separated in groups indicating the type of damage. The evaluation was separated into:

1. Superficial cracks
2. Visible full depth cracks
3. Structural cracks due to cutting
4. Damaged joints
5. Excessive cutting
