TABLE 1--TEST LOADS AND LOADING AREAS

TABLE 2--TEST RESULTS OF MD SQUARE COVERS

TABLE 3--TEST RESULTS OF MD CIRCULAR COVERS

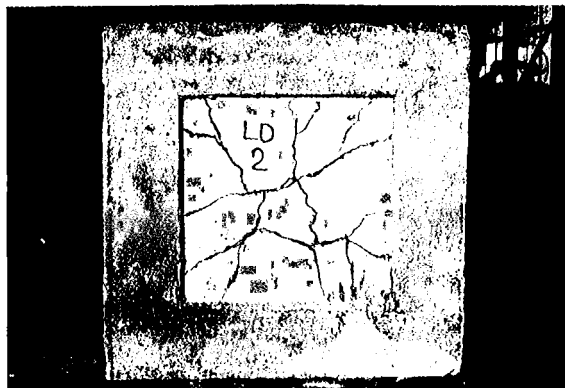
Fig. 11--Underside of LD cover after failure
