Longtime Studies and Field Experiences with Sulfate Attack

By Edward M. Harboe

Synopsis: Sulfate attack on concrete has long been studied and measures taken to combat sulfate attack. Therefore, damage due to sulfate attack is not prevalent today. Illustrations are given to show damage which results when preventive measures are not taken. Tests results are reviewed which led to preventive measures being taken, such as low C_3A cements, use of pozzolans, and low water to cement ratio concrete.

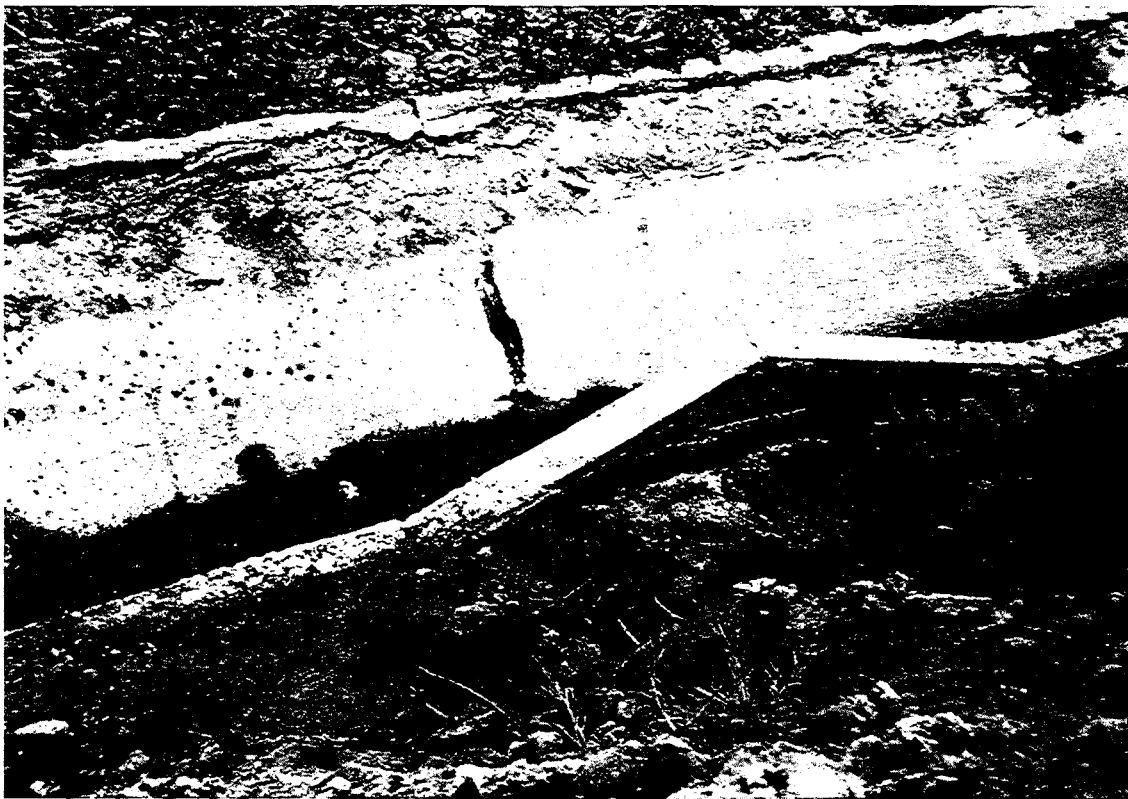
Fig. 2--Sulfate attack on concrete canal lining. San Luis Unit, Central Valley Project, California

Figure 2 shows a concrete-lined irrigation ditch on our San Luis Unit of the Central Valley Project in California. The concrete is in an extreme state of deterioration due to sulfate attack. The concrete was made with Type I cement and was 5 years old when the photograph was taken.
