INDIRECTLY-SUPPORTED ONE-WAY R/C SLABS: DURABILITY AND SAFETY ISSUES

Pietro G. Gambarova and Francesco Lo Monte

ABSTRACT: Simply-supported one-way R/C slabs are commonly used in the covers of small and medium underground facilities, where durability is the main issue face with rather limited service loads and short spans (2-4 m [6.5-13.0 ft]). The structural performance, however, should not be underrated, as being the slab in a roundabout does not prevent a heavy truck from straying off the right lane!

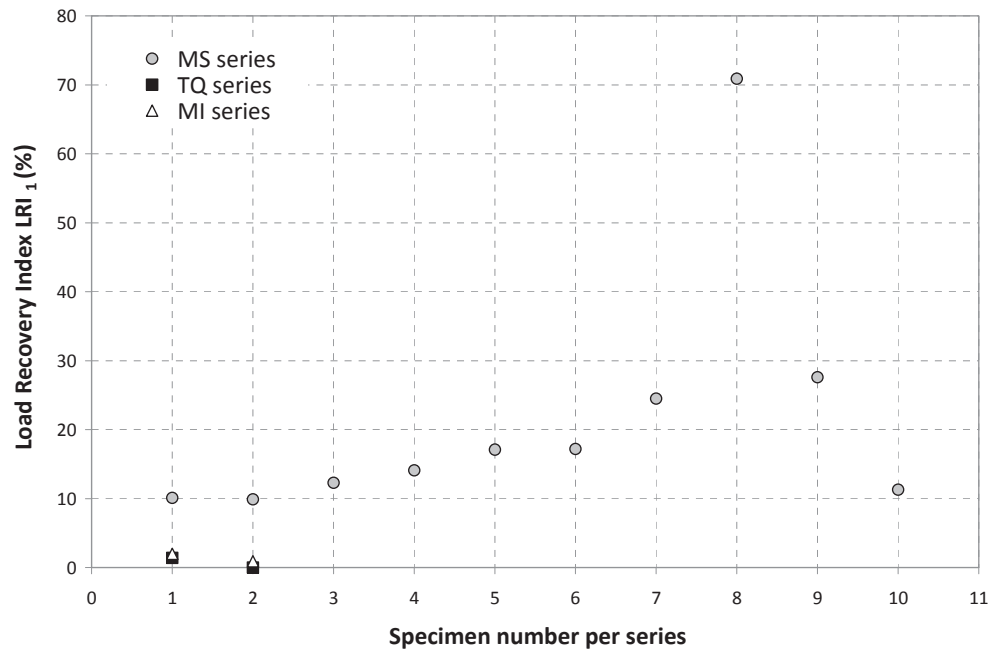
Figure 1 – Load Recovery Index in three-point-bending for control specimens (TQ and MI series) and self-healing specimens (MS series).

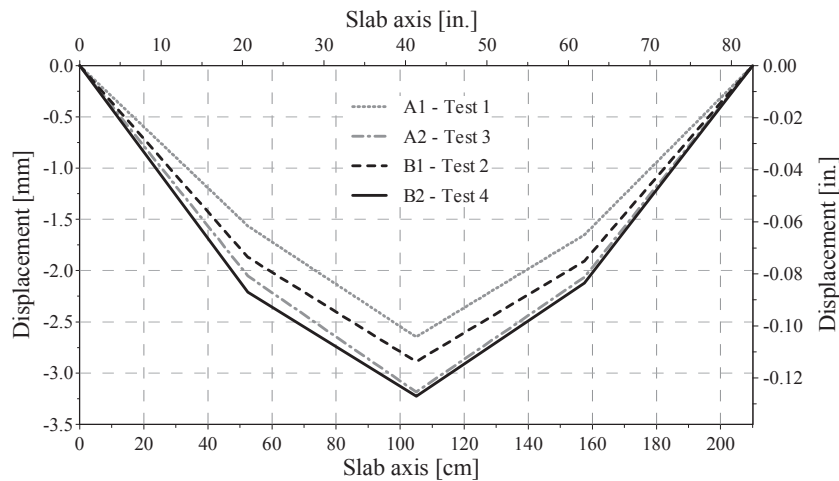
Figure 6. Bending tests (working loads): diagrams of the vertical displacement for the Slabs A1, A2 (hooks in the corbels and bent-up bars), and B1 and B2 (straight bars in two layers), for $P = 60$ kN [13.5 kips].

The longitudinal displacements under the working loads (60 kN [13.5 kips]) are plotted in Fig. 6 for the four slabs investigated in this research project (Slabs A1 and B1 with distributed load, and A2 and B2 with concentrated load). Each diagram is the average of the measurements taken along each of the unsupported sides.

The diagrams are very similar, since in the uncracked regions ($M < M_{cr}$) there is hardly any difference (because of the negligible role of the reinforcement), while in the cracked regions ($M \geq M_{cr}$) the deformations are controlled by the bottom reinforcement, which is the same in all slabs. (Under the working loads, the intermediate reinforcement hardly contributes to the bending behavior of Slabs B1 and B2, because of the closeness of such reinforcement to the neutral axis of the sections).

For the same arrangement of the reinforcement, the concentrated load yields a 20%-larger max. displacement in Slab A2 compared with Slab A1, and a 12%-larger max. displacement in Slab B2 compared with Slab B1. However, averaging the two load situations shows that straight bars (Slabs B1 and B2) bring in a very small increase (close to 4%) of the maximum displacement, compared with hooked bars (Slabs A1 and A2).

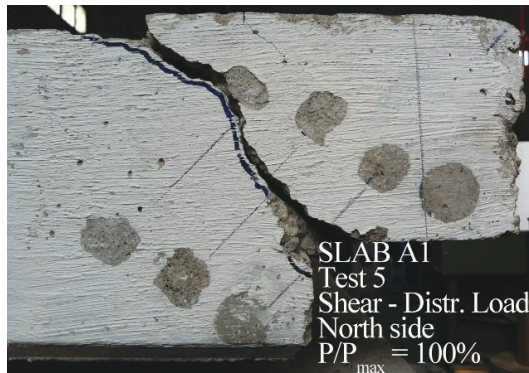
Figure 9 - Slab A1 with hooks and bent-up bars: shear Test 5, distributed load, $P_u = 401 \text{ kN}$ [90 kips].

Furthermore, in the slabs provided with web reinforcement (i.e. with vertical hooks and bent-up bars, Slabs A1 and A2, Figs. 9 and 11) the cracks turned out to be mostly inclined by 45° or were even steeper, but along the north side of Slab A2 (Fig. 11), where the initial cracks at 45° were accompanied by other flatter cracks certainly related to the 3D effects induced by the concentrated load, which was also responsible for the rather complex crack system visible along the top face.

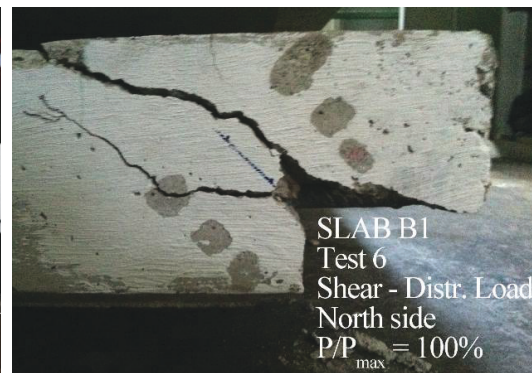
Figure 10 - Slab B1 with straight bars: shear Test 6, distributed load, $P_u = 172 \text{ kN}$ [39 kips].

In Slabs B1 and B2 provided with straight bars (Figs. 10 and 12), the cracks tend to be flat and extended; furthermore, the concentrated load (Slab B2, Fig. 12) induces a 3D behavior that is the culprit of a complex system of cracks extending from the top surface to the unsupported sides. The rather flat alignment of the cracks is justified by the formation of a *shallow-arch and restraining-tie* system (Fig. 13b). The closer the collapse, the more evident the shallow-arch behavior.

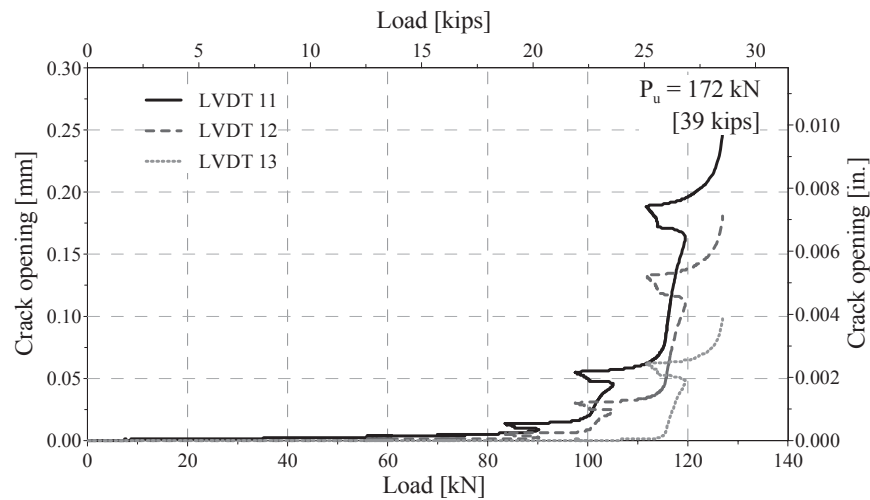
Figura 15 - Shear Test No.6 – Slab B1: cumulative crack width as a function of the load close to the internal corner of the corbel (west corbel, north side).

Up to the service load ($P = 60 \text{ kN}$ [13.5 kips]), there are no visible cracks originating from the internal corner of the corbel (crack opening $\leq 50 \mu\text{m}$ in Slab A1, Fig.14 and $\leq 10 \mu\text{m}$ in Slab B1, Fig.15).

In Slab B1 (Fig.15), the cumulative width of the couple of inclined cracks exhibits very low values up to 50-55% of the maximum load (90 kN [20 kips] compared with 172 kN [38.7 kips]). The LVDTs were removed at 75% of the expected maximum load. Between 100 and 120 kN [22 and 27 kips], roughly 60 and 70% of the maximum load, crack opening tends to diverge at lower values than in the previous case (Fig.14), as a confirmation of the less efficient control exerted by straight bars on crack opening, to the detriment of durability.
