## IMPACT ANALYSIS FOR WHARF 8 REMOVAL

## **Sediment Removal and Material Placement below Existing Structures: Challenges and Case Studies**

K. King, P.E.<sup>1</sup>; M. Whelan, P.E.<sup>2</sup>; R. Sherwood, P.E.<sup>3</sup>; and T. Wang, P.E.<sup>4</sup>

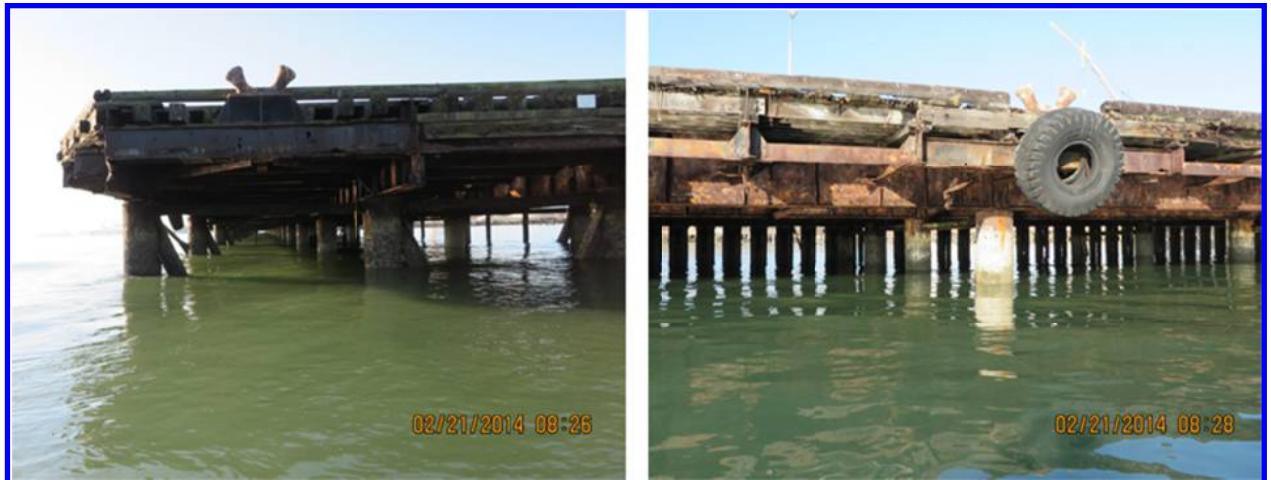
Wharf 8 is a 1,300-ft long, 82-ft wide pile-supported pier running in the roughly north-south direction that is connected to land by a perpendicular 700-ft section of pier. The wharf has been out of use for many years. The north-south span is supported by rows of circular steel pile (3 wide) which are spanned by 3-ft steel girders running along the length of the pier. The pile field has some effect on tidal currents as noted in the modeling, and at high tide, the bottom of the girders could provide some attenuation of storm waves. A 300-ft section of the wharf also has a vertical timber screen which could offer additional protection. Photos of the Wharf 8 structure and timber screen are shown in Figure 6.

**Figure 6. View from north end of Wharf 8 looking south (left) and timber screen on Wharf 8 (right), looking west.**

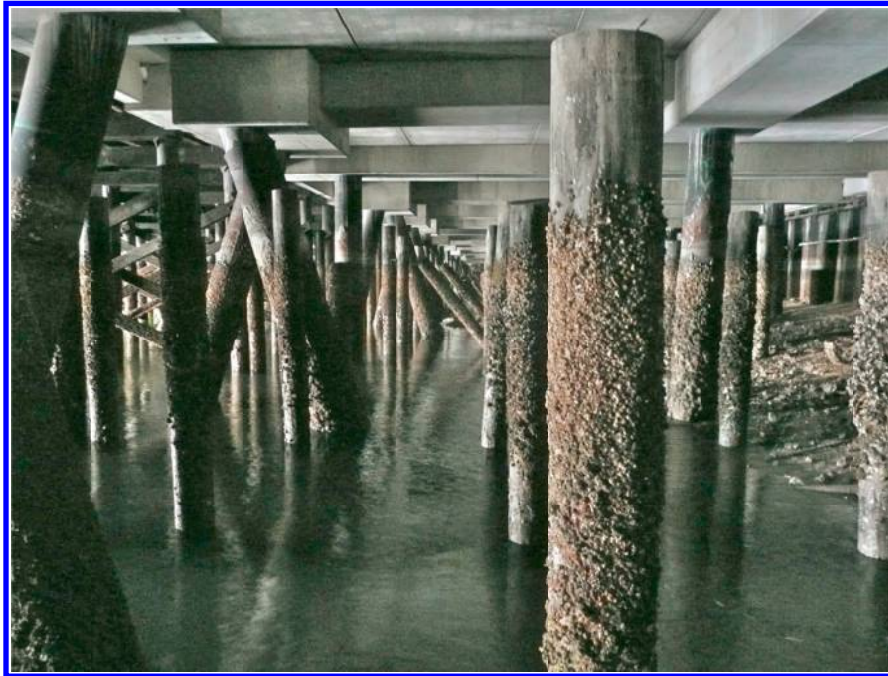
**Figure 1. Typical Under-structure Conditions, Including a Series of Piles, Batter Piles, Timber Lagging, and Shoreline**

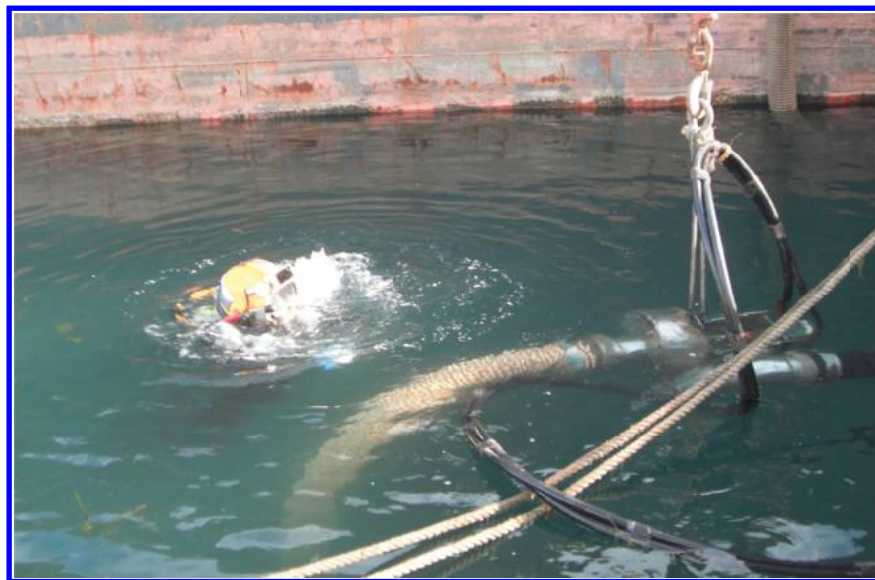
Hydraulic dredging was used successfully at the Pete Archer Rowing Center in Long Beach, California. The project involved removing approximately 380 cubic meters (500 cubic yards) of clean sediment below an existing dock, which was grounding periodically and incurring damage as a result of sediment buildup. Due to low production rates and in-situ debris encountered during dredging, the project took approximately 8 working days to complete. Figure 2 illustrates diver-assisted hydraulic dredging at the Pete Archer Rowing Center.

**Figure 2-1. Diver-assisted Hydraulic Dredging System Using a System of a Cutterhead Dredge and Hoses.**

An example of one hydraulic alternative for removing the sediment below an existing structure is through a long-reach hydraulic suction hose, potentially using diver-assisted equipment. A diver-assisted suction dredge is a commercially certified, umbilical-supported diver operation with hand-vacuum dredge units. Diving operations could be deployed from a dive-support platform above water. Hydraulic under-structure dredging can incur high costs compared to other techniques and can be labor-intensive (and therefore, relatively slow). Other feasibility concerns to consider are the significant volume of water generated and the potential for debris and broken piles to clog the dredge.
